Some Challenging Geotechnical Projects

Madhav Madhira

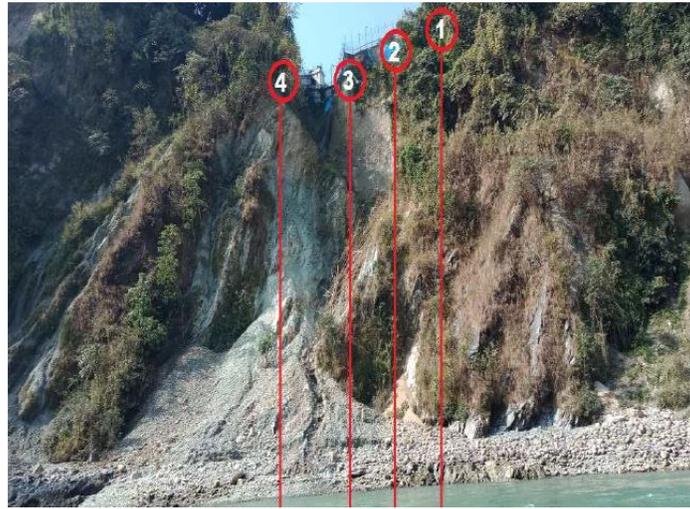
Fig. 3 Slope Failure leading to Collapse of part of the Compound Wall

The soils collected indicated silty soil with boulders at Point 1, weathered disintegrated flaky rock and silty soil at Points 2 and 3 and powdered rock with silty soil with boulders at Point 4. Causes of failure of the upper part of cliff are surmised as possibly due to erosion of soil near the toe of the fast flowing river, intense rainfall during the months of May to September and a storm water drain outlet.

Two alternate design solutions, viz., reinforced earth wall supported by plum concrete anchored to rock slope and rock/soil anchors were considered. However a combination of both (Fig. 5) was implemented.

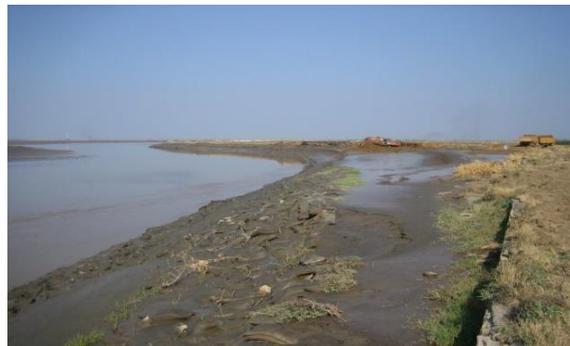
Fig. 7 Example of Coastal Erosion

Extreme coastal erosion was taking place in the Gulf of Khambat (Cambay) (Fig. 6) for years due to both natural changes and human intervention to the coastline. The tide was reported to be 5.5m to 6.0 m high and water velocity of the order of 5 m/s. It was reported that coastline was moving inwards (Fig. 7) at the rate of 10 to 20 m per year and damaging the boatyard (Fig. 8) and even some of the installations of ONGC a little farther inland. Attempts to prevent or control the rapid erosion with piles/sheet piles were unsuccessful.

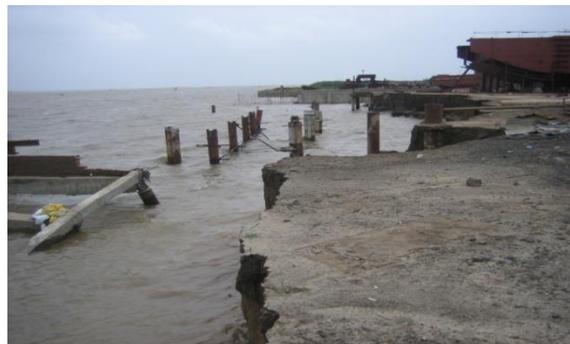
Fig. 8 Critical State of Erosion- Note State of Earlier Control Measures

The soil at the site was silty sand/sandy silty which is easily erodible. The problem needed an out of the box approach. The solution suggested and implemented consisted of using gabions and

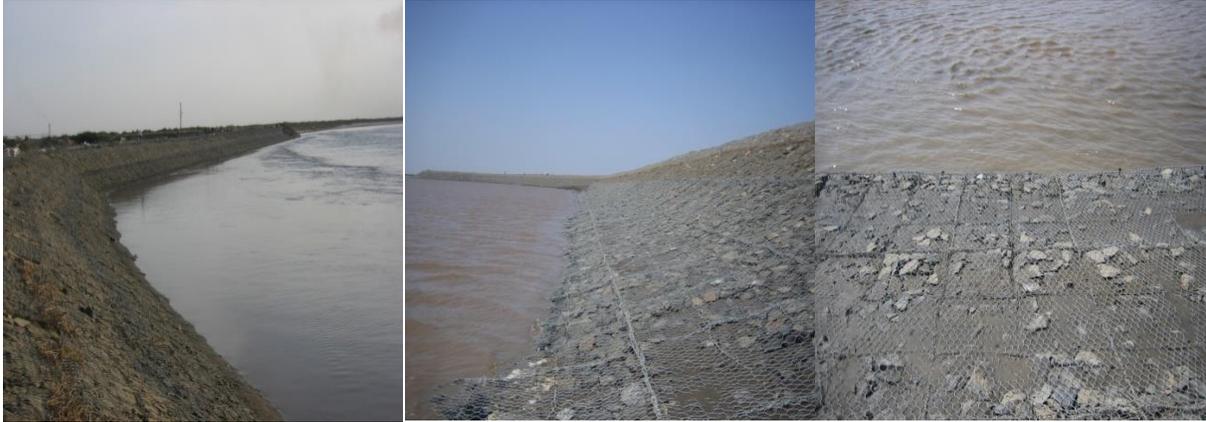
(a) (b) (c)
Fig. 10 The Solution (a) Immediately after Installation, April 6, and on (b) May 16 and (c) Aug. 4, 2007

Fig. 10 illustrates the solution soon after installation in early April 2007 and over the next four months, in May and August 2007. Needless to state the work had to be carried out in flowing water with pre-filled gabions launched from barges and with divers tying them under water. It has reported that the erosion has been controlled successfully. Some accretion of fines can be noticed at low tide.
