Geotechnical Problems in Dams: Case Studies

Case Study I: Geotechnical Problems, Design and Construction of Cofferdam on Narmada River for Indira Sagar Project in Madhya Pradesh.

Case Study II: Anchored RCC Diaphragm Wall Cofferdam for Bisalpur Dam Project in Rajasthan.

Case Study III: Restoration and Rehabilitation of Old Pagara Masonry Dam by Grouting Technique in Madhya Pradesh.

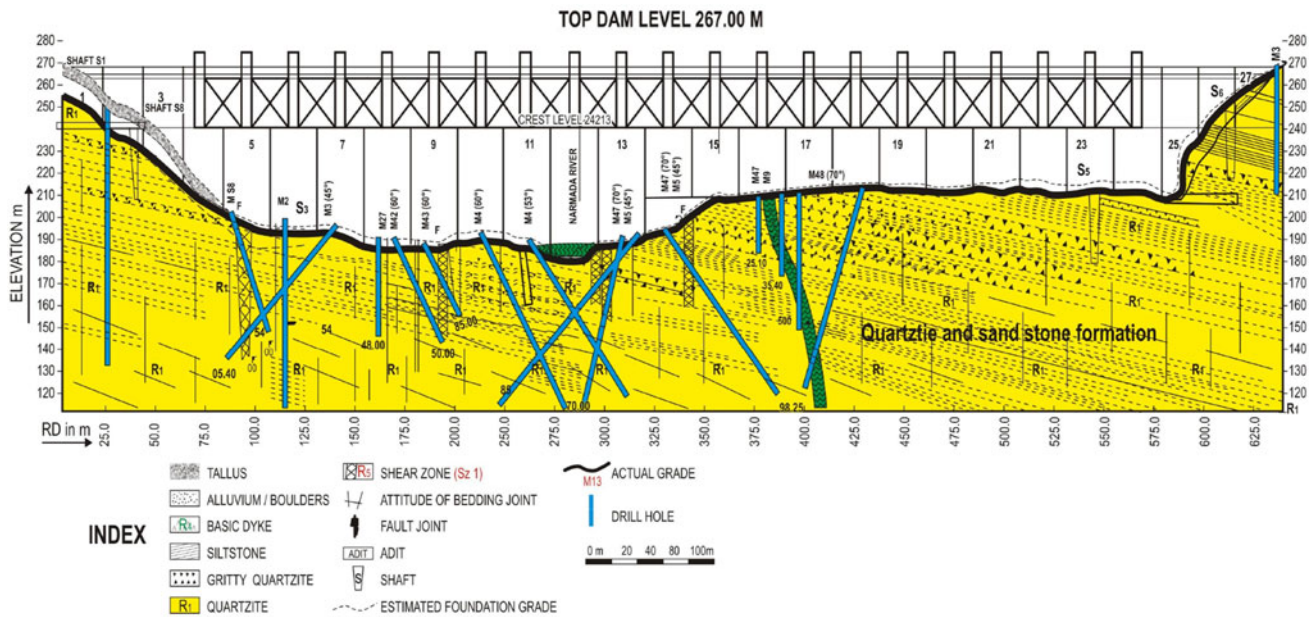
Fig. 3 Geological L-section along main dam axis showing shear zone and other discontinuities

The Geological survey of India had carried out elaborate geological studies at the Indira Sagar Project dam site. It has been indicated that the dam site is located in the upper vindhyan inter bedded sequence of tough quartz arenites (quartzite), sand stones with minor silt stones. The bed in general has an ENE-WSW strike and dip by 15–25 towards NNW with exceptional steep dips of 40–45 due to local warping. Bedding shears of 10–25 cm thickness confined to the silt stone beds are common features. The dam area in the river bed is occupied by a number of ENE-WSW trending vertical fault/shear zone, indicating horst/graben structure showing relative vertical displacement of blocks. It is WSW continuation of the Sone-Narmada fault. Mapping of the area has identified about five shear zones ranging steep dipping to vertical. These zones are braided with clayey gougey shear seams of 0.10–0.75 m thickness enveloping competent fractured lenses of quartzites and sand stone of 0.50–2.5 m width. Figure 3 shows geological L-section along main dam axis.

The fault zone includes the shearing (Sz-5), by virtue of its disposition and continuity, extends beyond the coffer dam located about 80 m upstream of the exposed section and opens into the water pool, created by the upstream coffer dam inspite of being directly connected to this water pool, created by the upstream coffer dam. Inspite of being directly connected to this water pool with a head difference

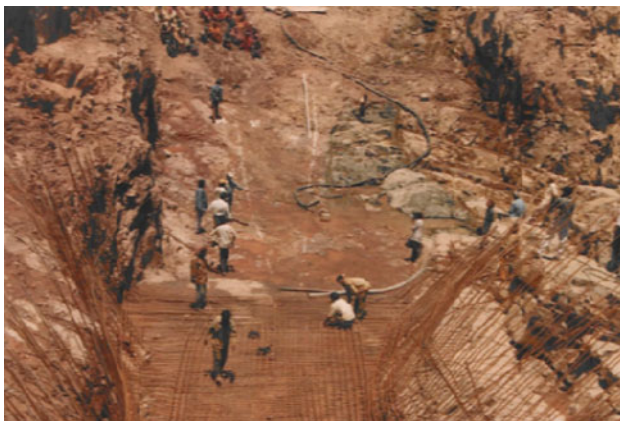
Fig. 4 Treatment of fault zone

of about 18–20 m the exposed section is completely dry and points to the near impervious nature of the fault zone material. Permeability test carried out in the new test holes in the fault zone confirm this observation (<1 Lugeon). Except in the highly crushed zone/intrusion dyke, the fault zone material looks well compacted and was expected to have high in situ density in the range of 2.2–2.3 (Fig. 4). The shear strength parameters were high and grain porosity may not exceed 20 %. The material did not show any significant deterioration notwithstanding the fact that there has been water to a depth of 1–2 m standing on it for a considerable time.

This Data indicated that the sheared/crusted rock mass shall get consolidated if consolidation grouting is carried out and after completion of coffer dam, curtain grouting is also recommended, 1 m from the upstream face of coffer

Consolidation grouting in each block of the coffer dam for full area of foundation was carried out and also the curtain grouting as recommended 1 m from upstream face of coffer dam. This treatment made the coffer dam fully watertight.

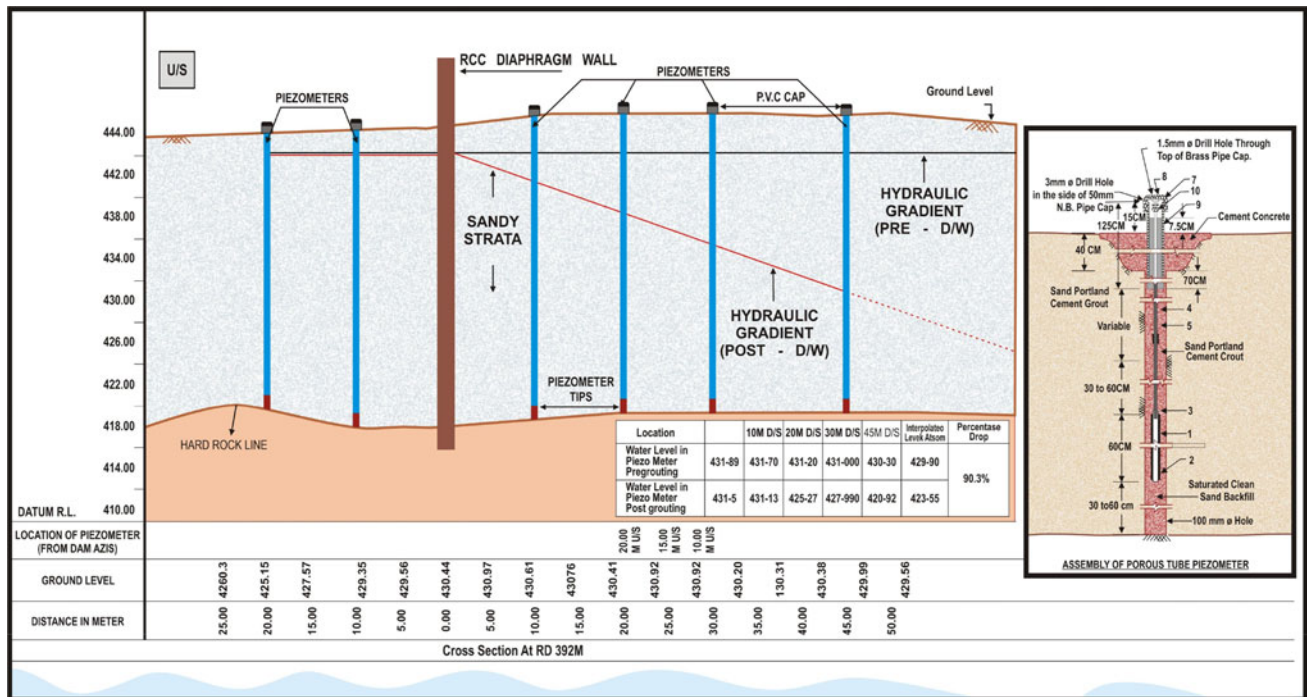
Fig. 40 Piezometer observation at Bisalpur dam

It was observed that drop of head across the diaphragm wall at 90 m distance is more than 90 %, practically in the entire length of diaphragm wall coffer Dam (Fig. 40).

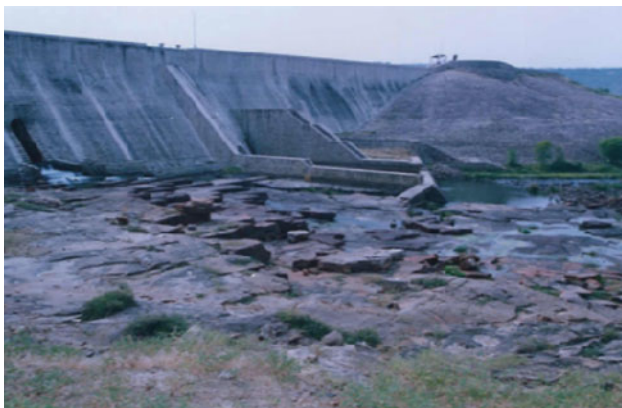
Fig. 42 Open joints in dam foundation

The masonry dam was founded on sand stone formations which had open joints (Fig. 42). These joints had not been treated. There existed high permeability in the upper layer of foundation rock.

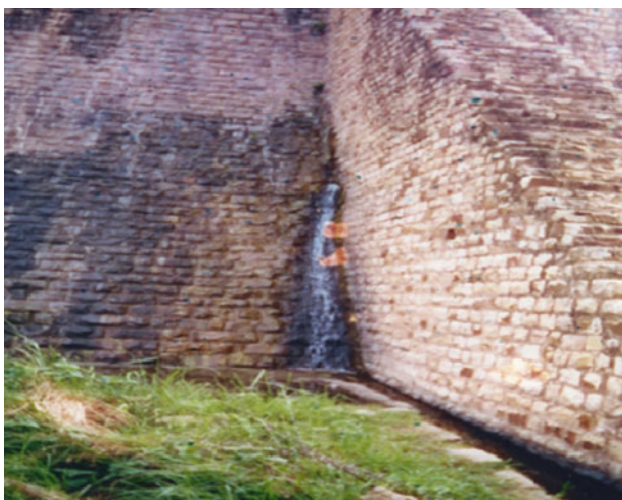
Fig. 43 Seepage through masonry dam

On the downstream face of masonry, very heavy spouts of water were coming out (Fig. 43). The entire downstream face was wet and most of the masonry joints were leaking. This further confirms that mortar from the joints has been washed out and lot of voids has been created in the body of the masonry. The body of the masonry dam was porous and safety of this structure was under danger zone.

For grouting a badly leaking masonry dam, cement grout is sufficient. At few places wherever porosity is very high, colloidal grout of sand and cement can be used.
