Proceedings of Indian Geotechnical Conference 2020
December 17-19, 2020, Andhra University, Visakhapatnam

Investigation and Design of Remedial Measures for Landslide in Hunthar Veng, Mizoram – A Case Study

Abstract. The city of Aizawl (Capital of Mizoram) is linked with rest of India through the National Highway-54 (NH-54). The highway near the Aizawl city is prone to landslide (at Km 179.50 on NH-54) and sinking due to haphazard growth of the city on vulnerable slopes and poor drainage system. The Hunthar Veng landslide area is active since 1993 and gets reactivated every year after the monsoon. If the area continues to slide and sink and not treated properly, it is possible that hazard could propagate to a much larger area, thereby putting a greater number of houses and properties at risk. Looking into the danger prevailing in the region, it was decided to focus on strengthening the slope and increase its stability. Slope stability analysis was carried out by considering the seismicity susceptibility. Different ground improvement options like (a) Grouted nails, (b) Removal of debris and installation of grouted Nails and (c) Stepped Slope with Cut-off Wall were considered for st

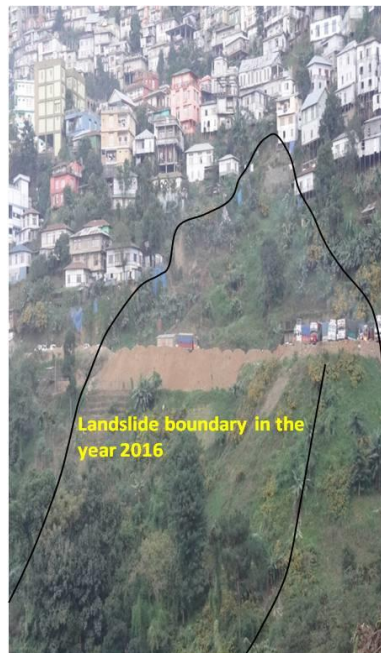
gets reactivated every year after the torrential rain. On August 2016, landslide took place due to heavy and incessant rains. The area currently affected by landslide covers 126886 sqm, affecting more than 100 houses as shown in Fig-1. The total affected length is about 490m and with a width of 185m at the top and gradually tapering at toe portion. If this landslide remains unchecked even for one more monsoon it could result in total blockage of highway which would result in shortage of food and essential daily basic needs of Aizawl city. In order to ensure safety of the people living near the slide area and for people travelling through this area daily and also for the entire economy of Mizoram, it was decided to stabilise the slope with suitable remedial measures with no further delays. This paper describes the complete analysis as carried out on the affected slope and remedial measures for mitigating the landslide. Remedial measures were worked out especially to stabilise the upper thick layer of debris that are located along the affected area as no bed rock has been observed in the subsidence zone. Another major factor considered in the stability analysis was water table, because most of the landslides in the region are found to occur during the monsoon period. During monsoon, overburden material gets saturated, resulting in the reduction of its shear strength and increase in pore water pressure, which decreases the slope stability.

Fig. 1. Hunthar landslide and Sinking Area (Ch : 179/500 km on NH-54)

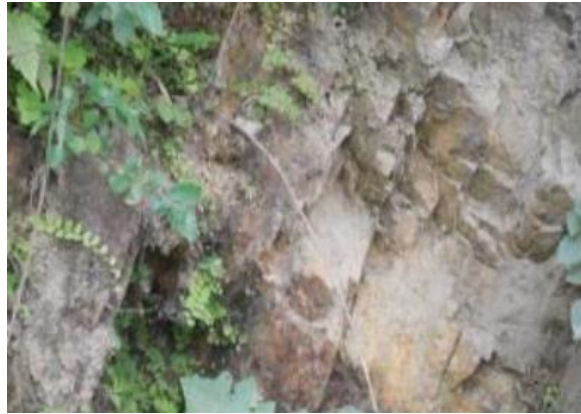
The soil formation in the Hunthar Veng area, in general, is of loose sedimentary type with high porosity and permeability. The top of hills being capped by sandstone having sufficient porosity, rainwater infiltrates down to interface with impervious clayey shale layers (Fig. 2) and exit to the surface due to gravity. While coming out through the shale/silty soil layers, the water carries with it the slope forming material from down below. It results into the subsidence of the area. It was also indicated that there are lot of water channels in the landslide affected area, out of which some are visible and some of them are required to be unearthed.

Fig. 2 Shale and interbedded siltstone–shale at the road section of NH-54

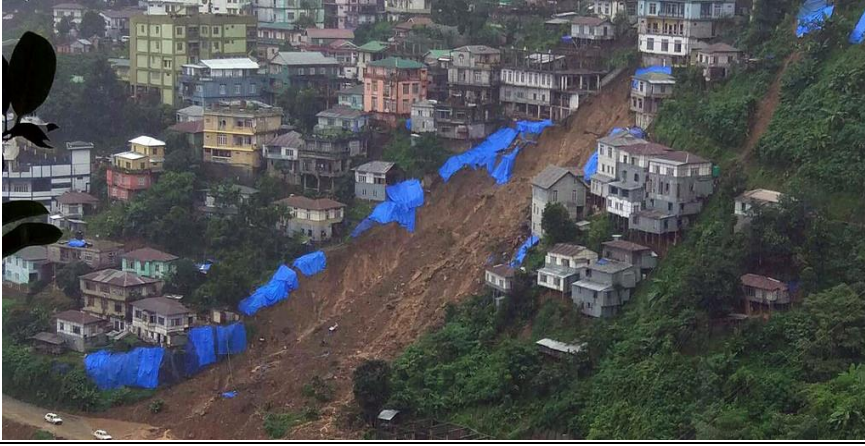
Fig. 3. Affected area above National Highway

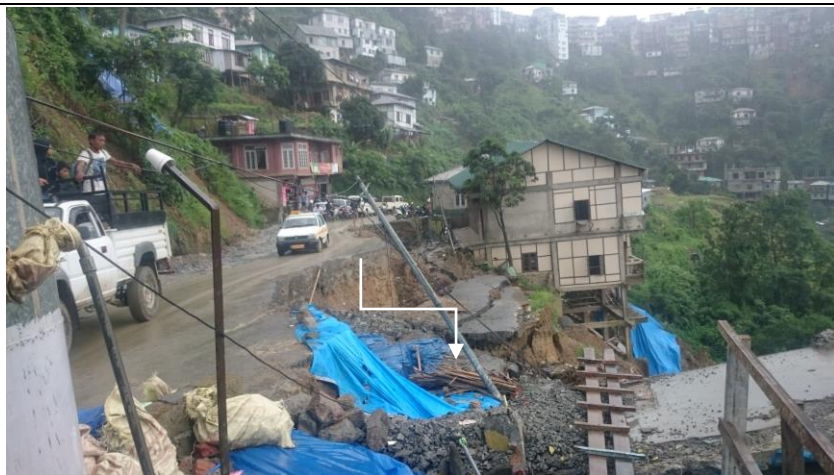
Fig. 4. Sinking / sliding of National Highway

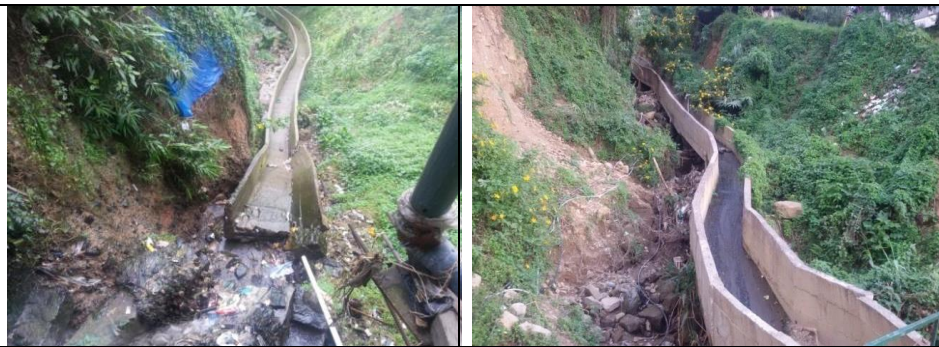
Fig. 5. Condition (eroded and broken) of side drains adjacent to affected slide

- **Surface water:** During investigation it was observed that the area is lacking improper road side and surface drainage system and also sewage system which induced instability of slopes that triggered landslides.

In view of the above detailed analysis, it is opined that the remedial measures such as provision of drainage (Longitudinal and Transverse drains, RCC tube wells), vegetation & turfiing, construction of retaining wall at the toe of the slope etc. including evacuation of population close to the affected slide area be implemented.

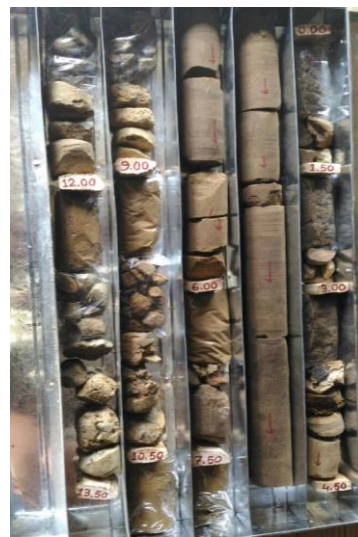
Fig.7. Rock showing poor core recovery

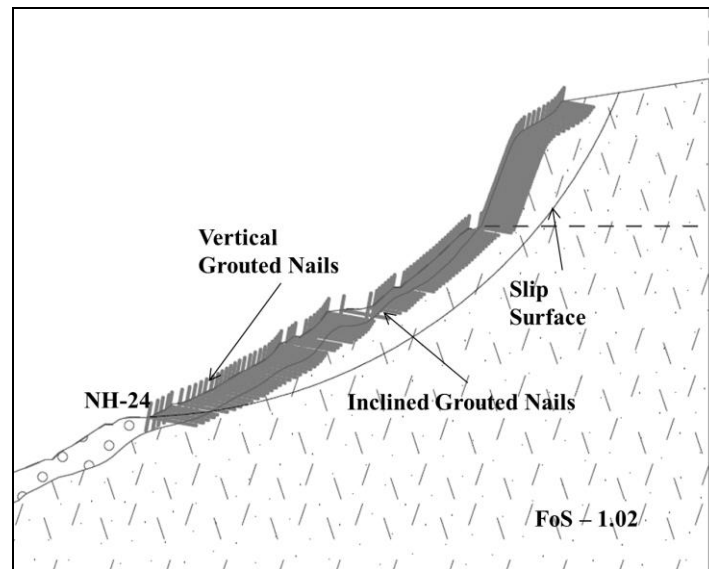
Fig. 9. Slip Surface for Option 1

Figure 9 presents the stabilization measures option 1 (Inclined and Vertical Grouted Nails) with grouted nails, it can be seen that the Factor of Safety (FoS) is still less than the required limit set by the standards (1.25 [6]). Slip surface passes well below the reinforced region and it starts from the crown of the affected area and ends at the toe of the affected area they still lead to a translational failure.

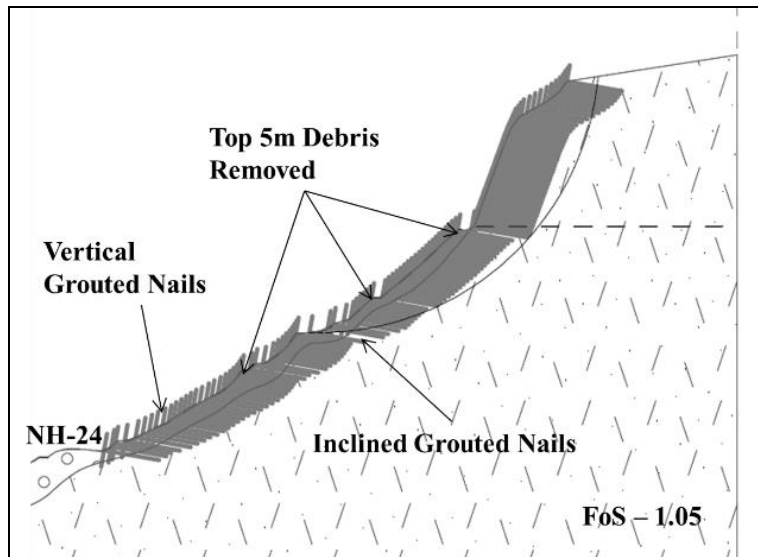
Fig. 10. Slip surface for Option 2

In order to improve the stability of slope, in option 2(Removal of Debris and Installation of Grouted Nails) it was further thought to remove the debris by 5m in vertical direction from bottom to top and making berms of suitable width and nails were installed on the slopes created in such manner. The results of the analysis are shown in Fig. 10. It may please be noted that even with such an arrangement the factor of safety was found to be less than 1 as face failure occurs.

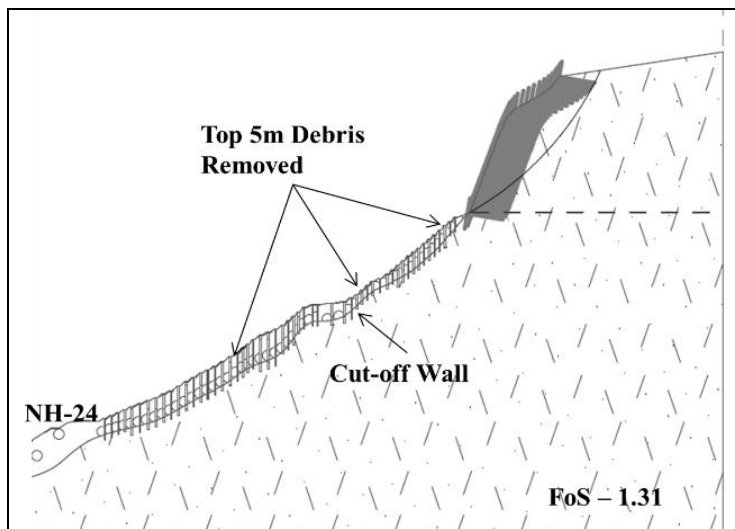
Fig. 11. Slip surface for Option 3

Figure 11 presents the final option 3 (Stepped Slope with Cut-off Wall). In option 3 cut off walls was provided in the form of continuous piles (very close to each other horizontally so that it forms a wall). They were provided from middle portion to lower portion at a vertical distance of 3m and up to a depth, where the piles are embedded into HWR at least up to depth of 3D to 5D. Only with this arrangement a factor of safety greater than 1.2 could be obtained. All the above slope stability analysis results are indicated in Table 5.

Based on the stability analysis, it was found that the slope above the National Highway-54 is highly unstable. The factor of safety of the slope after applying different measures was not adequate except in one condition, where cut-off walls of large depth i.e., up to 20m in depth at a spacing of 2.5-3m from top to bottom was provided. Such a solution though analytically appears to be satisfactory would involve high cost. This may also invite many unforeseen construction related problems for which highly experienced professional may be required to be involved.
