## Case studies and forensic analysis of buildings collapsed recently in Bengaluru and review on foundation failures in Delhi

H. S. Dharshan Kumar<sup>1</sup> and H. N. Ramesh<sup>2</sup>

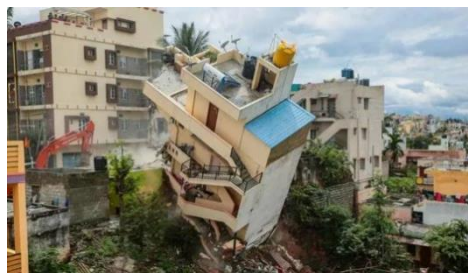
- a) The Foundation of the building was in an elevated plane above the empty site behind it with inadequate support.
- b) When it was raining heavily the soil under the foundation started to wash out towards the empty site.
- c) The ground floor sank following the foundation failure.

**Fig.1.** Building falling back due to foundation failure

**Fig.1.** Rare view of two buildings at Kamalanagar

- There was a building in the plot behind, which was demolished recently. Both buildings had common walls on the adjacent sides.
- After the demolition of the building behind, the adjacent building lost lateral support for the foundation at the back.
- The structure now had an unsupported floating wall on the back side, creating a risk of toppling at any given instance.
- Due to heavy rainfall the soil under the foundation washed off. Thus, the foundation failed due to the rapid movement of land mass over the slope.
- As soon as a building was demolished behind the plot, the soil slope should have been given the necessary support to hold back the foundation.

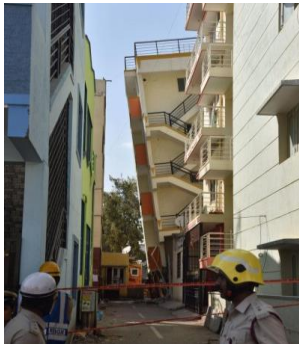
**Fig.5.** Tilted building

- The building was built with 5 floors without approval from the BBMP.
- It was identified that the owner of the adjacent plot carried out deep excavation of a 10ft x 10ft water sump using JCB.
- A foundation pillar of the collapsed building was damaged during excavation and caused the tilting of the building.

- a) It is observed that the building was not constructed according to the building bylaws, and adequate setbacks were not maintained.
- b) The JCB operator while excavating in the adjacent plot had damaged parts of the foundation column of the building causing the weakening of the structure.
- c) A sump in the adjacent plot developed cracks and water began to seep into the foundation. As we know the rising and fall in the groundwater level affects the soil behaviour. The water level rise in the ground reduces the bearing capacity of soil and receding water cause sinkhole formation due to overburden pressure.
- d) The weakened soil and damaged foundation pillar together has caused the failure.

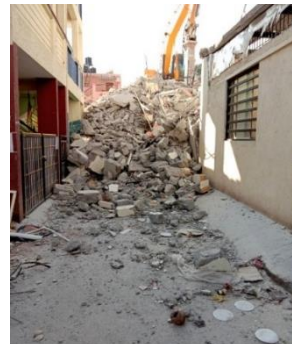
**Fig.6.** Demolition of the building

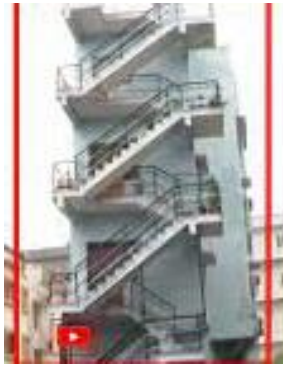
- a) Insufficient foundation, Poor structural design.
- b) Constructed by violating the building By-laws.
- c) The building was built next to the stormwater drain.
- d) Storm water drain runs deeper than the foundation of the building.
- e) The building tilted backwards following the rain in the city.
- f) Cracks were developed in the staircase, walls, and concrete flooring in front of the building.

**Fig.7.** Failed structure at Poornachandra layout

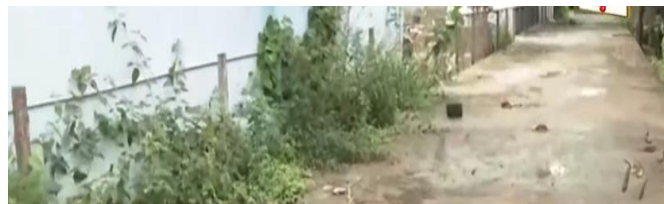
**Fig.8.** Building constructed adjacent to the storm drain side wall

- d) Since the stormwater drain was flowing deeper than the foundation of the building, the building loads through the foundation were acting on the sidewalls of the drain which was adjacent to the foundation.

- e) Due to the rains and rise in the water table affected the dimensions of supporting soil strata and increases the effective lateral pressure on the sidewalls of the drain.

- f) The sidewall which was old and weakened over the course of time failed under the building load and increased lateral pressure.
- g) This made the foundation lose support in the backside of the building and caused the partial sinking of the foundation.

- h) This is a classical geotechnical failure called the differential settlement that is usually caused by unequal load distribution resulting in unequal settlement of the foundation.

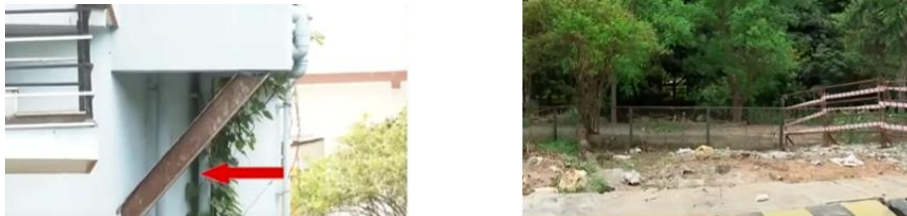
- c) Although the building owner realized the threat of this unsafe structure instead of demolishing it or getting help from professionals, he tries to repair it by himself giving an iron rod support behind the building.

**Fig.9.** Temporary support to the building at Poornachandra layout
