Forensic analysis of building collapsed in Bengaluru and Review of foundation failure in shanghai.

O.Madhu¹ and H. N. Ramesh²

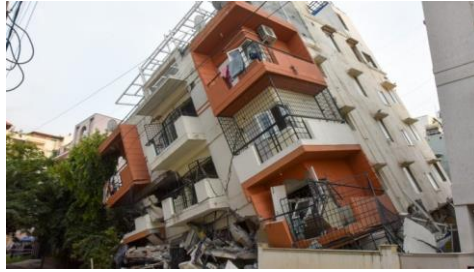
Fig.1. Failed structure at Kasturinagar.

- ❖ The main reason found to be the size of the concrete column, minimum 8 inches is must for the high rise buildings but the builder for to reduce construction cost provided 6 inches column instead of 8 inches.
- ❖ Setbacks for the building are not met up to the limits of Building bylaws.
- ❖ Deep excavation not done properly.
- ❖ The plan was approved by the BBMP officials in 2012-13 for to build ground and two floors on them but the agency built ground and three floors on them and later an illegal construction Pent house is carried out.

5. For load transfer failure one of the commonly adopted remedial measure is Underpinning process which helps to strengthen and stabilizing the foundation of an existing building and this process could be carried out at Kasturinagar building.

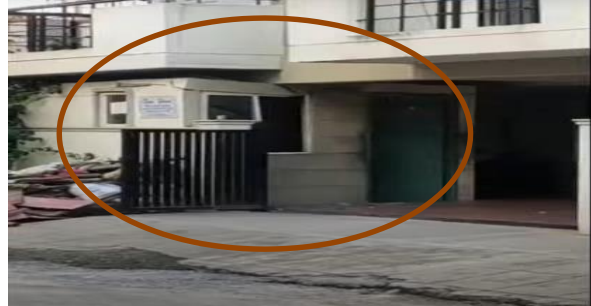
- ❖ **Load Transfer:** - Interconnected rigidity is absent because of that the whole load transfer through single support, due to that the size of

the footing varied which directly related to pressure distribution on subsoil.

Fig.2. Load transfer through single support

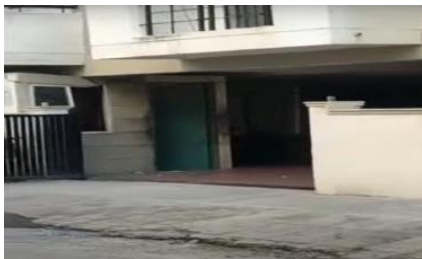
(5.a)

Fig.1. (a, b, c). Building collapsing images at Kasturinagar.

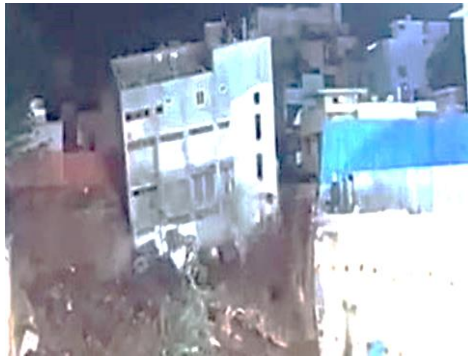
Fig.6. Failed structures at Gandhinagar.

Causes of Failure:- Set back rule violations, set back dimension reduced to get more rental square footage.

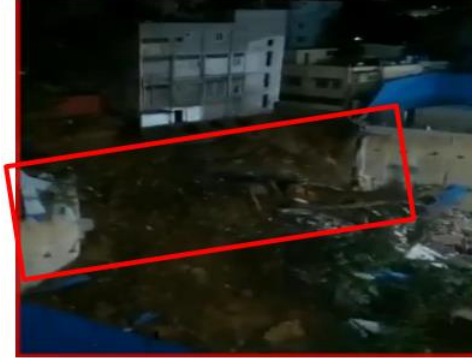
- **Lateral loads:** - Due to improper side supports to adjacent building lateral movement of soil is occurred. Kapali theatre located beside the building until 2017, but after theatre was taken down for a mall and multiplex having four basements, ground floor and five floors then site clearance and deep excavation process started with that simultaneously retaining walls construction work carried out other three sides of building except the side where collapsed building stands.

- Workers delayed the construction of retaining wall and it is happened during monsoon season which caused lag in work due to rain that become reason for soil displacement under the collapsed building foundation failure occurred.

Fig.7. Reason for soil displacement

6. Monitor potential sinkhole formation and control on dewatering and lower the ground water level at Gandhinagar site.
7. Soil nailing technique if may be used or proper design and construction of retaining walls at Gandhinagar site before work progress.

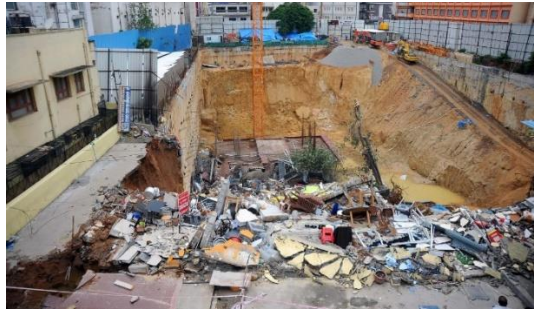
- **Water level fluctuation cause liquefaction of soil:** - the site and surrounding area comes under majestic locality in which historians say there were 12 kalyanis around majestic but later as city developed those kalyanis were filled up with mud and the construction carried on it later. This become one of the reason for rise and fall in ground water level and sinkholes are formed due to overburden of effective stress and ground subsidence, Rise in ground water level reduces the bearing capacity of the soil. The engineer involved in the project believes a rise in ground water table contributed to the weak of the soil.
- **Construction errors:** - Due to some poor construction practices during deep excavation also leads to failure in foundation that is building of retaining wall and deep excavation also started simultaneously

Fig.8. construction error at site.

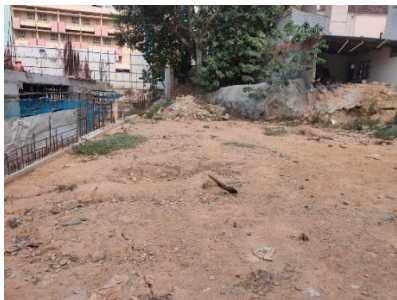
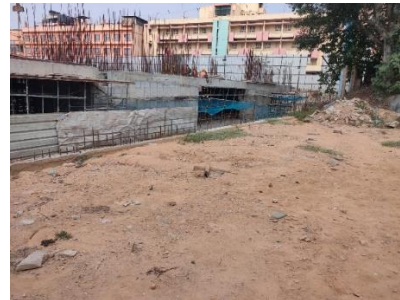
Fig.9a & 9b. Gandhinagar site after collapse.

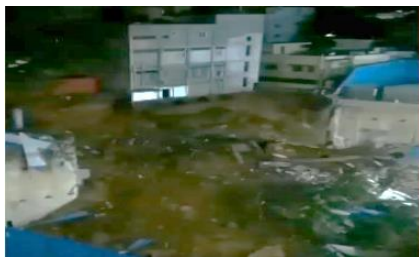
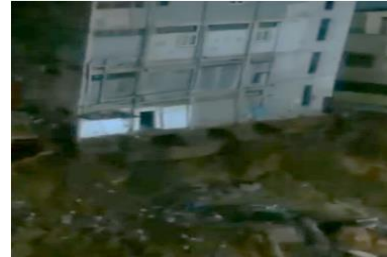
Fig.10. (a, b&c). Building collapsing images at Gandhinagar.

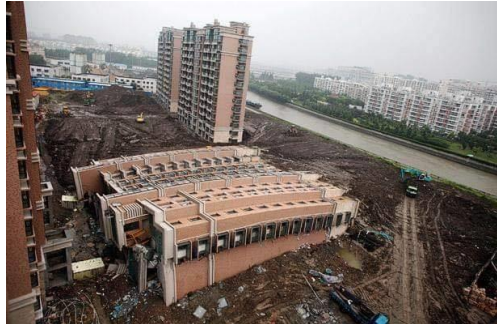
Fig.11. Failed structure at Shanghai

Lotus riverside residential complex located beside the river Dingpu and the building at finishing stage. The building rests on expansive soil and foundation for the building is pile foundation of pre-stressed high strength concrete piles driven to the depth of 33 meter rested on fine sand. Total 114 piles are used for construction. On 27 June 2009 the structure collapsed and a worker died due to collapse. The main reason for unoccupied building collapse found to be pressure difference on two sides of structure.

1. Lateral loads: - An excavation about 4.5 meter for the underground garage is carried at a distance of 7 meter from building and the vertical supports are provided with soil nailing of steel nail 7.2 m meter long, and those nails damaged the pile of structure.

2. Construction errors: - Excavated soil are disposed at other side of the building, and soil covered 36 meter wide and 10 meter thick of mass about 3000 tonne. Due to heavy surcharge load or overburden pressure occurred, the flood prevention wall constructed beside the river is in poor quality due the construction of the wall is not made of good quality material.

3. Failure of piles: - The piles located close to the dumped soil, whole 3000 tonne of surcharge load occurred on the pile head that leads to pile failure in the form of tension on dumped side and compression of concrete at excavated side. By examining this it clearly shows bearing capacity failure. By the observation, it indicates that while designing the piles surcharge load is not considered which further leads to damages in pile.

- Due to river located beside the site and the soil is expansive there should be a proper soil investigation should be carried out for to analyse the profile and stability of soil.
- Surcharge load is not considered in the design of piles, by considering this case is an example, geotechnical engineers and contractors should better to improve their understanding the importance of surcharge load on pile.

- Construction sequels and site supervision scheme should be carried out without any third-party interference.
- Design of soil nail should be carried out as per site condition.
- The designed parameters should meet all the safety condition of geotechnical, environmental and other major engineering parameters and procedure for construction should followed as per International building standards.
