## Slope Repairing Methodologies in Railway Embankment

**Abstract.** The generalized methodology of slope repairing for railway embankment considering several case histories in northern India is presented in this paper. There are many available literatures to assess the reason of recurring slope failures and its preventive measures from construction point of view. However, there is no synthesized practical recommendations to overcome the issues of recurring slope failures and address the common methodology for already failed slope repairing system. The present study focuses on the slope repairing methodology under different scenario of rain-cut problems. The common issues like rainfall infiltration, slope height, soil types, fines content, level of compaction etc. Slope stability analysis has been performed for the respective sites with the already failed slope conditions to understand the requirement and utility of slope repairing techniques. About 7000 km of Indian railway track has been built on the weak formation it's inevitable to have slope failure and the high demand of high-speed railway track also support the requirement of long-term stable slope repairing methodology. Se

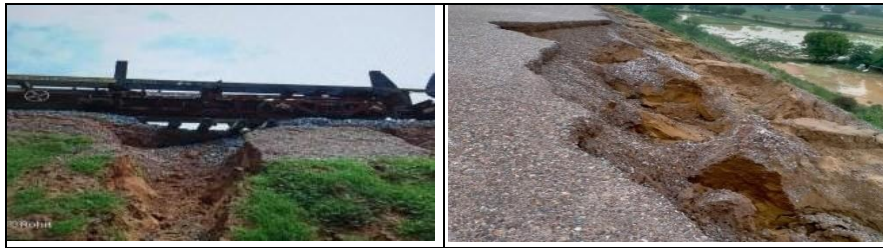
1. Edges of track platform has been damaged due to heavy rains (as shown in **Fig. 3**)
2. Slope area embankments are facing soil erosion.
3. Vegetation survival at slope areas of embankment is very poor.
4. Poor drainage around embankments.

**(a)** Rain-cut in track platform

**(b)** Side slopes erosion in embankment

- The concrete kerb on both sides of formation top (blanket top) along with chute drain has to be provided at every 40-meter interval. First trial section of 250 m has been proposed nearby Faridabad section. After successful performance in terms of run off the solutions have been employed for rest of the whole stretch. The detailing of kerbs has been designed based on M25 grade concrete as shown in Fig. 4. The proposed formation has been shown in Fig. 5. The significant reduction in the soil erosion has been observed in the next monsoon.

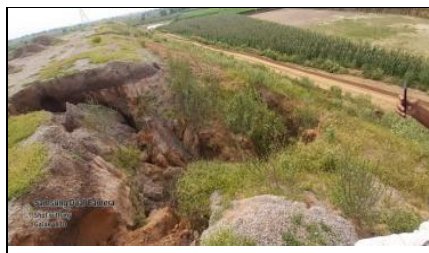
(c) Insufficient growth of vegetation

3. The suitable vegetation has been proposed to stabilize the soil in slopes, edges and at the bottom of the slopes. The reported soil has very less growth of the vegetation. The seeds of vegetation must be chosen carefully to make sure about the growth inside the slopes.

Due to very high percentage of sand fraction ranging from 40% to 70% at various section the proper compaction of dumped soil has not been possible. Thus, the favorable situation of vegetation growth is not there, it would need treatment in form of engineering solutions along with vegetation models with use of amenders, suitable species if grasses, herbs, bushes and other woody species.

It has been found that grass tufting is very economical, requires very little water once it has grown. The deep roots of the grass prevent water from tunneling underneath the surface of ground. For this purpose, a research has been conducted on various available grasses and has been proposed for different locations based on the sand fractions. In Table 3 it has been shown in detail with species name.

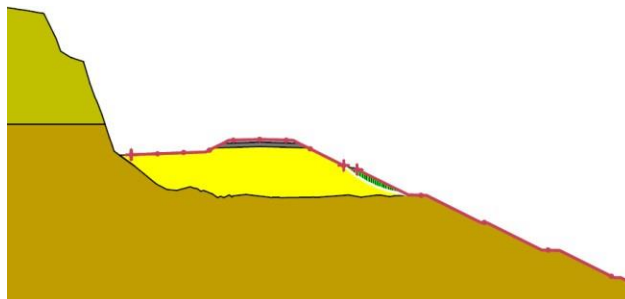
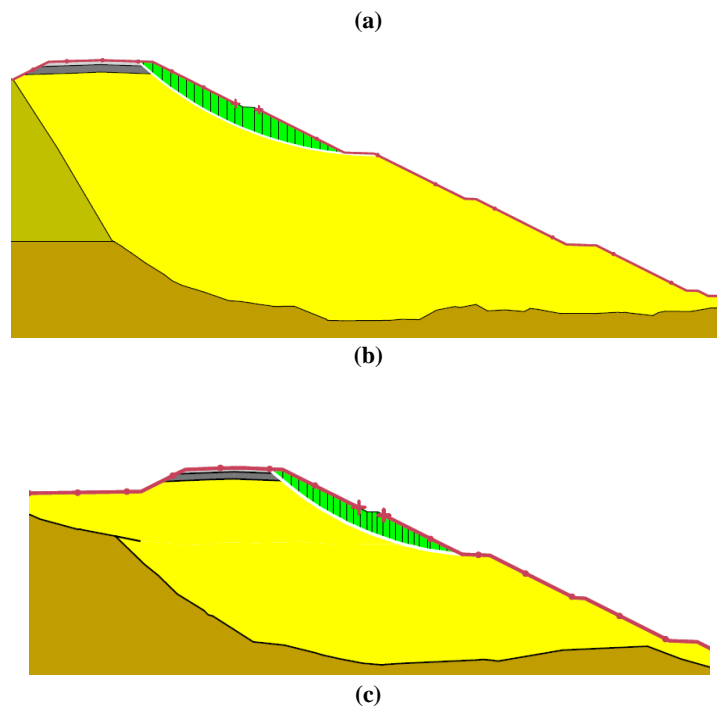
**Fig. 6.** Slope stability analysis for height a) 2.1 m , b) 4.2 m and c) 5.6 m height slope.

The slope stability analysis for different height of slopes have been shown in Fig. 6. The different height of the slopes has been shown the changes in the factor of safety. The reduction in factor safety with larger height of slopes shows the importance of consideration of protection methodology for larger height of slopes, which is very common for railway formation. In the RDSO guidelines it has been recommended to provide only turfing if the slope height is 4 m, coir mat with turfing for 4 to 6 m height and above 6 m height of slope Geocell with grass turfing has to be provided. Although no information has been provided about the rainfall based design and steady-state seepage coupled with stability analysis an inferences can be drawn about the types of protection methodology to be adopted from static slope stability analysis.

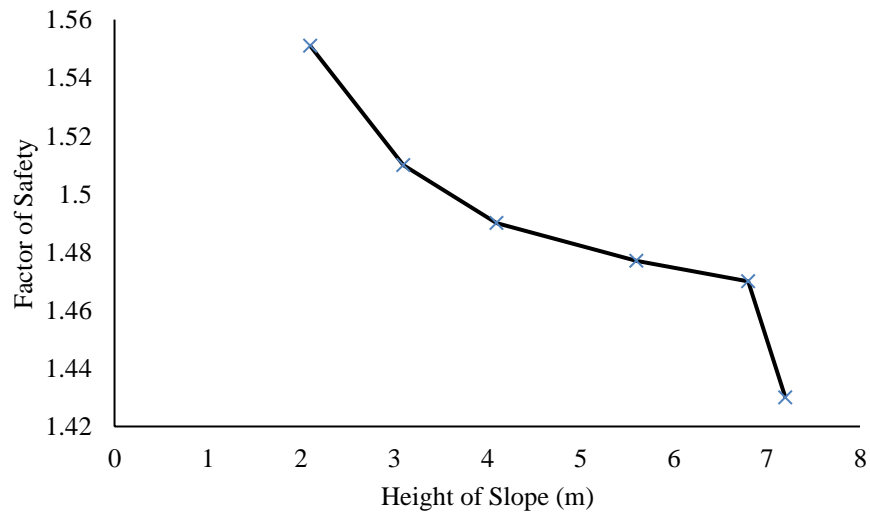
**Fig. 7.** The variation of static factor of safety with different slope height.

The variation of the factor of safety with the different slope height has been shown in Fig. 7. It has been seen the larger height is not safer for slope to be stable. The protection methodology to be designed in such a way in the larger soil slopes.
