Indian Geotechnical Conference

IGC 2022

# Rehabilitation of a Distressed Vertical Cut in Lateritic Soil

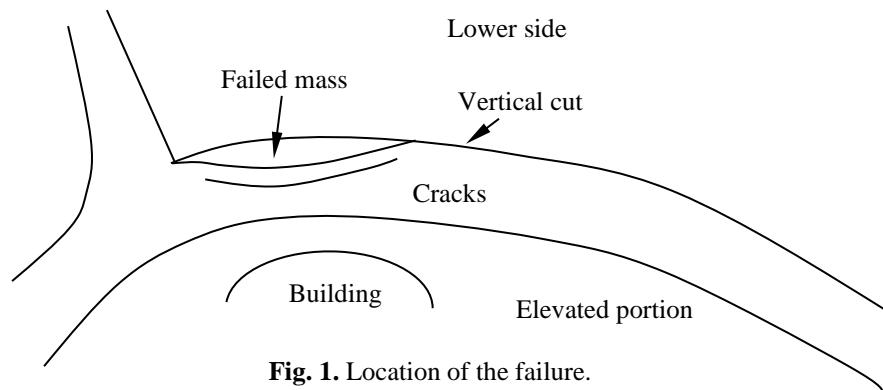
**Fig. 1.** Location of the failure.

Figure 1 shows the location of the failure. The main road that provides access to all facilities passes close to this vertical cut. During a rainy season, the portion of a vertical cut of almost 31m in height and length of 100m caved in. A three-dimensional scoop-like earth mass movement was noticed. Curved cracks were developed in the road indicating the plastic separation of another potentially failing soil mass. A tall building was located at a close distance on the other boundary (elevated) of the road. The building was reportedly on isolated column footings. On the lower side of the vertical cut, the surface soil appeared to be marshy due to the heavy seepage. A narrow stream was seen originating in this region. Elevated land is noticed on the left bank of the stream. The vertical cut is on the right bank. Such cuts were largely unprotected and remained stable for a few decades. However, laterite formations are known for delayed failure due to the change in drainage pattern resulting from the modification of geometry. Failure of vertical cut that is being dealt with herein is a typical case of delayed failure in lateritic cuts.
