A Geotechnical Study on Breached Summer Storage Tank

Abstract. This paper presents some of the observations made as well as geotechnical testing carried out in search of reasons of breached out summer storage tank, which was about to be commissioned for supply of water especially during summer season to the villagers of Nuzendla mandal in Andhra Pradesh. The tank has about 10 acres of storage area and the levels of water in the tank are not the same throughout the area but varying from 3m to 5.5m. The breaching of tank was occurred, at a location where the water level is 5.5m high, and where two mutually perpendicular bunds are joining. The disturbed and undisturbed soil samples collected from the location where breaching of tank took place were tested in the laboratory to understand the basic characteristics of the soil used for bund construction. The grain size analysis, compaction control, free swell index, liquid and plastic limits, permeability and shear characteristics are determined. It is noticed that the locally available soil is used for bund construction and it is of medium to high plastic in nature. The compaction levels at certain places are found to be inappropriate

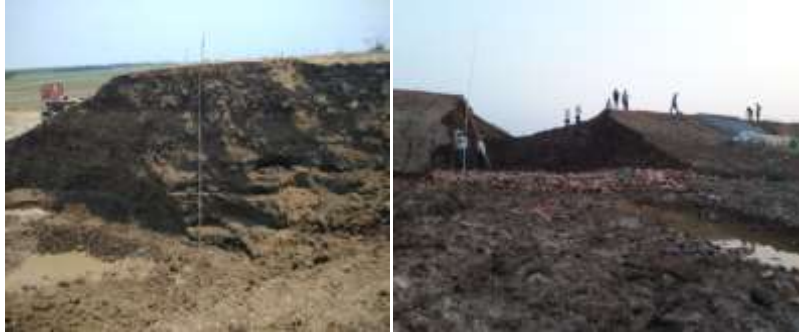
Fig.2. Photos showing breached sections of summer storage (SS) tank

- The sloping of bed towards breached portion caused more concentration of water pressure as compared to the other portions of bund.
- Instead filling the tank with water in stages, the tank was filled up at a time to the full storage level.
- As per the specifications the revetment of thickness 0.25m to 0.3m is required to be provided on the upstream slope, but it was not provided.
- The windblown water wave action was prevailed predominantly in the tank area.
- The compaction of soil was inappropriate.

- No gullies and slope failures in the bund are noticed around the tank. The failure is due to hydraulic action on the upstream slope of bund where water concentration is high.

- The breached portion of the earth bund can be closed by selecting a suitable soil such as GC, GW, SC, SM and required to compact in layers as per the specifications and ensured the required degree of compaction.

- If it is expensive to get the suitable soil to close the breached portion of the earth bund, the same clay soil (CI or CH) which was used previously for earth bund formation can be used towards closing of the breached portion provided; the upstream and downstream slopes respectively are required to be changed from 2.5:1 and 2.5:1 to 3.5:1 and 2.5:1.

- A gravel cover and revetment layer each of minimum 300mm thick as per the specifications is required to be provided so as to avoid the direct attack of wind generated water waves and to keep the upstream slope safe.

- It is required to ensure such that no gaps and uncompacted soil is left while closing the breached portion of the bund and it is also required to ensure the appropriateness of connectivity of bund formations.

- It is important to ensure that the filling up of water in the tank should be done in stages not at a time to the full capacity.

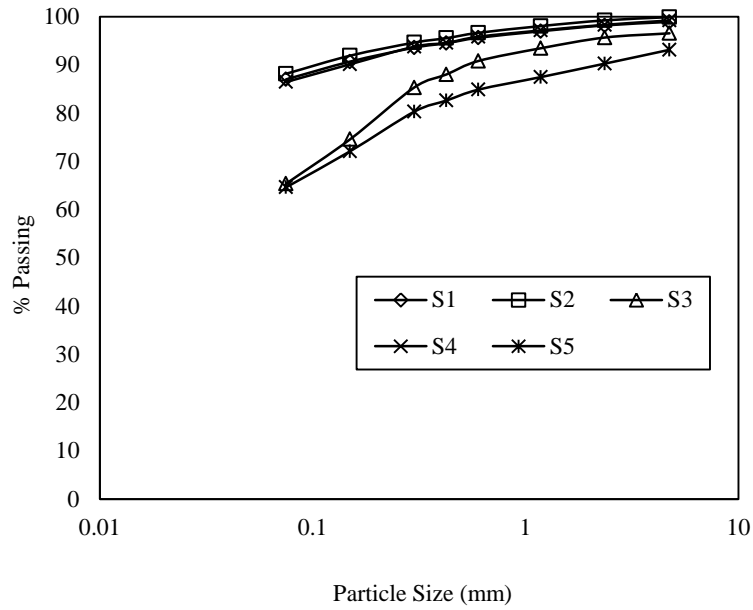
From the results (Table 3), it is noticed that all the soil samples have percentage silt & clay fraction more than 50%. Fine sand fraction is varying from 8% to 22.5% and remaining soil fractions such as gravel, coarse sand and medium sand are negligible. With the help of test results presented in Tables 2 and 3, the soil samples are classified. The percentage of soil fraction available in each soil sample is further presented in Fig.5 in the form of bar chart. From the classification of soil samples presented in

Fig.3. Grain size distribution curves for soil samples 1 to 5

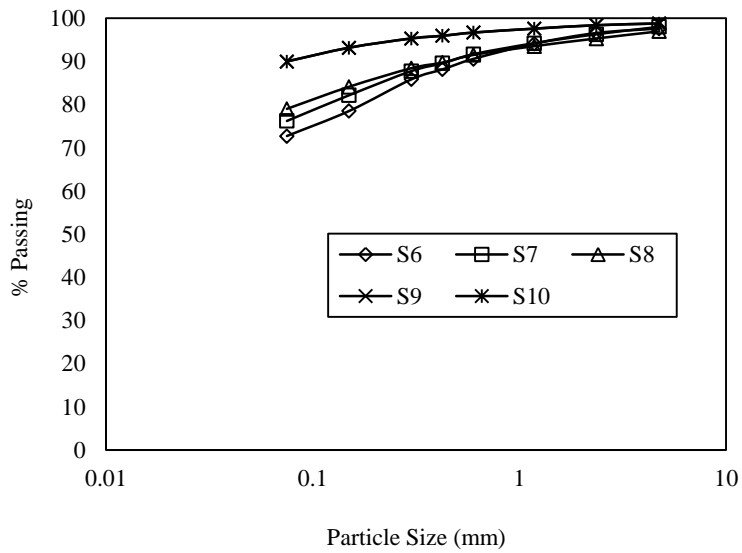
Fig.4. Grain size distribution curves for soil samples 6 to 10
 Table. 3 Soil fractions in per cent present in samples 1 to 10

Samples 1, 2, 4 and 10 have fine fraction (which is passing through 75 micron sieve) more than 85%. Soil samples 6, 7, 8 and 9 have the % fine fraction above 70 and below 80. Soil samples 3 and 5 have the fine fraction about 65%. Overall all the samples 1 to 10 have the fine fraction above 50%. The sample 10 is the bed sample and it has fine fraction 90%.

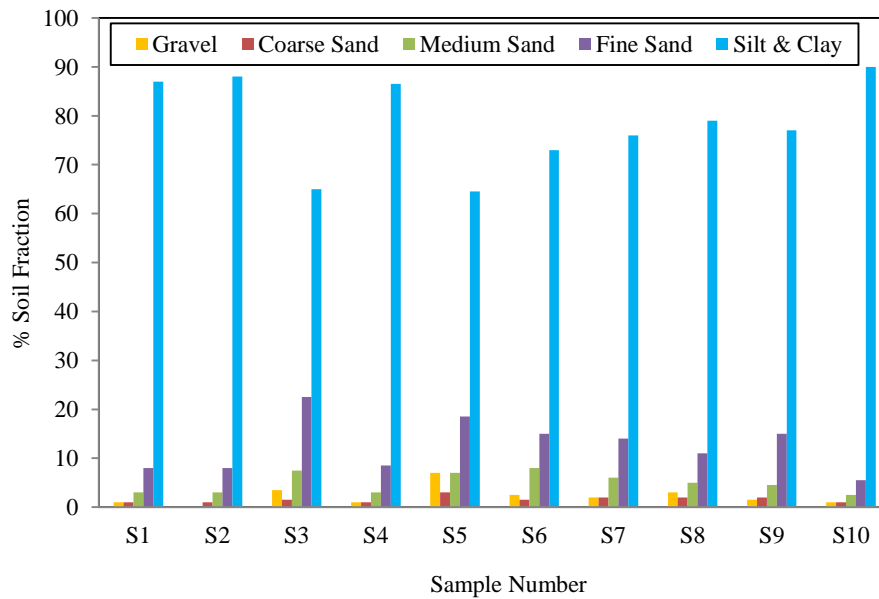
Fig.5. Soil fraction in per cent present in soil samples 1 to 10

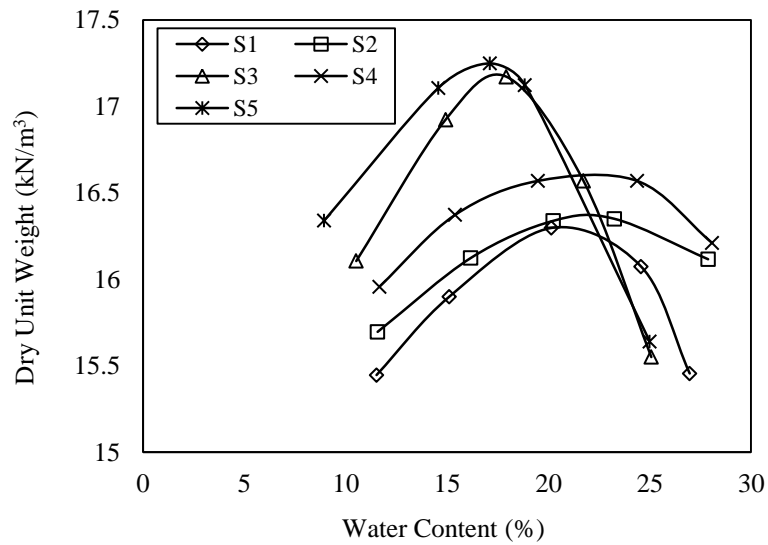
The standard Proctor's compaction test was conducted on all the samples in the laboratory as per the standard test procedure of testing of soils [13]. The compaction curves showing water content-dry density relationship are presented in Figs. 6 to 7. The optimum moisture content (OMC) and the maximum dry density (MDD) results obtained from the compaction curves are presented in Table 5. From the OMC, MDD results, it is noticed that the soil samples possess typical clayey soil behaviour. The MDD of earth bund soil samples (1 to 9), is varying from 16.3 kN/m^3 to 17.25 kN/m^3 and OMC is varying from 17% to 22.5%. The tank bed sample has OMC 25% and MDD 15.10 kN/m^3 . The bed clay is highly compressible and impervious in nature.

Fig.6. Compaction curves for soil samples 1 to 5

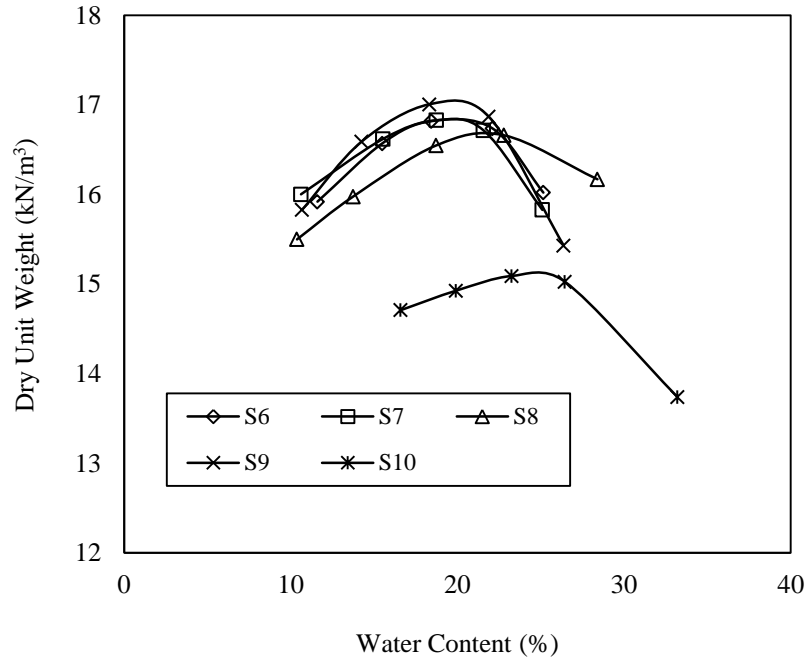
Fig.7. Compaction curves for soil samples 6 to 10

For soil samples 6, 7, 8 and 9, the degree of compaction is estimated and the result is presented in Table.6. For the above four samples the degree of compaction is above 95%.

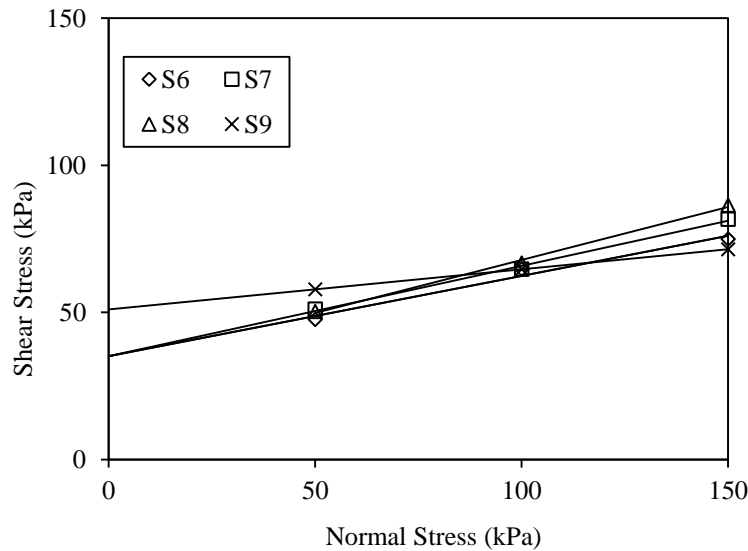
A simple direct shear test (quick test) was conducted on the undisturbed soils collected from the locations 6, 7, 8 and 9 of an earth bund near the breached portion. The test was conducted as per the standard test procedure [14]. The strength envelopes obtained from the tests are presented in Fig.8. The shear parameters such as cohesion and angle of shearing resistance obtained from the tests are presented in Table 6. The cohesive strength is varying from 30 kPa to 50 kPa and the angle of shearing resistance is varying from 7.75 degrees to 19.87 degrees.

**Fig.8.** Shear stress versus normal stress curves for samples 6 to 9**Table 7.** Direct shear test results of core samples
