# INFLUENCE OF LOW PERMEABILITY CAPPING LAYERS ON LIQUEFACTION INDUCED FAILURE IN STRATIFIED GROUND

Divyesh Rohit<sup>1</sup>, Siavash Manafi Khajeh Pasha<sup>1</sup>, and Hemanta Hazarika<sup>1</sup>,  
Takaji Kokusho<sup>2</sup> and Sukiman Nurdin<sup>3</sup>

<sup>1</sup>Kyushu University, Fukuoka 819-0395, Japan

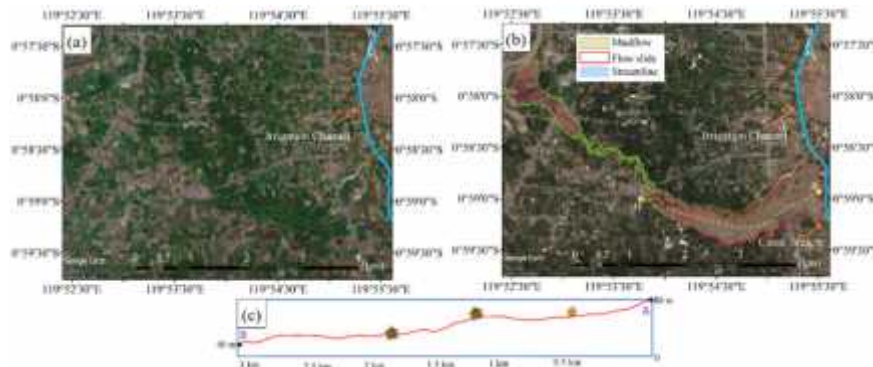
A team of researchers from Kyushu University visited the flow liquefaction sites in Juno Oge, Sibalaya and Balaroa in Palu aftermath of earthquake. The survey elements included site reconnaissance, disturbed soil sampling, portable dynamic cone penetration tests (PDCPT) and aerial survey with drone. Fig. 3 here depicts the condition of the flow failure site at Juno Oge before (Fig. 3(a)) and after the seismic event (Fig. 3(b)). The site mainly composed of agricultural fields with a scant population and an a very gentle sloping ground of less than 2% (Fig. 3(c)). It was also found that an irrigation channel which was passing from the eastern side of failure zone breached due to liquefaction during the shockwave propagation as shown in Fig. 3(b). Due to the presence of irrigation channel, the ground water level was very high ( $< 5\text{m}$  from ground surface) which is also considered to be a key factor contributing to flow failure. The breach of water channel discharged a large volume of water into the already failed zone causing a massive mudflow as depicted in Fig. 3(b).

Figure 3: Lateral flow area in Juno Oge village due to Sulawesi Earthquake, (a) before flow failure, (b) after flow failure with mud flow and water channel and (c) slope profile of the flow area (modified from Google Earth).

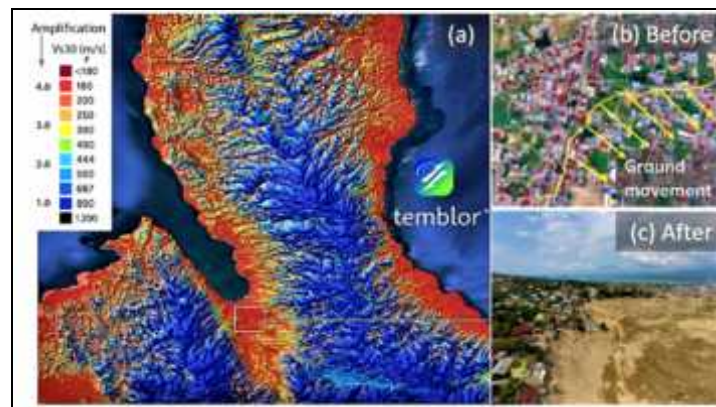
The maximum site amplification occurred in the Palu valley, which has deposits with low shear wave velocity profile [15], as can be seen in Fig. 4 (a). It can be seen that the valley region along with the coast line has very low shear wave velocity while the mountainous region has high  $V_{s30}$  values. Fig. 4 (b) depicts the satellite image of liquefaction site at Balaroa before the event while Fig. 4 (c) shows the condition of the site after liquefaction taken by a drone camera. It can be ascertained from Fig. 4 (b) and (c) that a large scale liquefaction occurred devastating and displacing all the housing structures in the area to hundreds of meters.

Figure 4:  $V_{s30}$  map of Palu region along with a site amplification forecast for an Mw 7.5 earthquake (Patton et al., 2018), (b) Google Earth image for site in Balaroa, Palu prior to 2018, Sulawesi Earthquake and (c) Drone Image of Balaroa site after the event showing mass displacement of structures from original location.

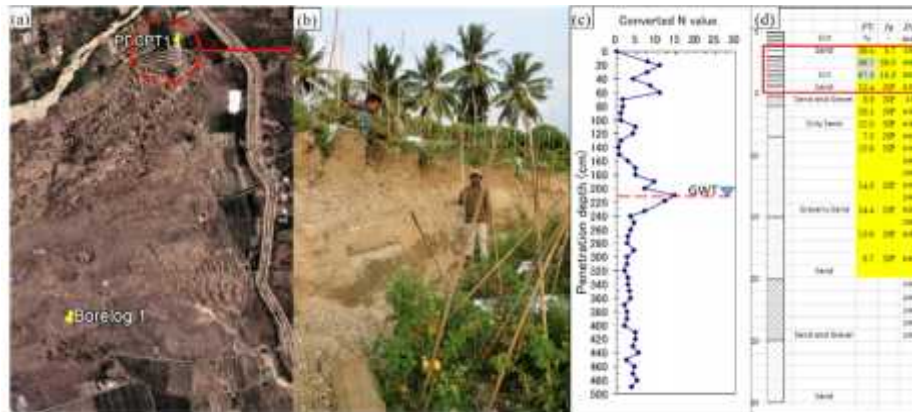
Further in Fig. 5(a) shows the location where the PDCPT and SPT tests were performed at the flow failure site in Juno Oge. Fig. 5(b) shows the condition of soil profile at crown of failure, also depicting the difference in elevation of ground after liquefaction. Fig. 5(c) represents the plot of N values versus depth obtained from

PDCPT test conducted outside the crown of failure zone. It can be seen from the plot that the subsoil condition is weak with a maximum N-value reaching upto 15 and dropping back to low numbers and presence of water table at a shallow depth of 2.15 m from the ground surface. Further Fig. 5(d) shows the subsoil condition at location of Borelog 1. It can be seen from the illustration that the silt layers are sandwiched in between sand layers at shallow depth with a higher fines content and some plasticity characteristics. These soft sandwiched silt layers are considered to be a probable contributor to the large scale flow failure by inhibiting the dissipation EPWP from below sand and gravel layers.

Figure 5:(a) Location of PDCPT and SPT at Juno Oge, (b) Location of crown of the flow failure at Juno Oge site with high vertical settlement, (c) plot of N-value versus depth obtained by PDCPT1 test outside the failure zone and (d) Borelog1 profile of soil in failure zone.
