Strengthening of Reservoir Embankments

Rajaraman Ramanathan¹

Abstract. This paper is a case study of breach of embankment of 12 Lakh m³ capacity raw water reservoirs, situated in Gujarat, India. Three reservoirs were constructed within a cellulose fibre plant to provide water for the plant and the colony. The embankment of one of these reservoirs along with mid embankment was breached, resulted in minor losses to the property. The root cause analysis of the reservoir breach has been carried out and rectification measures have been suggested after a detailed analysis. Slope Stability and seepage analysis have been carried out by Geoslope software. All the safety measures were taken care for design and the same have been implemented at site during execution.

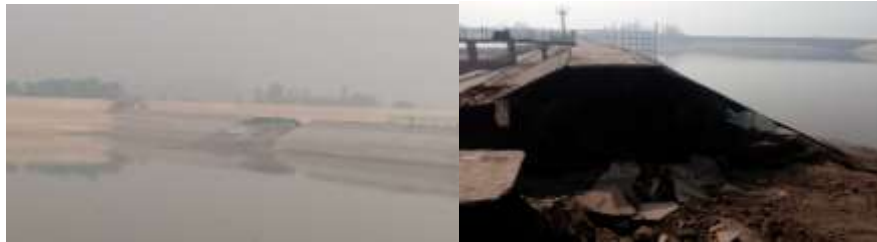
The southern embankment of reservoir-3 and intermediate embankment between reservoirs-2&3 was breached on 10th December 2016. Three embankments were constructed and raised during different years.

Fig. 1. Some photos of breached portion of embankment

- i) By overtopping: This aspect needs to be addressed by providing sufficient free-board above the maximum water level. Water was filled up to a height leaving a free-board of 500mm from the top of embankment. The final layer of 2m embankment was constructed not in monolithic with the bottom layer. The water started coming from the top, which was not having enough strength to resist the water pressure and the body of dam subsequently failed.

- ii) Foundation slide: Since the foundation is having sufficient bearing capacity, the breach was not occurred due this reason.
- iii) Faulty construction and poor maintenance: Compaction was done at water content less than Optimum Moisture Content (OMC). Soils compacted in less than optimum water content; have a certain skeleton strength composed by suction effect between soil particles. This skeleton strength readily disappears by wetting (saturation) during the filling of the reservoir, which results in large settlement also in differential settlement and opening cracks. During filling of water in the reservoir, seepage started from the top layer. The fill material at the top layer might not have sufficient strength and overtopping was triggered due to this.

- On the breach portion on the southern side of reservoir 3, concrete lining with construction joints to be provided after preparation of surface and plate compaction.

- Loose materials in the breached portion shall be removed up to hard soil and compacted using plate compactor. Sides of the breached portion to be trimmed to a slope of 1V:3H and to be protected using 125 thick concrete lining on the sides and bottom to avoid further erosion. If unprotected, this will lead to uncontrolled seepage along the direction of the embankment on northern side, which may further breach.

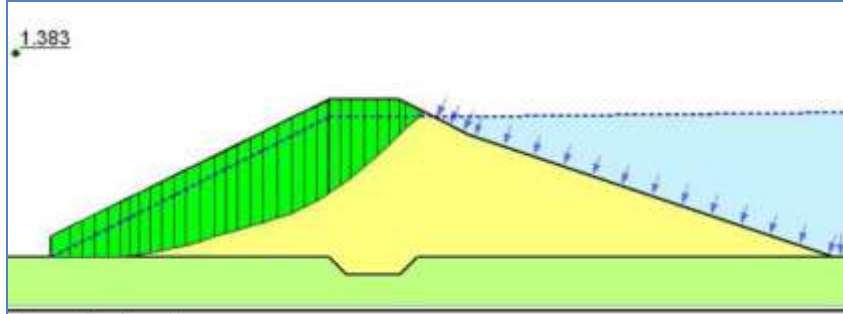
Fig. 2. Typical slope stability analysis conducted using SLOPE/W software

Analysis has been performed for the most critical combination of external forces, which are likely to occur in practice. The factor of safety calculated for the stability analysis is more than the codal requirements.

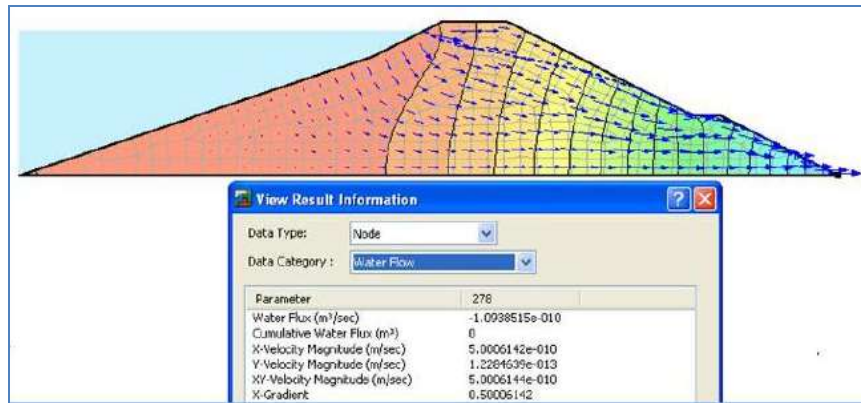
Fig 3- Typical seepage analysis conducted using SLOPE/W software
