# Retrofitting of Existing Earthen-Fly Ash Dam by Finger Drains & Gabion Wall

**Abstract.** Coal based power plant generates huge amount of fly ash as residual waste for ash ponds with significant dam heights have been constructed over a period of operation. Sometimes in long run, seepage may threaten the stability of dam due to internal erosion or clogging of filters. This paper presents a case study on fly ash dam where seepage and distress of dam section had a concern for the Owner. The entire pond had raised by up-stream method of construction with earthen as well as pond ash material. One stretch of dam settled including starter dam and moved horizontally under heavy seepage during monsoon. The root cause of problem had been identified through new geotechnical investigations and engineering solution was proposed to stabilize dam section. The rectification measures involved revival of old rock toe, strengthening of dam by constructing gabion wall at toe of starter dam with geotextiles and graded filters. The internal drainage was streamlined with provision of PVC perforated finger drain wrapped with non-woven geotextile material inside trenches filled with graded filters. The

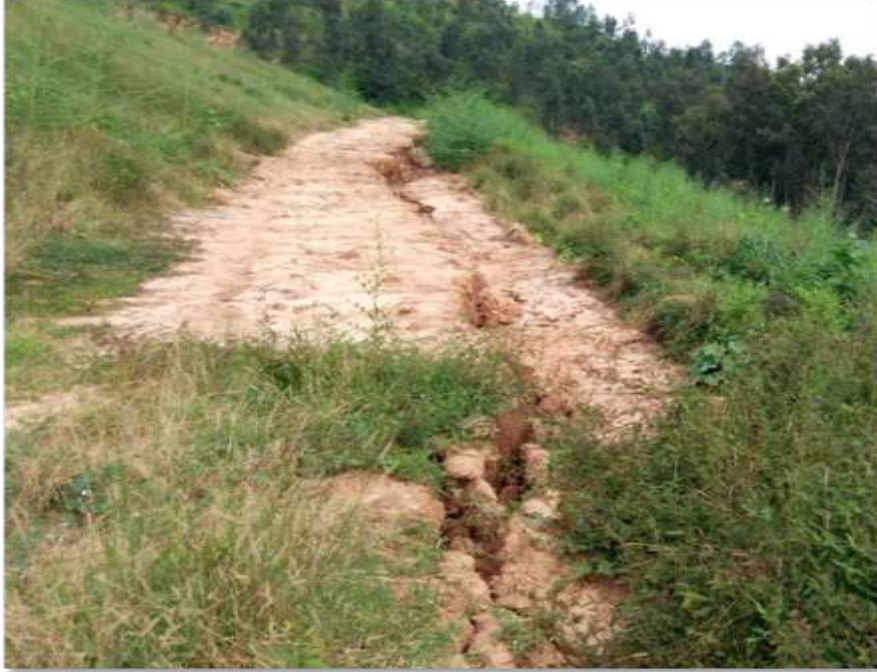
ther aggravated by subsidence of dam at top of the buttressing portion which resulted in horizontal sliding of mass at starter dam top. It was analyzed that part of the starter dam could be on the verge of collapse. Therefore, the total area was immediately covered with sand bags from toe up to the distressed portion. Three borewells were made inside the pond for dewatering purpose, but pumping was not fruitful due to less water in borewells. The seepage problem was caused by accumulation of water inside dam body due to choking of filters in chimney, relief well and sand blankets and further connectivity to existing rock toe.

**Fig.4.** Subsidence Stretch at Upper Bench above Starter Dam

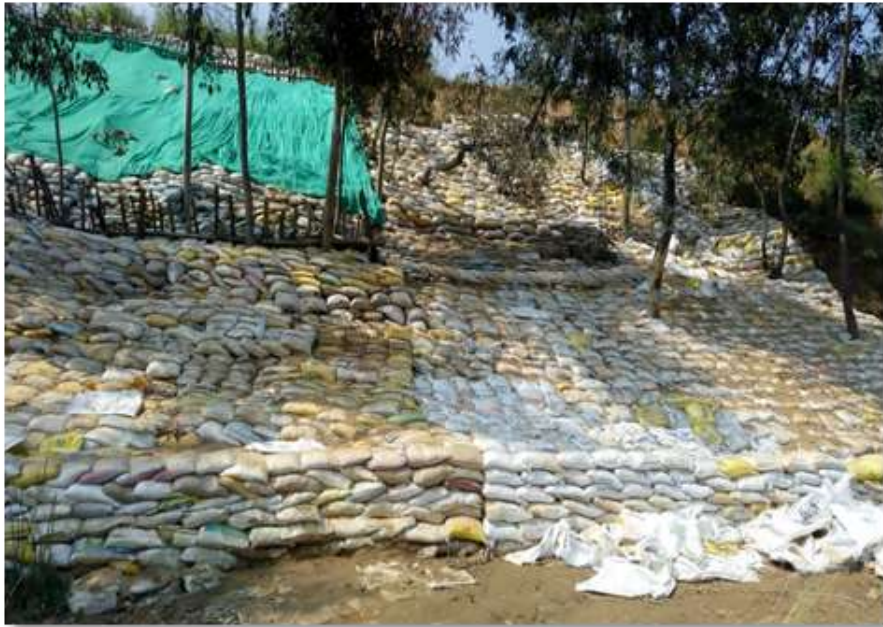
The pond was operated and filled up to the 5th stage raising. However, at the end of operation minor seepage were observed for a stretch of about 60m at the starter dam. The seepage continued to increase during the monsoon period. The situation was fur-

**Fig.5.** Seepage Zone of Starter Dam Toe & Downstream Slope with Sand Bags

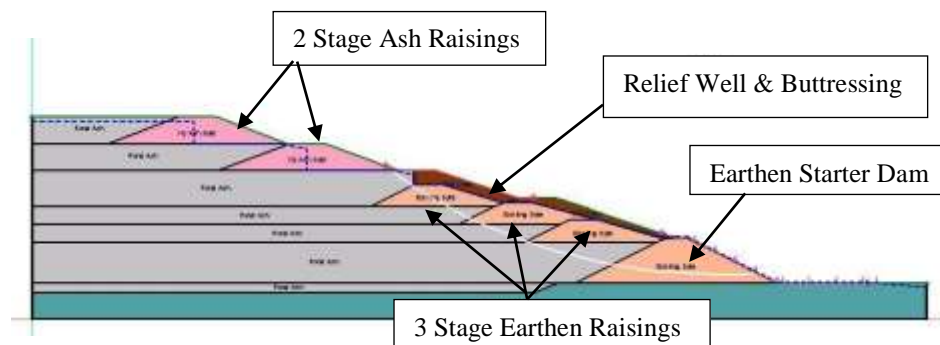
Stability of the dam was assessed under worst condition to simulate the seepage problem by established classical limit equilibrium methods using professional software. Analysis revealed that the dam in existing condition would have inadequate global stability considering persistent seepage through the dam body. It was evident that horizontal movement of starter dam would occur progressively and trigger ultimate failure of dam in the susceptible stretch. Therefore, it was essential to reduce seepage through the dam body and strengthen it to increase stability of the dam. Finger drains made up of perforated PVC pipe wrapped with geotextile were inserted within the dam body and these were connected to the collection drains at downstream. Afterward, next course of action was to stabilize the movement of toe portion by providing a heavy counter-berm within the limited space. Without proper seepage connectivity from existing toe through the new counter-berm could lead to collapse with major consequences. Therefore, gabion wall with geotextile & graded filters scheme was developed after thorough study of different situations that could arise during progress of execution or thereafter. Stability of starter dam with new gabion wall under all possible conditions that could arise during and after execution under controlled seep-

Fig. 7. Static FOS under Steady Seepage Condition with Existing Dam (Bishop Method)

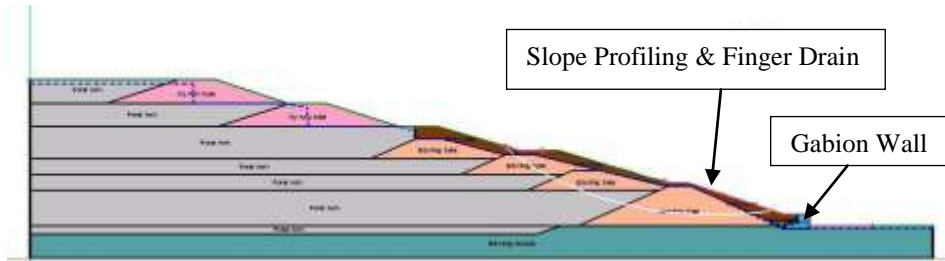
**Fig. 8.** Static FOS under Steady Seepage Condition with Gabion Wall (Bishop Method)

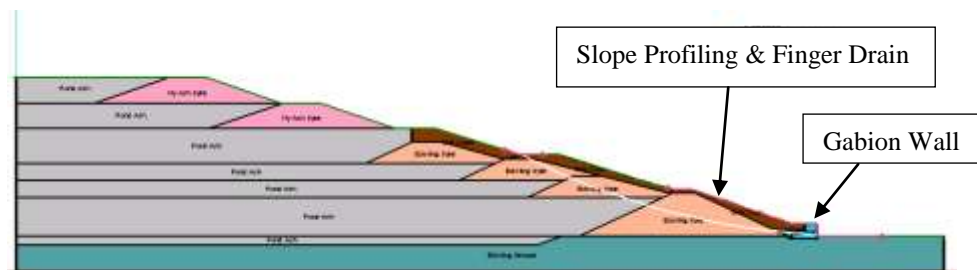
**Fig. 9.** Static FOS under End of Construction Condition with Gabion Wall (Bishop Method)

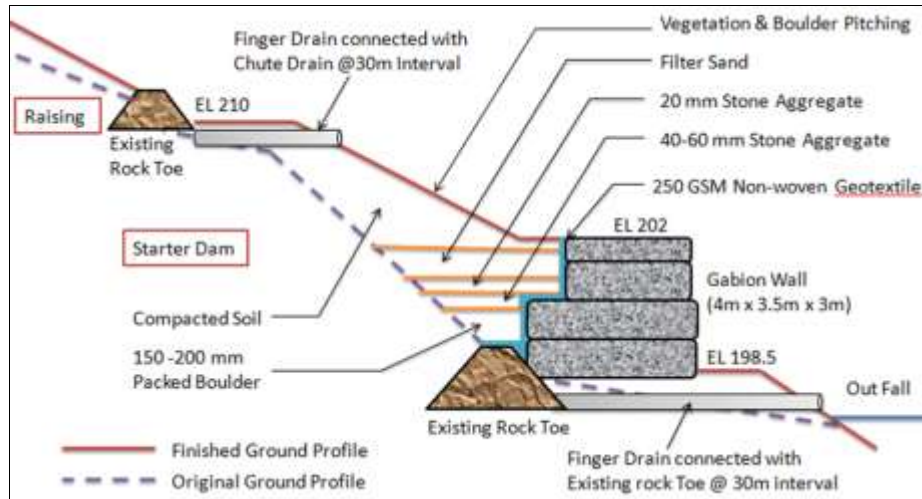
**Fig. 10.** Schematic Drawing for Retrofitting Scheme (Not to Scale)

- Immediate dewatering of surface water from pond to decantation pond and safe channelization of surface run-offs of rain water away from the affected zone.
- Cleaning of existing rock toe from overburden soil, vegetation and rearrangements of rock ripraps to reduce pore water pressure.
- Excavation at toe portion and placing of finger drains with geotextiles and filters for safe channelization of seepage water through existing rock toe.
- Construction of gabion wall at starter dam toe with placement of graded filters up to the existing rock toe.
- Engineering fill above gabion wall with slope profiling with vegetation, boulder pitching.
- Installation of piezometers and settlement gauges at various benches for appropriate measurement of phreatic surface and further settlement.

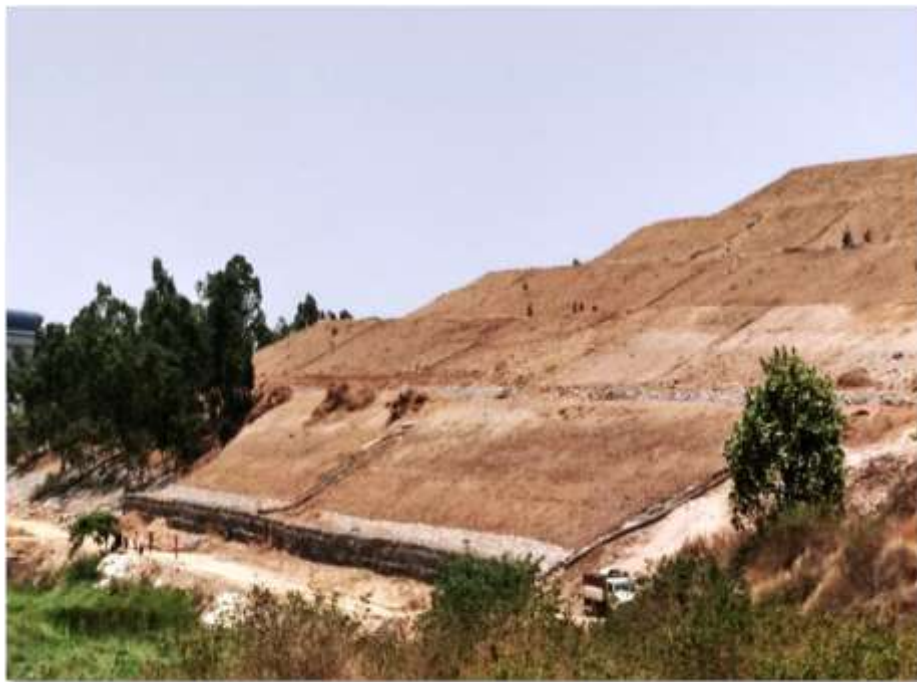
**Fig. 11.** Gabion Wall and Slope Profiling during Retrofitting at Subsidence Stretch

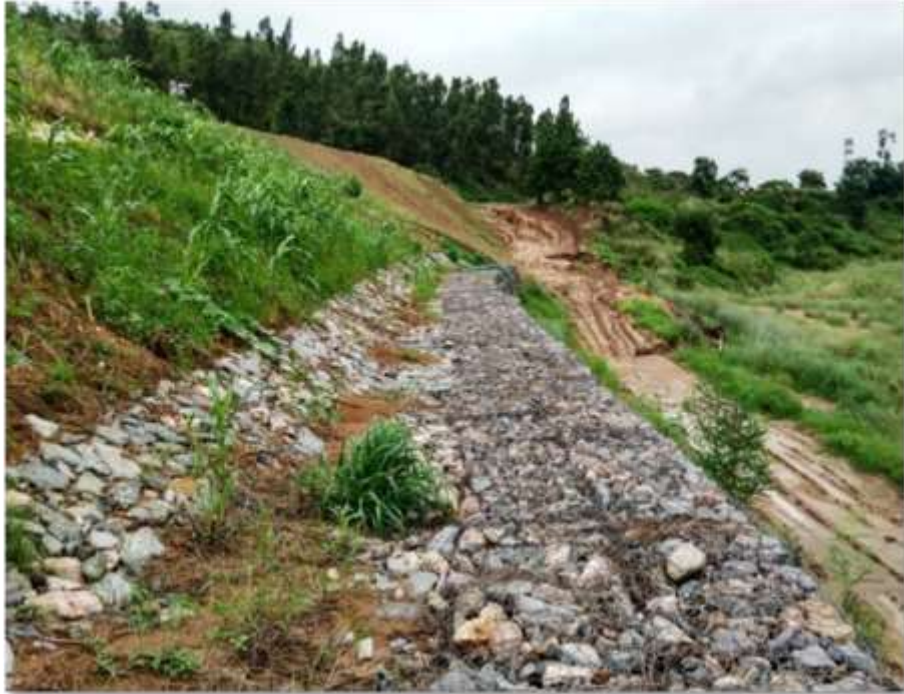
**Fig. 12.** Gabion Wall at Toe of Starter Dam and Grown Vegetation on Slope
