# Some Challenging Geotechnical Problems in River Valley Projects in India\*

Y.K.Murthy\*\*

<sup>\*</sup>Second IGS Annual Lecture delivered on the occasion of its 21st Annual General Session held at University of Roorkee, Roorkee, on 21 December 1979.

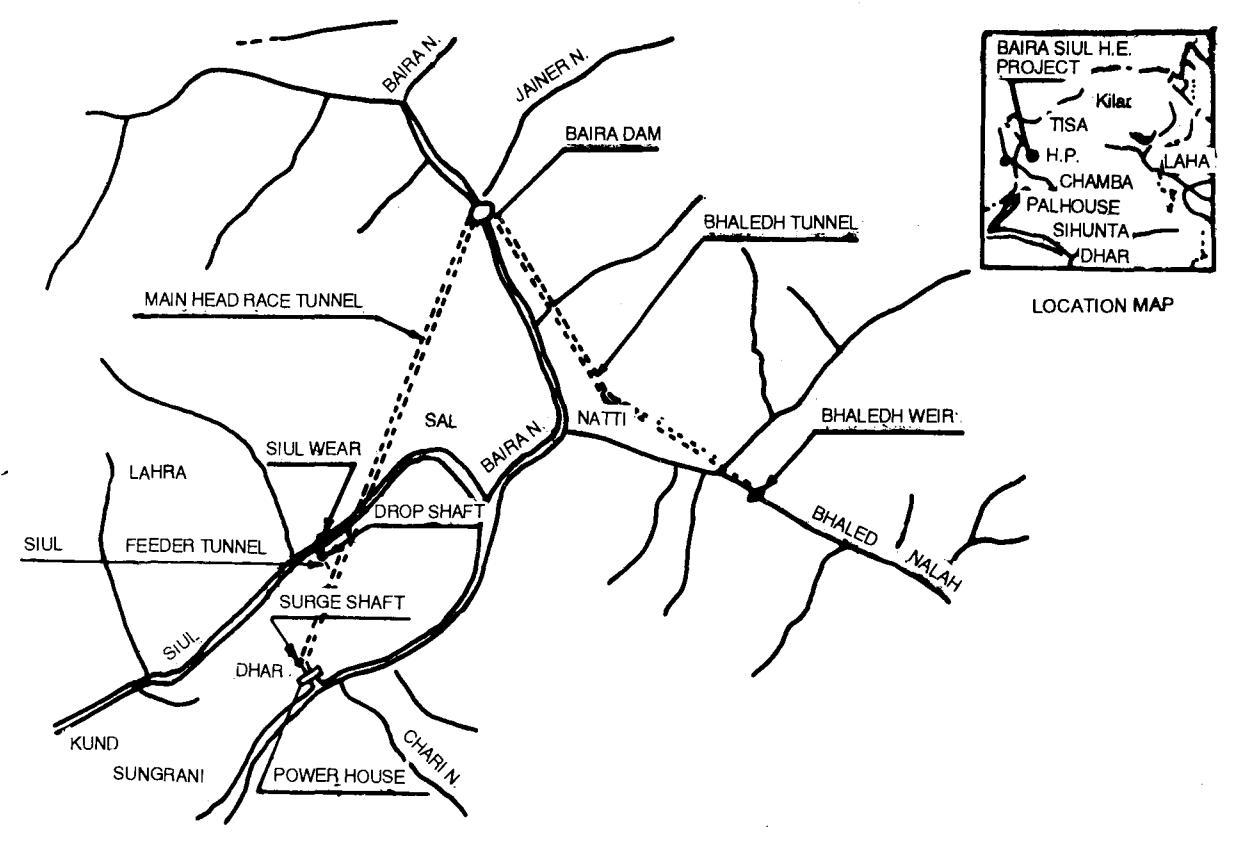
FIGURE 1 Layout plan of Baira Siul Hydro-electric Project

(i) the hill slope consisting of debris overlying the phyllite rock above the power house is unstable. Heavy

landslide occurred in the year 1976 bringing large mass of debris and filling up the power house area under construction.

- (ii) in the year 1978 another large scale landslide occurred on the right bank hill slope just downstream of the proposed axis of the Baira Dam. The landslide filled up the river bed by about 10 m. along its length upstream of the dam axis.
- (iii) after a heavy downpour in March 1979, the slump movement which had occurred in the previous year had extended towards the upstream in the overburden on the right side abutment hill of the Baira Dam. The zone of the movement extends up to approximately the point above the power intake structure of the Head Race Tunnel. A problem had arisen whether to shift the intake portion upstream to a stabler location. A detailed study of the contour of the slump area was made and was found that the present position is more appropriate and was retained with some protective works.

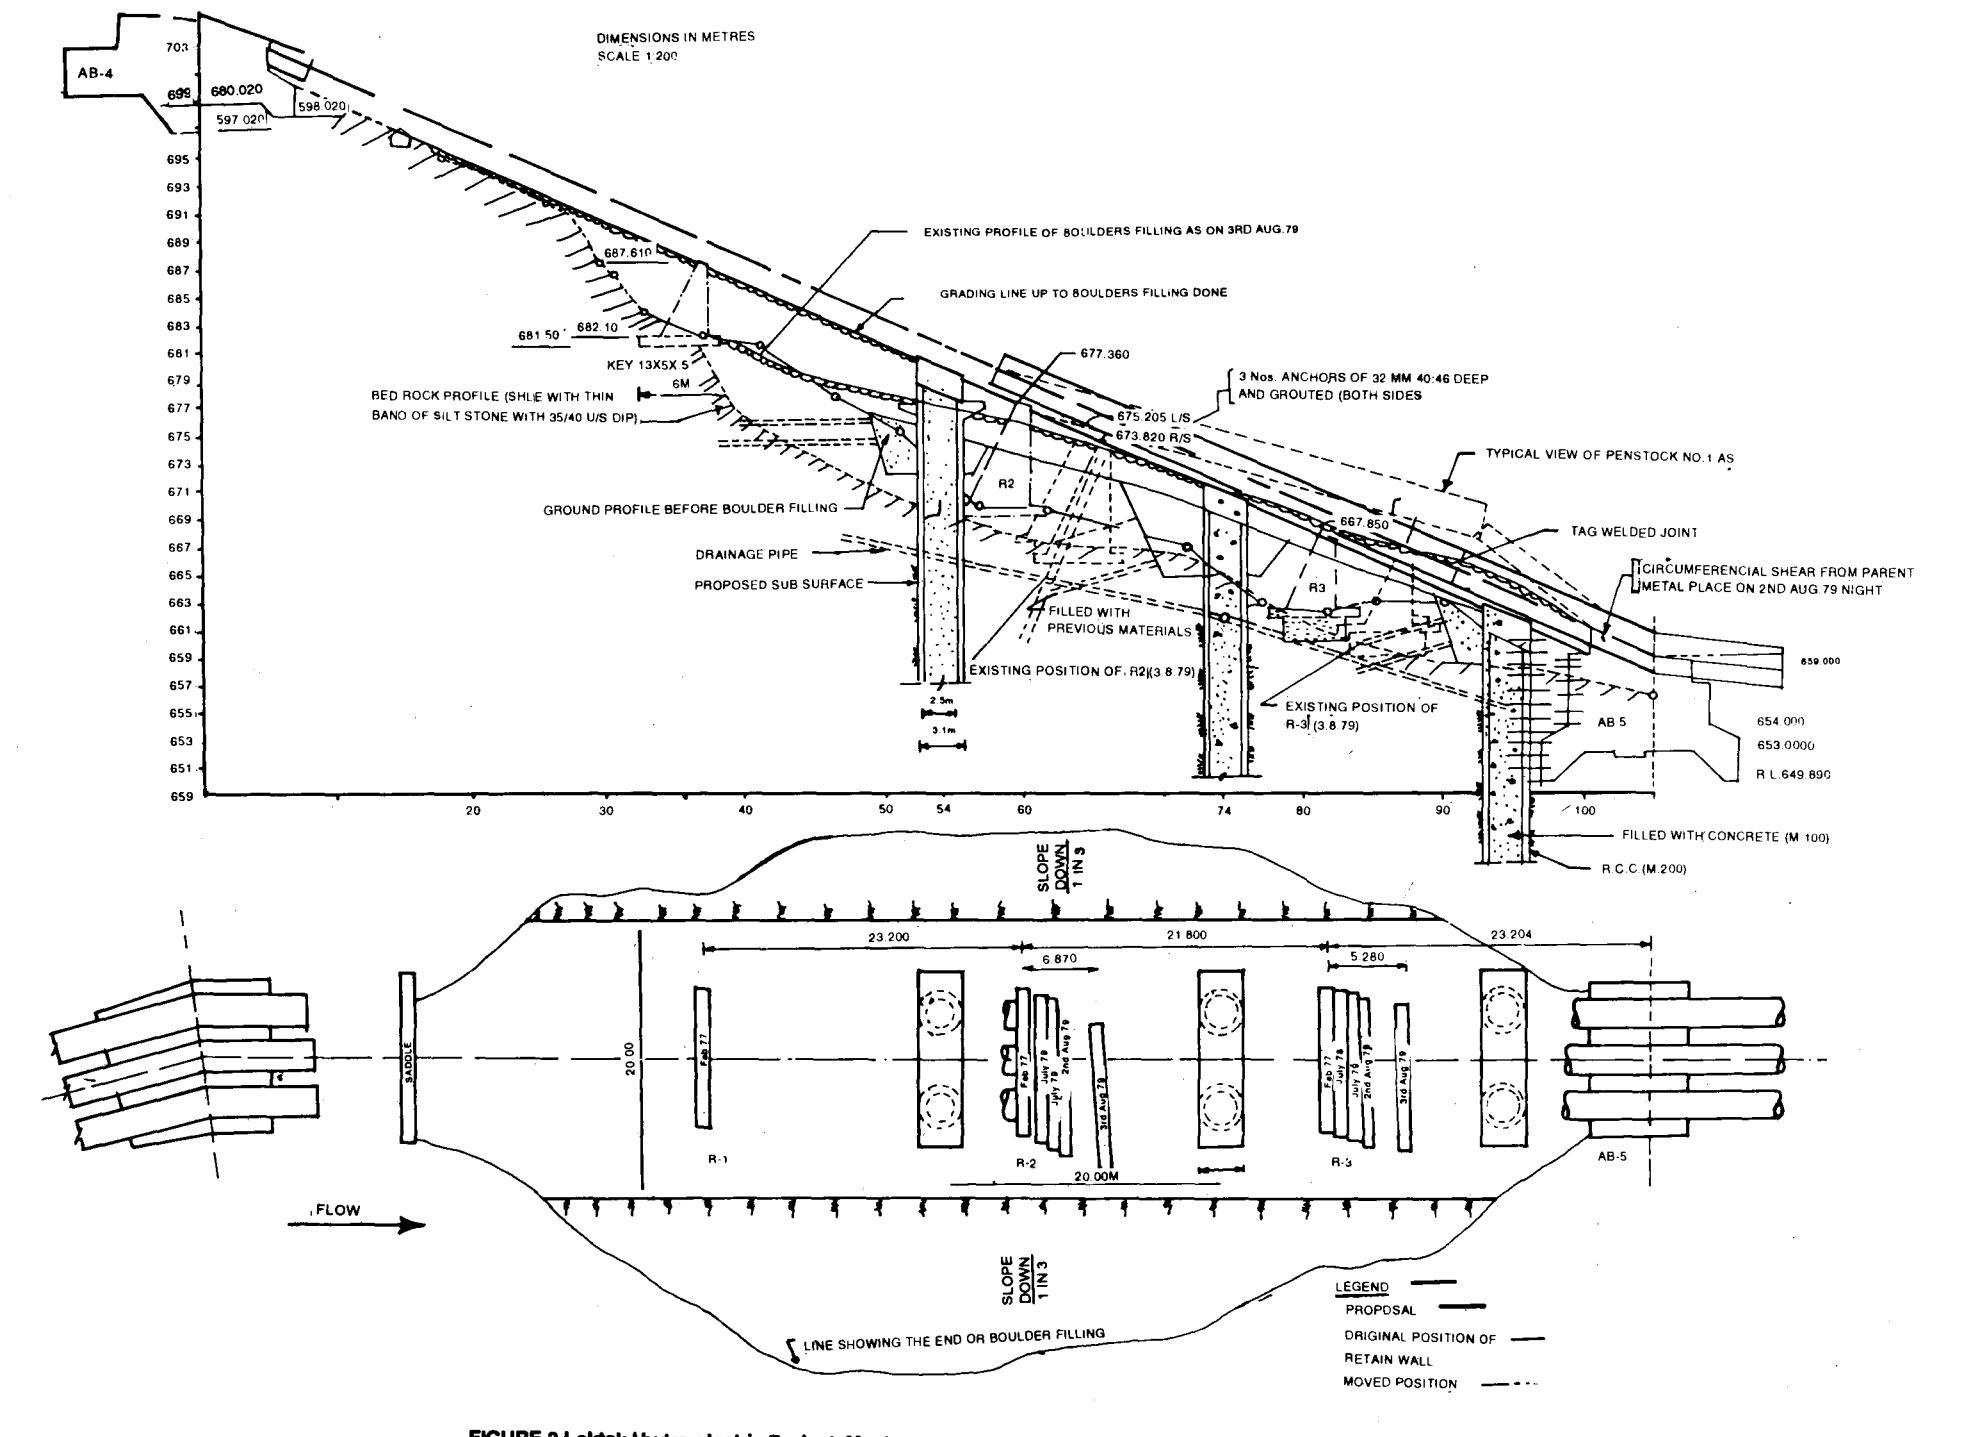
FIGURE 3 Loktak Hydro-electric Project, Manipur, Plan and longitudinal section of reach anchor block (4-5), showing the details of movement of retaining walls and proposed shafts and drainage

The penstocks are supported on 12 Anchor Blocks and 68 saddles. The reach between Anchor Block I to Anchor Block 4 and the reach between Anchor Block 5 and Anchor Block 8 have been completed. The strata particularly between Anchor Block 4 and 5 and 11 and 12 are highly unstable and often has been subjected to loughing resulting in the movement of the saddles.

In the years 1973 and 1974, massive subsidence in the area downstream of Anchor Block 5 occurred. As a result of the subsidence the saddle supports between AB-5 and AB-6 got moved laterally towards the right by about 2 m. Therefore, the saddle supports between AB-4 and AB-5 were reviewed and the saddles were proposed to be founded on the rock. Accordingly, three saddle-cum-retaining walls were constructed in 1976-77 and the reach from the excavated ground levels upto the penstock grade levels were filled with boulders with a carpet of shingle on the excavated ground level.

During the monsoon of 1977, there was settlement of boulder filling on the downstream of the retaining wall-cum-saddle support and upheavel between retaining wall 3 and Anchor Block 5. As a result of this, formation level between retaining wall 3 and Anchor Block 5 touched the penstock bottom and continued to rise, resulting in lifting of the penstock No. 1 by about 100 mm. Retaining walls 2 and 3 also moved laterally towards the right by 230 mm and 165 mm respectively.

- (i) Further longitudinal lateral and vertical movements of retaining walls 2 and 3.
- (ii) subsidence of the boulder filling dowstream of retaining wall and upheavel between retaining wall 3 and Anchor Block 5.
- (iii) high pressures are built up around anchor block No. 5 resulting in buckling and shearing off of penstock pipes; and
- (iv) cracks in the surrounding area of Anchor Block 4 and 5.

Remedial measures to get over the problems have been seriously considered.

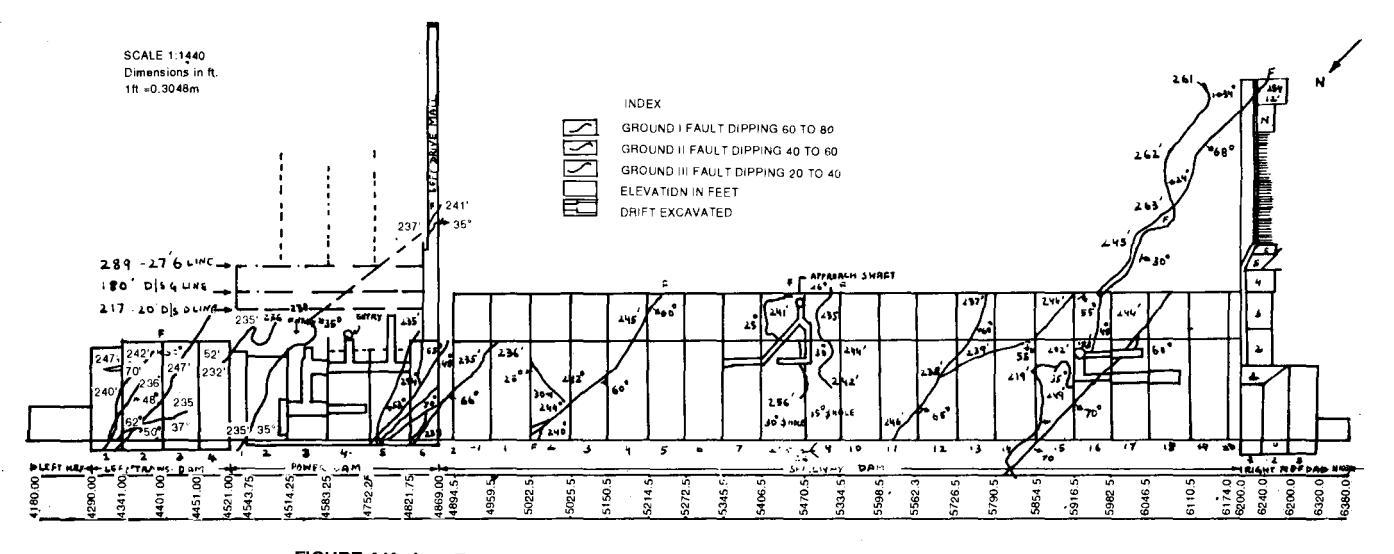
FIGURE 4 Kadana Reservoir Project, Plan showing the disposition of faults in the foundations of masonry dam and appurtenant structures

The general geology of the dam site comprises quartz-mica-schists, mica-schists and phyllites. A number of faults have been encountered below the final foundation grade of the blocks, which are present in almost all the blocks of the gravity dam. The faults have a general dip towards the right bank as they continue towards the right abutment and they are met at deeper and deeper levels. The fault zones consist of clay and braccia and other fractured materials and vary in thickness from 10 cms to 40 cms. In the tranverse direction, the fault is continuous from upstream to downstream of the dam section. The materials of the shear zones have very low shear properties and therefore the zones present potential sliding planes. Sliding analysis on these blocks have shown very low shear friction factor of safety against sliding. An earthquake acceleration of 0.1g has also been considered in the stability analysis. In order to improve the resistance, shear keys were required to be provided intercepting the shear fault planes. A number of drifts had to be excavated in such a way that they will extend atleast 1 m both on top and bottom and sound rock. They are back filled with concrete to form shear keys. The total length of the drifts provided in all the dam blocks is about 300 m.

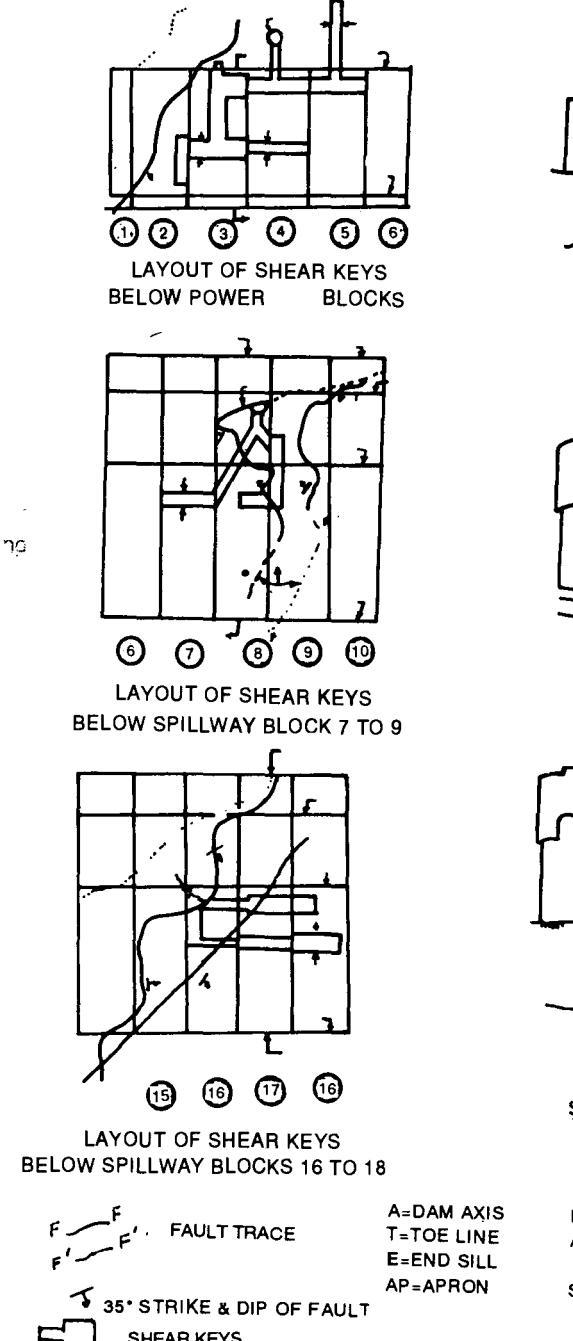
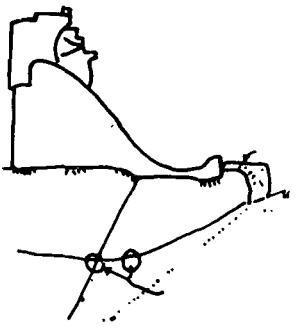
LAYOUT OF SHEAR KEYS ELOW SPILLWAY BLOCKS 16 TO 18 F F F F AULT TRACE A=DAM AXIS T=TOE LINE E=END SILL AP=APRON SHEAR KEYS T=TOE LINE AD=ADDITIONAL GALLERY H = 90 CM4 CLAY HOLES S=APPROACH SHAFT SHEAR KEYS SCAIF 1:1920 FIGURE 5 Shear keys for treatment of low angle faults below foundations of Kadana dam length of the masonry dam.

- (ii) as there was fractured rock above and below the fault plane, it was necessary to wash and grout the rock through the drifts.
- (iii) in order to have adequate grouting and drainage additional galleries downstream of the upstream gallery have been provided.

With this treatment, the safety against sliding has improved to the desired and acceptable value.
