**Indian Geotechnical Conference
IGC 2022**
15th – 17th December, 2022, Kochi

Foundation Investigations in Thick Overburden Matrix Material of a Proposed Dam – A Case Study

Rajesh Khanna¹, Palani kumar A², Manish Gupta³ and R Chitra⁴

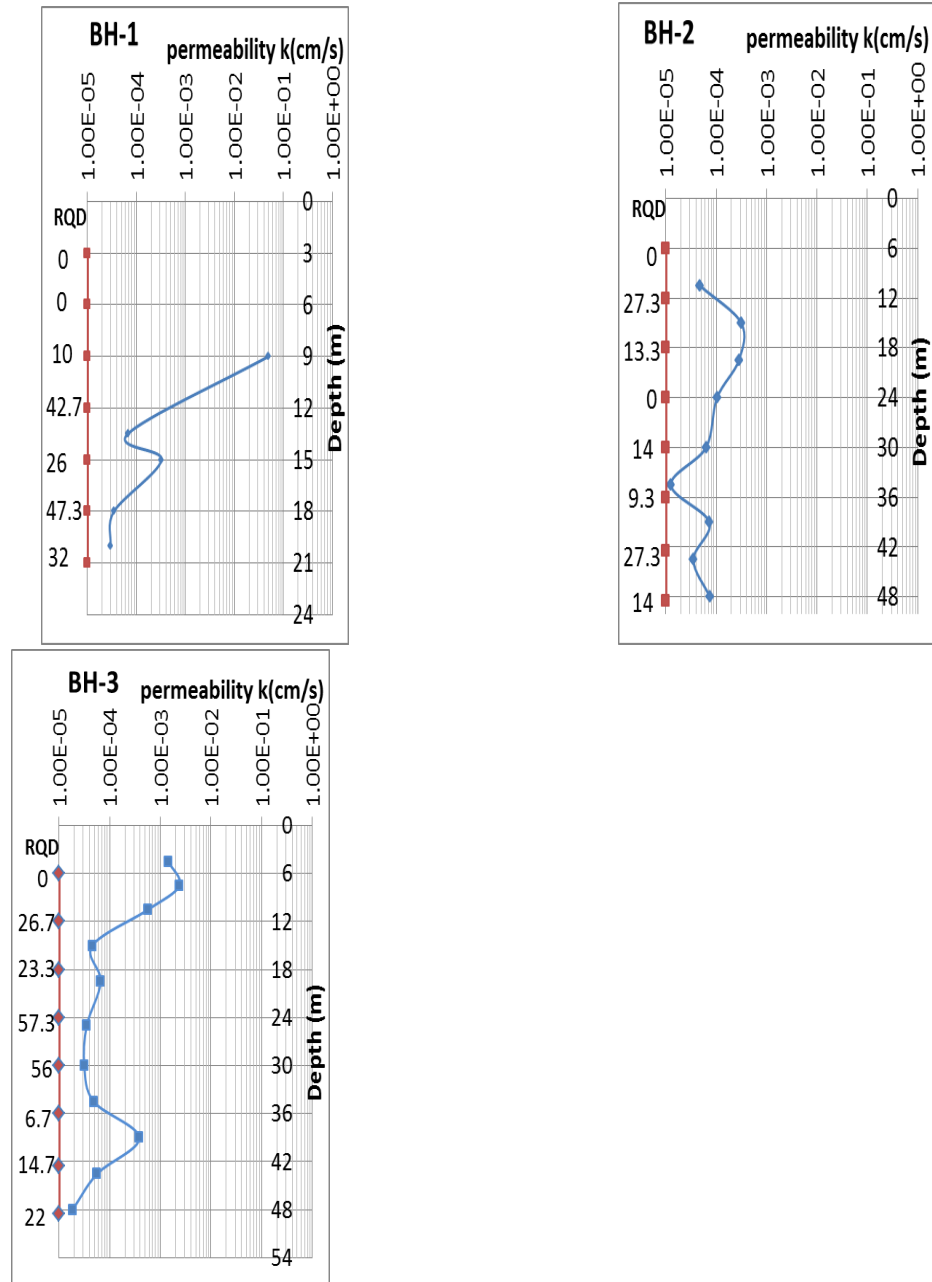
From the log of Bore Hole 1, it is inferred from the log that SPT test was conducted at a depth of 3.0m, 4.5m and 6.0m and the N value at these depths was 48, 53 and 82 respectively. It indicates presence of hard strata at these depths. SPT test could not be conducted further due to presence of boundary strata. Water table was at a depth of 0.45m from the surface. Field Permeability Test by Constant Head method at these depths which indicates complete water loss. Lithology of strata depicts overburden upto 6.0m. Further, lithology of the substrata from 6.0m to 20m indicates presence of fractured rock. Field Permeability Test by Packer Test from 8.0m to 20m depicts that the value of field permeability value vary from 3.265×10^{-4} cm/sec to 6.70×10^{-5} cm/sec. Permeability values at different depths indicate that substrata are semi impervious in nature. RQD values vary from 10.00 to 43.33 (fractured rock).

From the log of Bore Hole 3 on R/B it is inferred presence of exposed rock from the surface. Water table could not be detected. Field Permeability Test by Constant Head method at 4.5m and 6.0m which indicates semi pervious strata. Field Permeability Test by Packer Test from 9.0m to 48.0m depicts that the value of field permeability value vary from 1.84×10^{-5} cm/sec to 6.65×10^{-5} cm/sec, indicating that substrata is semi impervious in nature. The lithology of the substrata from surface to 48.0m indicates presence of highly fractured rock. RQD values from 9.0m to 48m vary from 0 to 68.

From the log of Bore Hole 2 (L/B) it is inferred presence of exposed rock from the surface. Field Permeability Test by Packer Test at different depths from 9.0m to 48.0m depicts that value of field permeability vary from 1.04×10^{-4} cm/sec to 7.30×10^{-5} cm/sec indicating that substrata is semi impervious in nature. The lithology of the substrata from surface to 48.0m indicates presence of highly fractured rock. RQD values from 9.0m to 48m vary from 0 to 59.

Fig 3 Variation of permeability with respect to depth in bore holes 1, 2 and 3

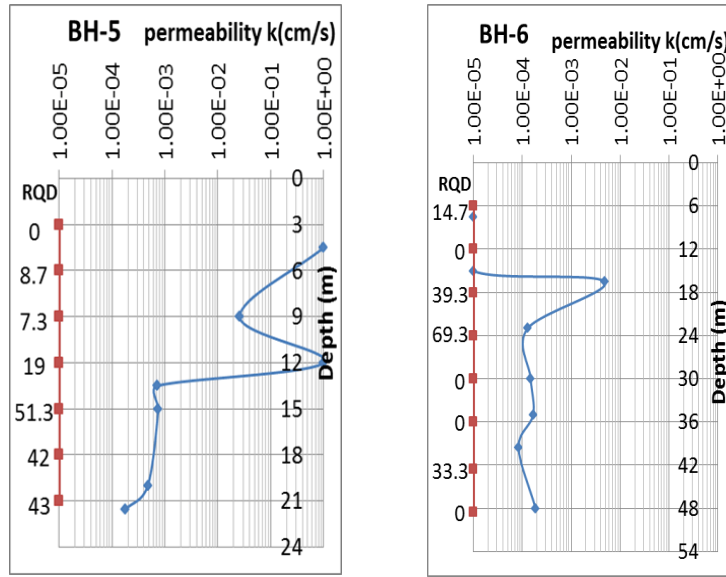
From the log of Bore Hole 5 (D/S) it is inferred presence of exposed rock from the surface. Field Permeability Test by Constant Head method complete water loss at 4.5m and 12.0m and field permeability at 9.0m was 7.19×10^{-4} cm/sec which indicates semi pervious strata. Field Permeability Test by Packer Test from 12.0m to 21.5m depicts that the value of field permeability value vary from 1.75×10^{-4} cm/sec to 7.51×10^{-4} cm/sec indicating that substrata is semi impervious in nature. RQD values from 9.0m to 48m vary from 0 to 51.33.

From the log of Bore Hole 6 it is inferred field Permeability Test by Constant Head method at from 0 to 16.5m shows no water loss. Permeability value at 18.0m is 4.78×10^{-3} cm/sec . Field Permeability Test by Packer Test from 21.5m to 48.0m depicts that the value of field permeability value vary from 8.32×10^{-5} cm/sec to 1.28×10^{-4} cm/sec. Indicating that substrata is semi impervious in nature. The lithology of the substrata from surface to 48.0m indicates presence of highly fractured rock. RQD values from 0.0m to 48m vary from 0 to 74. Figure 3 & 4 shows the variation of permeability with respect to depth in bore holes 1 to 6

Fig 4 Variation of permeability with respect to depth in bore holes 5 and 6

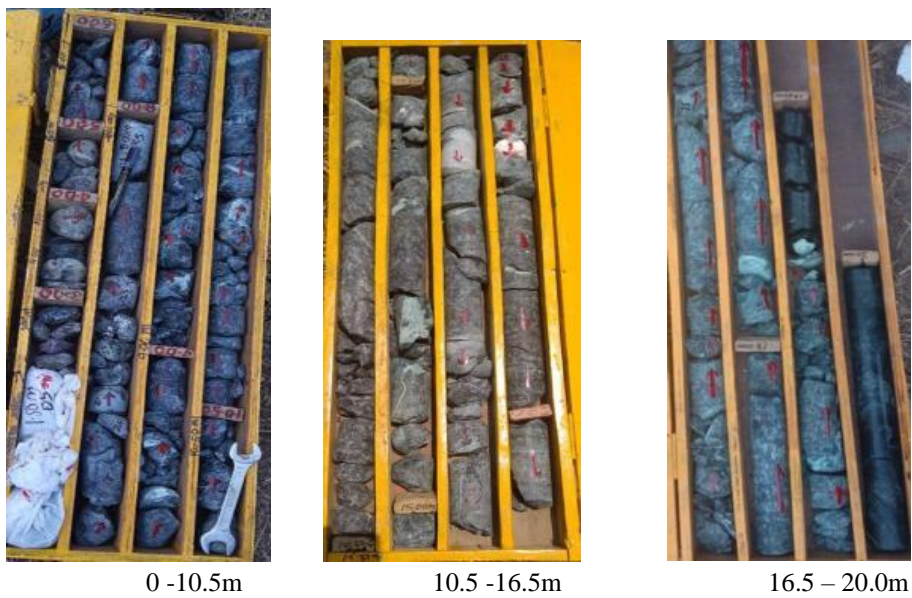
Fig 5 Display of core recovery in core boxes of bore hole 1
