Towards Excellence in Geotechnical Engineering Practice in India*

V.S. Raju[†]

^{* 25}th Annual Lecture delivered at IGC-2002, MNNIT, Allahabad, Uttar Pradesh.

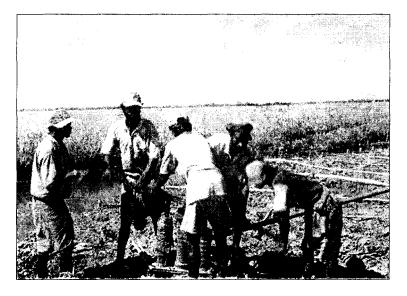
FIGURE 3 : No Safety Measures, Bare Foot, No Helmets

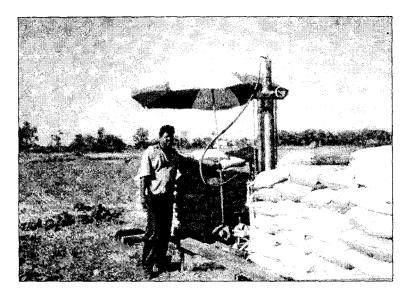
FIGURE 5 : Safety ?

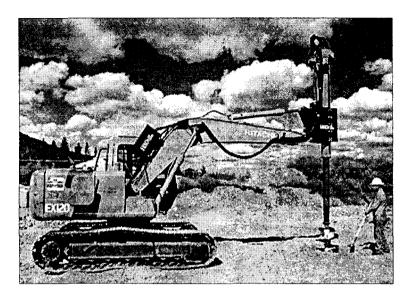
FIGURE 9 : Auger Boring with All Necessary Safety Measures

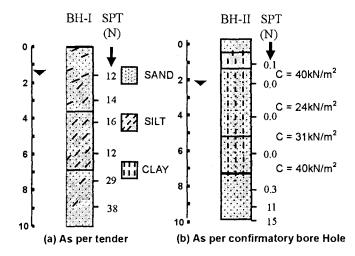
..... 'C' Values from Field Vane Shear Test

FIGURE 12 : Comparison of Bore Profile and SPT Values (Railway Bridge near Madras)

Figure 12 shows (case1) a comparison of two boreholes for a Road over bridges. The bridge has 5 spans of 10.7 m, with earthen embankments on either side. As per tender Borehole I, top two layers extending upto 7 m depth have SPT (N) values between 12 to 16 and the soil report recommended an allowable bearing pressure of 150 kN/m² for pier foundation at 2m depth below ground level. Accordingly, the piers were constructed on shallow foundation. When foundations for four piers were completed and the fifth was under construction, the approach earth embankment had a settlement of 2 m with corresponding heaving up of the soil by 1.5 m (Fig.13).

A Confirmation soil investigation was carried out and the average soil profile obtained is shown in Borehole II of Fig.12. This reveals that except

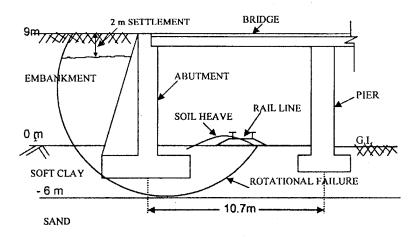
FIGURE 13 : Cross Section of Road Ove Bridge (Schematic Diagram)

top 1 to 1.5 m layer of sandy clay, the soil is soft marine clay extending up to about 8 m below ground level. The rehabilitation measures included piles installed around the shallow foundations and integrated with the foundation. There was considerable delay in completion of the project and of course additional costs and disputes as well.

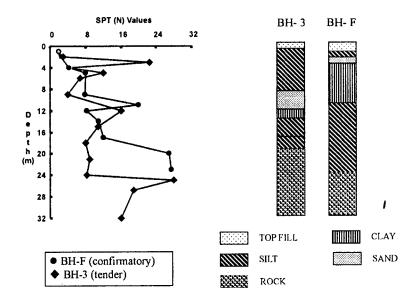
FIGURE 14 : Comparison of Bore Profile and SPT Values (Perto-Chemical Complex near madras)

Figure 14 show a comparison of two boreholes (Case 2), made just 3m apart from each other for conformation for the petrochemical plant. Twelve such confirmatory boreholes carried out showed consistently that the SPT (N) values reported in original soil report are higher and pile depths have to be around 25 m as against 20 m originally recommended. A test pile as per the original recommendation has also failed to take the design load. The confirmatory soil investigations have saved a major disaster. The pile penetration depths decided on the confirmatory boreholes resulted in large increase in piling quantity.

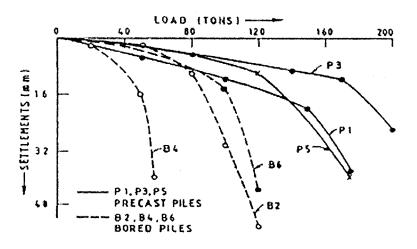
FIGURE 16 : Results of Pile Load Tests

Bored cast-in-situ pile were installed by regular bailer boring method and concreting with a tremie pipe. Precast piles were installed first by water jetting in the top sand layer and subsequently driving with a drop hammer of 4–5 t-m energy per below. The final settlement observed was about 20 mm for last 10 blows.

The loading was applied by regular kentledge arrangement. As the top sand layer was expected to settle, no resistance from this layer was considered in pile design. To simulate this condition during load test, an annular gap was created in the sand layer around the pile by placing an oversized casing up to the soft clay layer. The gap between pile and the casing was filled with bentonite slurry.

- i) For comparable dimensions, the precast pile has about 50 to 80% higher structural capacity than a bored pile.
- ii) Precast pile offers better protection to reinforcement than bored pile. This is particularly important under the present saline ground water conditions.

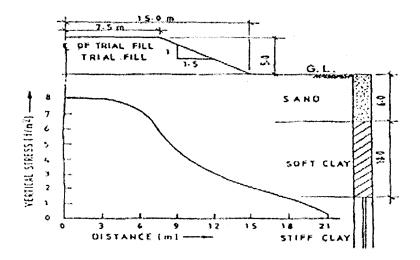
FIGURE 17 : Vertical Stress Distribution below Trial Fill on Top of Soft Clay

The 5 m high trial fill measuring 30 m \times 30 m at ground level and 15 m \times 15 m at 5 m height was instrumented with two inclinometer tubes and five settlement gauges as shown in Fig.17. The stresses transferred at the top of the soft clay layer are theoretically worked out and shown in Fig.17. As can be seen, the stress at the centre is equal to the total intensity of 5 m

high fill (about 8.5 t/m^2) which reduces along the sloping surface as shown in the figure.

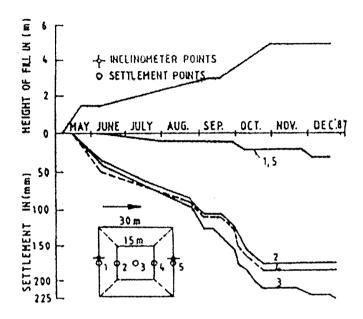
FIGURE 18 : Settlement Below Trial Fill

The resulting settlements measured by settlement gauges and lateral movements measured by the inclinometer are shown in Fig.18 and Fig.19 respectively. As can be seen the maximum settlement observed is 225 mm with settlement almost stabilizing over a period of six months only. Maximum lateral movement observed by inclinometer (Fig.19) is also within 20 mm.

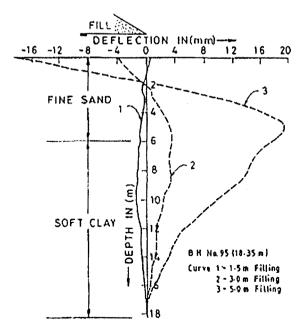
FIGURE 19 : Horizontal Displacements Measured under Toe of the Trial Fill

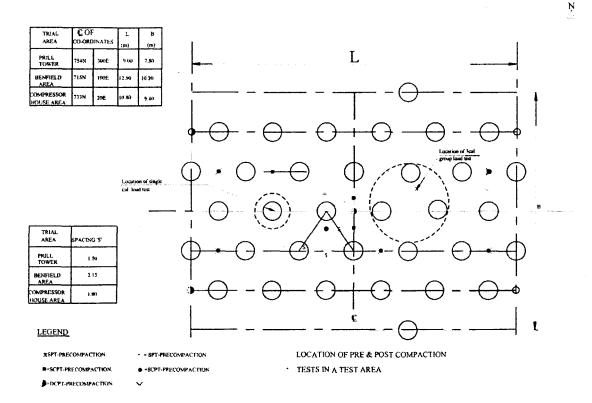
FIGURE 20 : Location of Pre and Post Compaction Tests in a Test Area

of stone columns. The footing size for single columns and three column groups were chosen considering the individual stone column and its contributory area of soil surrounding it. The locations of various tests carried out is shown in Fig.20.

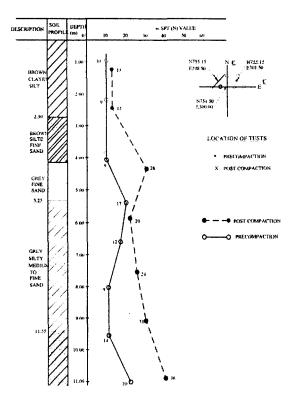
FIGURE 21 : Comparison of Pre and Post SPT in Prilling Tower Area

Pre and Post density tests were carried out in all the three test plots. For each test plot, two boreholes along with SPTs were carried out on virgin soil and after treatment. In addition, two SCPT's and five DCPT's have also been carried out for each test plot. One single stone column footing load test and one test on three stone columns group were conducted after installation

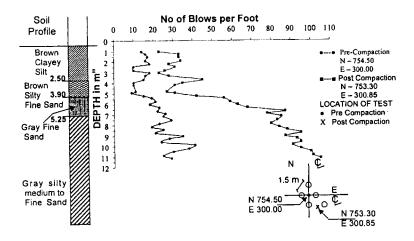
FIGURE 23 : Comparison of DCPT Test Results in Prill Tower Area (Spacing 1.50 m)

The tests were conducted as per IS:4968, Part III by driving a standard size cone (62.5 mm dia) provided with vents for flow of bentonite slurry and attached to a string of drill rods. A continuous flow of bentonite slurry is pumped through the rods and the cone to avoid friction between the rods and the soil. The number of blows, required for every 0.30 M penetration of cone is being recorded.

The DCPT values (N_{cbr}) are plotted with reference to depth for prill tower as shown in Fig.23. The results confirm the increase in value of Ncbr with depth after stone column installation.

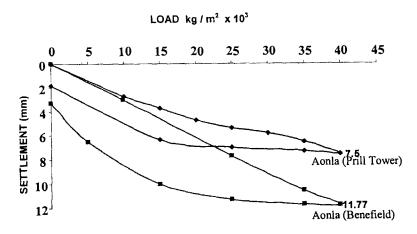
FIGURE 24 : Load Settlement Curves for Single Column Load Test

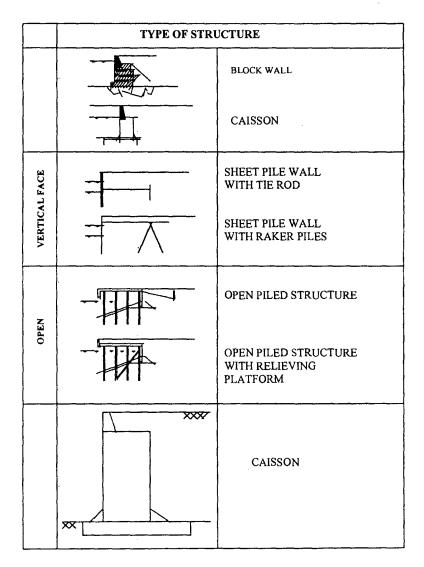
FIGURE 26 : Various Types of Arrangements

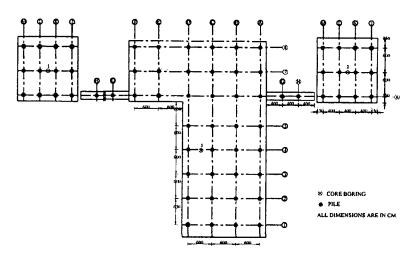
FIGURE 27 : Layout Plan of the Oil Jetty at Tuticorin Port

Figure 27 shows the layout plan of the structure. Berthing dolphins on its either side are designed to resist the horizontal impact when the ship berths. They are provided with 2.6 m thick deck supported on 1200 mm dia piles in 4 m \times 6 m grid. Two cat walks are provided for approaching the berthing dolphins.

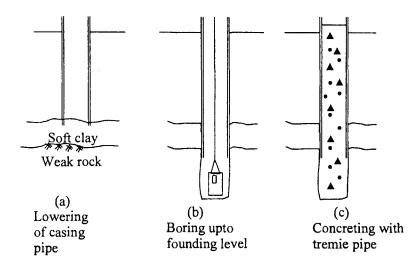
FIGURE 28 : Pile Construction Procedure (Oil Jetty)

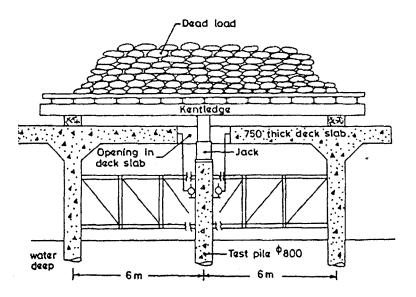
FIGURE 29 : Load Test Arrangement at Oil Jetty

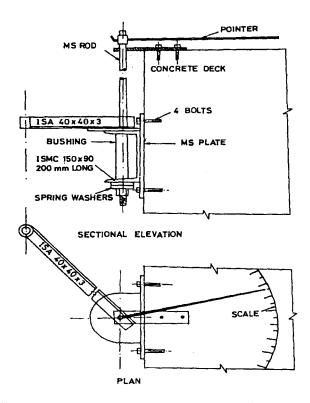
FIGURE 31 : Gauge for Measuring Fender Compression

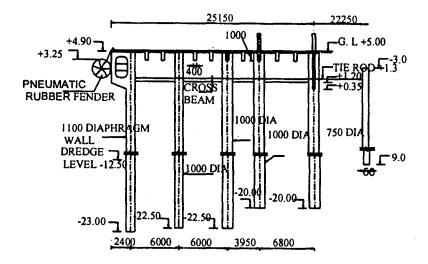
FIGURE 32 : Vertical Piles with Tie as per the Original Design

- 1. Vertical piles with tie as per the original design (Fig.32)
- 2. Modified design using only vertical piles and with increased pile diameters (Fig.33).

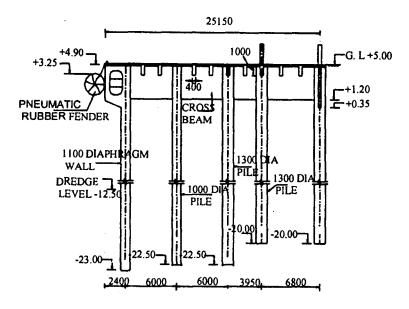
FIGURE 33 : Modified Design using only Vertical Piles and with Increased Pile Diameters

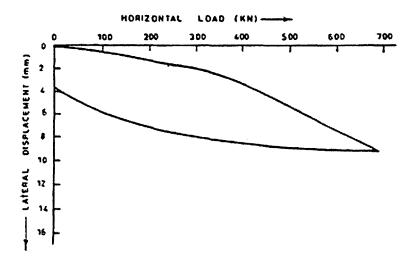
FIGURE 34 : Lateral Load Test on 1300 mm Diameter Pile

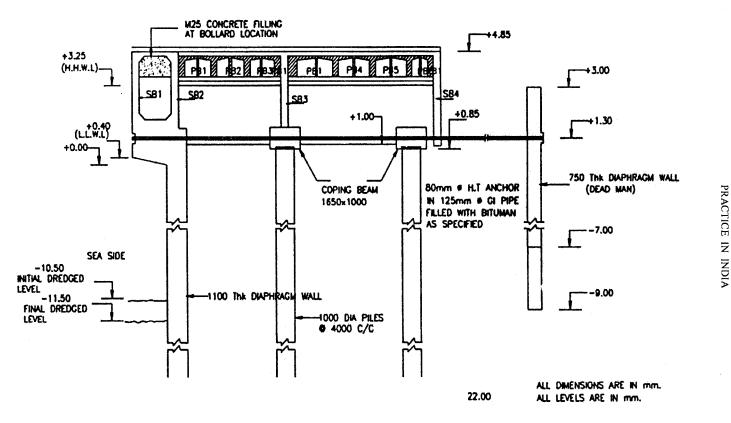
FIGURE 35 : Typical Cross Section of Third General Cargo Berth

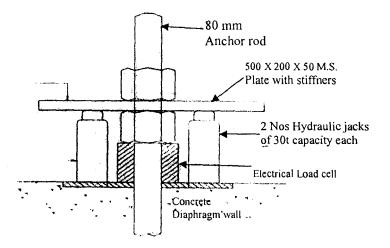
FIGURE 36b : Testing Arrangement

- 3. Arrangement for moisture proofing of the gauge
- 4. Load cell must allow the tie rod to pass through it so that the load on the cell will be compressive

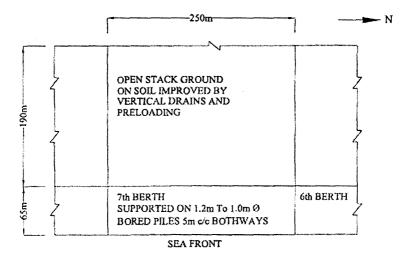
FIGURE 37 : Layout of Cargo Berth

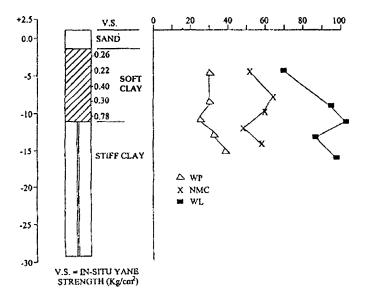
FIGURE 39 : Typical Soil Profile - Kandla Port

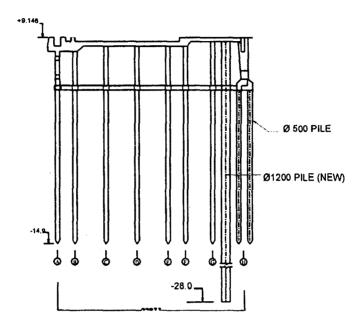
FIGURE 43 : Cross Section with New Piles

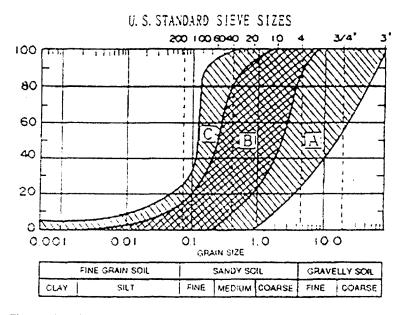
Three main points are illustrated in the above figure.

- 1. The vibroflotation method is most effective in loose sand with gradation in zone B $(-D_{20} = 0.1 \text{ to } \text{Imm}, D_{50} = 0.3 \text{ to } 2.5 \text{ mm})$
- 2. Compaction by vibroflotation becomes very difficult in sand with gradation in zone C, and
- 3. Compaction is possible for soils with a portion of the gradation curve passing through zone C. Penetration of the vibroflot becomes difficult in relatively dense sand, cemented sand, and gravel in zone A.

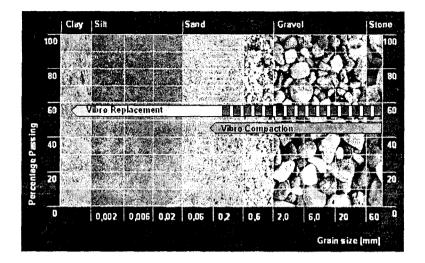
FIGURE 44b : Gradation Appropriate for Vibro Flotation / Vibro Compaction Method

Note : Vibro compaction suitable for $D_{20} > 0.109$ mm and $D_{50} > 0.116$ mm Vibro compaction ideal for $D_{20} > 0.144$ mm and $D_{50} > 0.24$ mm

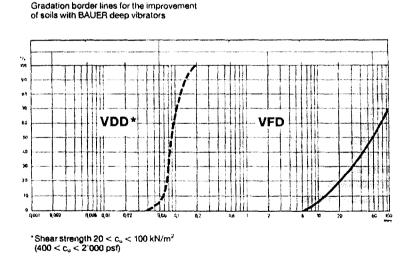
VDD - Vibro Displacement Densification VFD - Vibro Flotation Densification / Vibro Compaction

FIGURE 44c : Gradation Appropriate For Vibro Flotation / Vibro Compaction Method (Source : Bauer Spezialtiefbau GmbH, Germany)

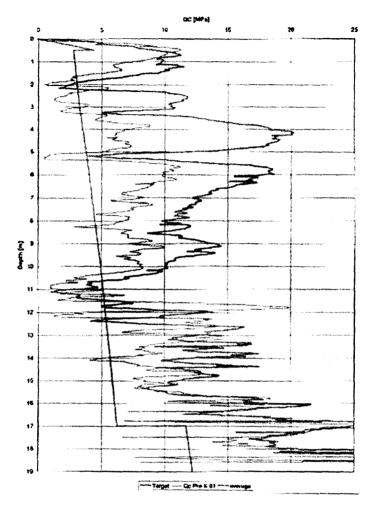
FIGURE 49 : Cone Resistance Values

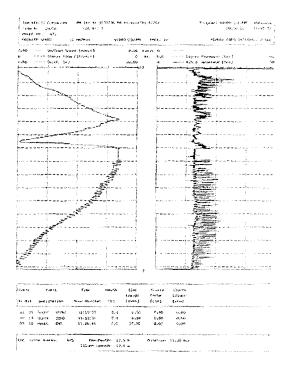
FIGURE 51 : Typical Computer Printout

- Start and finish times of installation
- Period required for installation
- Power consumption during penetration
- Power consumption during compaction
- Maximum power consumption
- Maximum depth

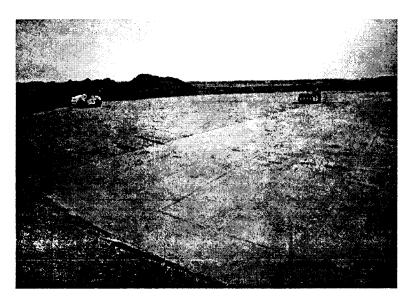
FIGURE 53 : View of Tank Area after Excavation

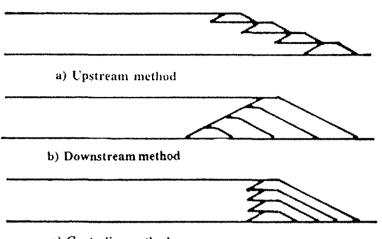
c) Centreline method

The desirable aspects of downstream and centreline techniques are greater compaction control and hence better stability and steeper outer slopes. However, the upstream method is usually the most economical and hence adopted most often. In the upstream method, the embankments are constructed progressively on soft ash deposit. Therefore, special measures for proper drainage of the ash deposit are critical for stability of upstream

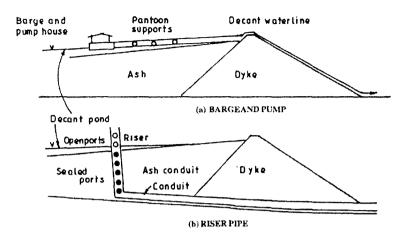
FIGURE 55 : Methods of Decanting Water
