2 Project Details

2.1 General

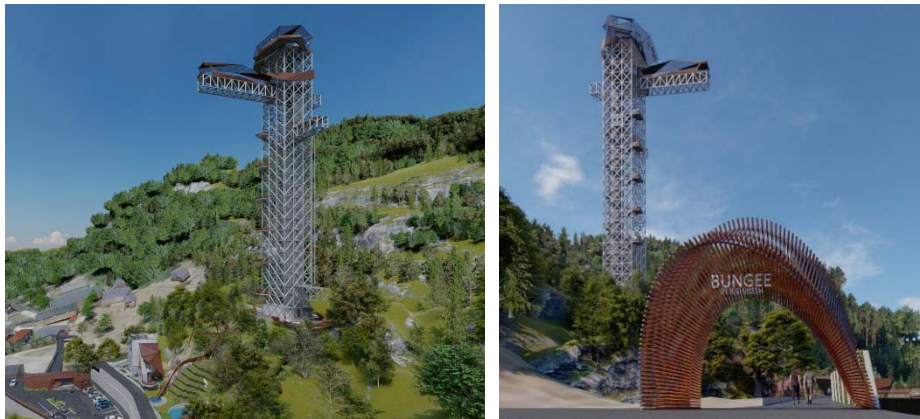
Fig. 3. Architect's visualization of the tower and its surroundings

The tower is designed and constructed as RCC-steel hybrid structure. The substructure up to the plinth level shall be in RCC and the superstructure shall be constructed using braced HR steel frame of steel frame with stay wires. Steel columns have been analyzed as fixed at top of RC pedestal. Cross bracings in vertical and horizontal planes are provided at suitable locations to resist the lateral force and torsional effects due to earthquake and wind. The foundation was checked for overturning moments due to wind forces. A conceptual visualization of the tower as developed by the architect is presented on Fig. 3.

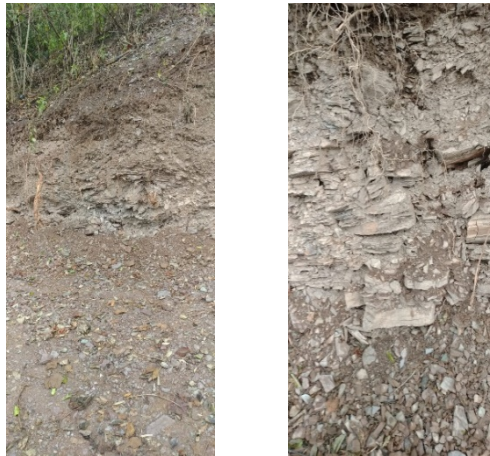
Fig. 4. Exposed rocks at site.

North Almoda Thrust and Saknindhar Thrust are present close vicinity of the site which are separated by distance of 1.5-2 km from each other. Site is located at nearly the centre of these two thrusts. There is high possibility that area could be part of a shear zone. Photographs in Fig. 4 illustrate the shearing and disturbance to the rocks at site.

Note the shearing and disturbance to the formation

Gentler dips of the disturbed rocks near the tower area, seem the result of old slope creep. The area could be part of a shear zone as suggested by the dips of the rocks and the overturned and highly fragmented and crushed rock-mass.

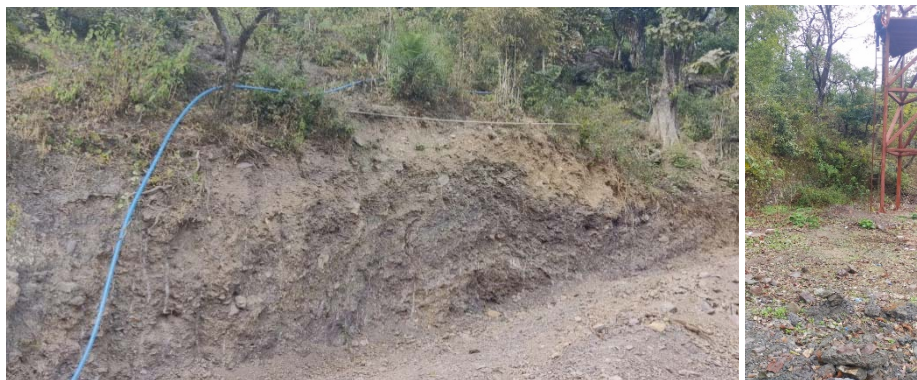
Fig. 6. Site Overview

The tower site is in the mountainous terrain of lesser Himalaya on right bank of Hule river, near its confluence with the River Ganga at Shivpuri. The tower shall be located in an artificially terraced soil, covered rectangular area (about 21m x 13m) bound by concrete masonry walls, in moderate to steep, largely debris covered slopes. The terrace is about 22m high with relatively steep (35-40°) debris-covered-and-forested slope with a gentler slope below. Fig. 6 presents photographs illustrating an overview of the site.

Debris contains small angular fragments of shales in a silty-clayey matrix. Large dolomite boulders of up to about 3m size lie sparsely in the debris on northern side and on the slope below the terrace. Occasional smaller trees on the slopes are tilted downslope, however, many large, fairly old trees of normal appearance exist on the debris slopes, suggesting fairly stable-slope conditions. A sketch of the site identified for the tower is shown on Fig. 7.

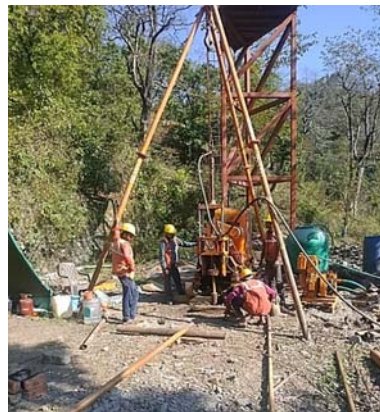
Fig. 8. Borehole Drilling in Progress

The scope of the geotechnical investigation included a borehole and a plate load test. A photograph of the drilling in progress is illustrated on Fig. 8.

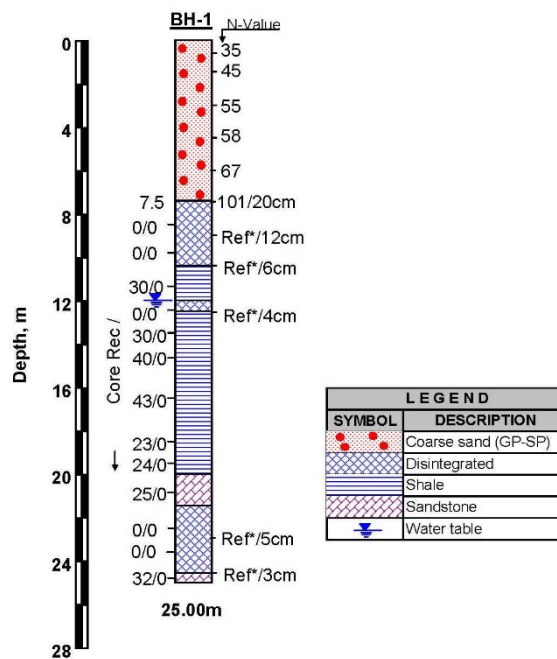
Fig. 9. Borehole Profile

An overburden of coarse to fine sand intermixed with rock fragments is met at site to 7.5 m depth. It is likely that part of this may be debris material from an old landslide; however, the overburden appears to be fairly compact and stable.

Below this, completely to moderately weathered and very weak to weak purple, shale (rock) was met at site to 20.0 m with core recovery 0-43% and RQD 0%. The underlying rock classifies as completely to moderately weathered and very weak to weak grey, sandstone (rock) was met to final explored depth of 25 m. Groundwater was met at 12.00 m depth during the period of the field investigation.

Field SPT-N values range from 35 to 45 to about 3 m depth values indicating the dense condition of strata. Below this, SPT values ranges from 55 to 67 to about 7.5 m, below this, SPT values exceed 100 to the final explored depth of 25.0 m. Groundwater was met at 12 m depth. Fig. 9 presents the pictorial representation of the borelog.

An overburden of sand intermixed with rock fragments is met at site to 7.5 m depth. Below this, completely to moderately weathered and very weak to weak purple, shale (rock) was met at site to 20.0. This is underlain by completely to moderately weathered and very weak to weak grey, sandstone (rock) was met to 25 m depth. Groundwater was met at 12 m depth.

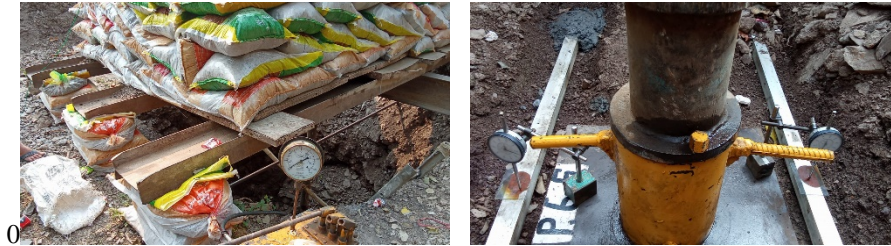
Fig. 10. Plate Load Test in progress

A plate load test was conducted on a 60 x 60 cm size test plate at 3 m depth. Fig. 10 presents a photograph of the test in progress. The load-settlement curve is presented on Fig. 11.

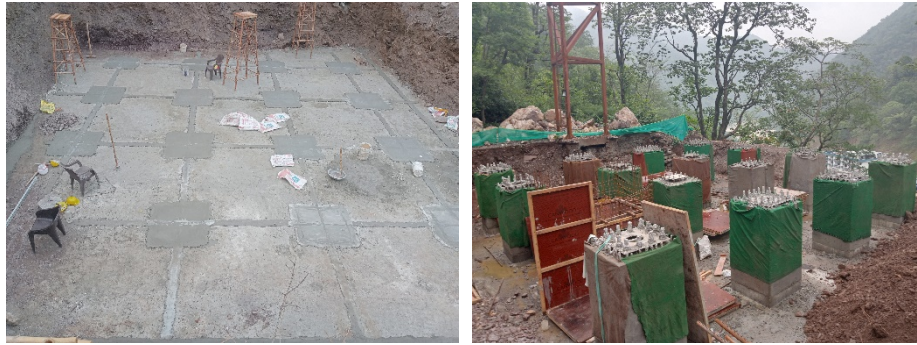
Fig. 12. Foundation construction in progress

The foundation construction is nearly over and the steel structure erection is in progress. Fig. 12 presents site photographs of the foundation construction and the 16 columns.
