Stabilization of a collapsed rock mass and installation of 100 tons permanent strand anchors at the Punatsangchhu-II Hydroelectric Project, Bhutan

Abstract

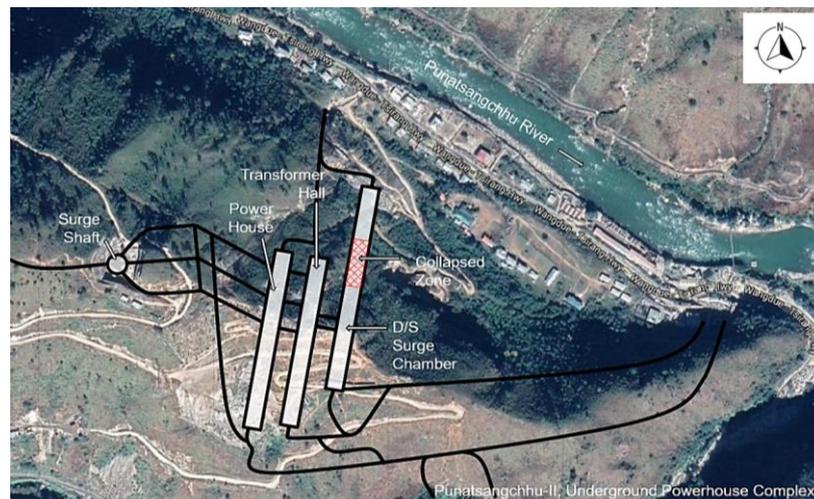
Fig. 1. General layout of Punatsangchhu-II Hydroelectric Project, Bhutan

The Punatsangchhu Hydroelectric Project Authority (PHPA) of Bhutan is implementing two mega power plants with an installed capacity of 1,200MW and 1,020MW respectively (Fig.1). Both the projects spread over a distance between 20Km and 35Km downstream of Wang- due Bridge along Wangdue-Tsirang National Highway in Wangdue Phodrang Dzongkhag of Bhutan and it is approximately 115Km east of Thimphu, the capital of the Royal Kingdom of Bhutan. Both projects are undertaken by the Royal Government of Bhutan (RGoB) and Government of India (GoI) for the mutual benefit of both the countries. Punatsangchhu-II Hydroelectric Project (PHEP-II) envisages the construction of one concrete gravity dam (CGD) across the Punatsangchhu river, and an underground power- house complex (PHC) and a complex of three major caverns. One major roof rock fall incidence took place on 3rd March 2016 in the downstream surge chamber (DSC). The total quantity of collapsed muck who entered the partially excavated cavern was assessed to be around 65,000m³, approx. 35,000m³ of collapsed muck lay above the cavern. An empty cavity, with a volume of approx. 45,000m³ is laying above the collapsed rock mass. The bouldery muck fill completely covered the complete 50m high cavern. It was necessary to determine the cavity's extent, dimension, volume and orientation to design suitable remedial measures. Hence, the project management explored different options to decipher the cavity dimensions by application of surveying, geophysical techniques, cavity monitoring system, exploratory drill holes and other feasible methods.

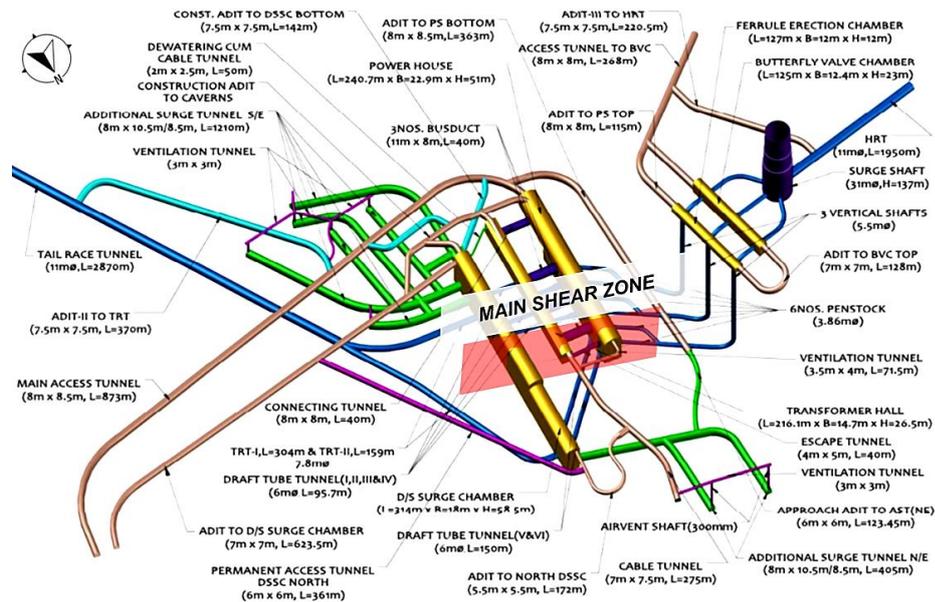
Fig. 2. Power House complex and approximate location of shear zone

Regionally, PHEP-II area is located within a part of the Tethyan belt of Bhutan Himalayas, which lies north of main central thrust. The rocks of Sure and Chekha Formations of the Thimphu Group of Precambrian age are exposed in this region. Different rock variants were encountered in the DSC including quartzo-feldspathic-biotite gneiss, biotite gneiss, biotite schist, micaceous quartzite, leucogranite and pegmatite. Generally, the foliation has gentle dip, ranging between 5° and 25° directed between N190° and E240°, Figure 2 shows a 3D projection of the shear zone crossing the DSC cavern.

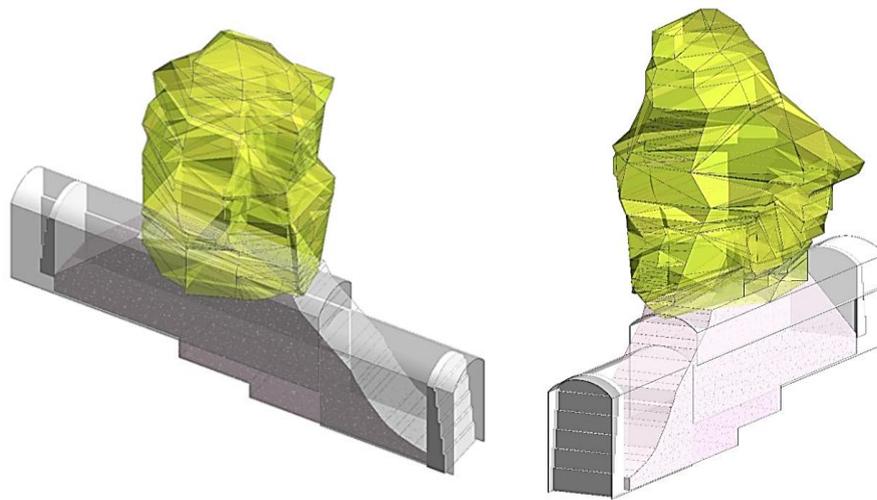
Fig. 3. Approx. shape of the cavity above the DSC and fallen muck inside the cavern

Excavation in DSC started in the month of March 2013. As published in the Journal of Geotechnical Research (Vol. 01, Issue 01, 2019), on 3rd March, 2016, a first major rock fall occurred in DSC with intermittent loose falls, followed by two major falls on 11th and 22nd March, 2016. The condition of the cavern with muck flown from the crown blocking the approach towards northern end after different major falls are shown in Figures 3 and 4. The

Attempts were made to drill NX sized boreholes from the surface at apt locations intending to daylight into the cavity so that at least point data information can be obtained which could provide the coordinates of the apex of the cavity above DSC crown. Three holes punctured into the cavity indicating the cavity apex at an elevation of 694.5 m, 153m above the roof of the DSC. This provided some insight into the height of the cavity, but this approach too could not help in determining the complete extents of the cavity. The Figures 3 and 4 show the shape and dimensions of the cavity.

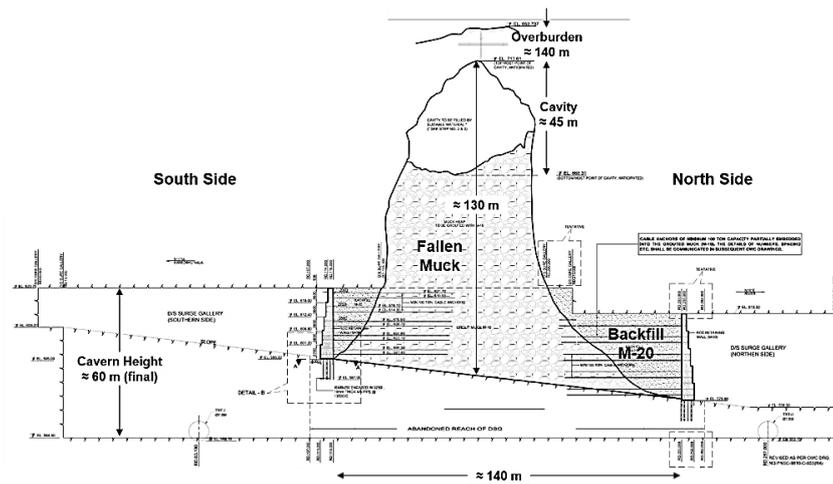
Fig. 4. Longitudinal section (tender stage drawing) of the surge chamber with the cavity

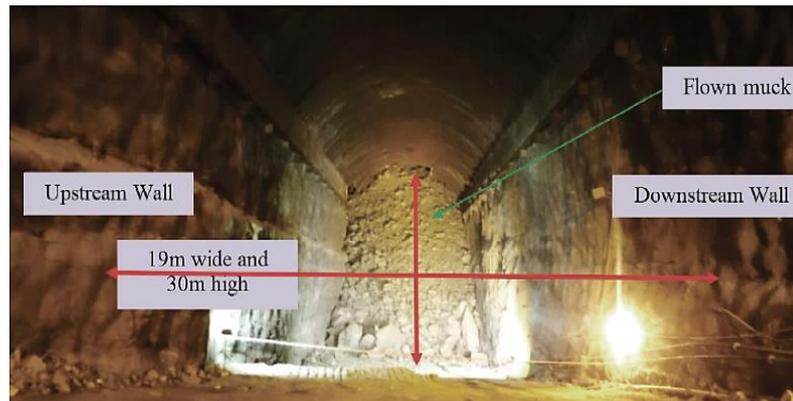
Figure 5 shows a picture of the collapsed material taken inside the DSC in 2016 March 22. The failure of the rock mass initiated from the crown of DSC between along the major shear zone extending on either wall dipping towards face. The rock mass gave up within a very short span at an odd hour, around 1 AM on 3rd March, 2016.

Fig. 5. Flow of muck inside the DSC on 11/03/2016 north side

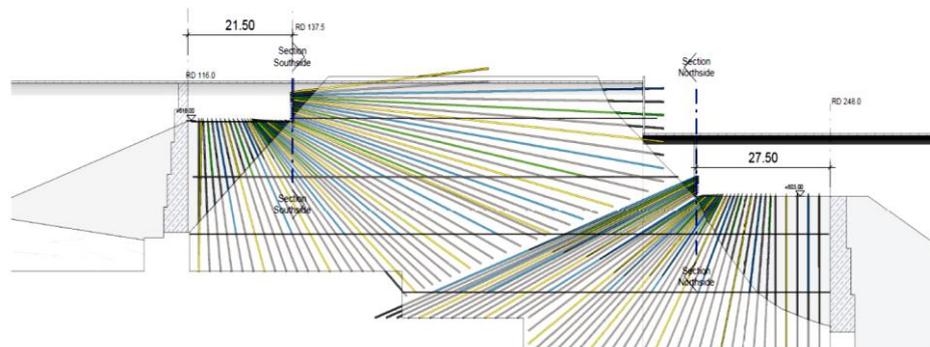
Fig. 6. Longitudinal section with fallen muck borders, containing walls and injection holes

Reinforced concrete wall were constructed after the collapse, simultaneously with the backfill of the caverns. The partial backfill of the tunnels outside the collapse area was required to stabilize the two separate cavern sections and to facilitate the drilling and grouting works (Fig. 6) . The designer required the fallen rock debris between the walls to be improved by means of a cement-based injection, to create a monolithic block in between the containment walls. Finally, the boundary sidewalls were tied back with permanent anchors. Anchor scope comprises 359 permanent cable anchors of 100T capacity each. The central part of the cavern will be abandoned, and two smaller compensation chambers connect by a bypass tunnel will be created. The abandoned volume will be partly compensated via additional tunnel adits.

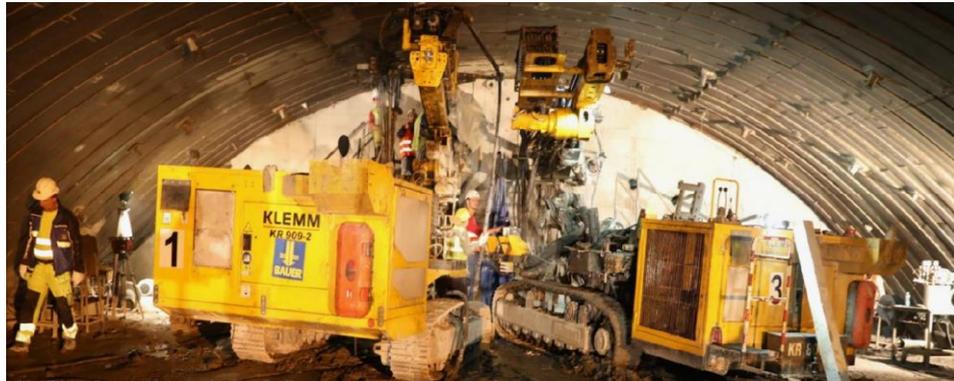
Fig. 7. Two Klemm KR 909 rigs working in narrow space inside the cavern

Drilling works started in January 2020, approximately four years after the collapse of the rock mass in the DSC cavern occurred. The fallen rock mass was quite unstable, it included large blocks of hard rock, massive steel beams of the collapsed cavern roof and buried equipment and abandoned strings of drilling rods and tools. Klemm double head drilling rigs type KR 806 and KR 909 (Fig. 7) have been mobilized for this project. Drilling immediately appeared as the

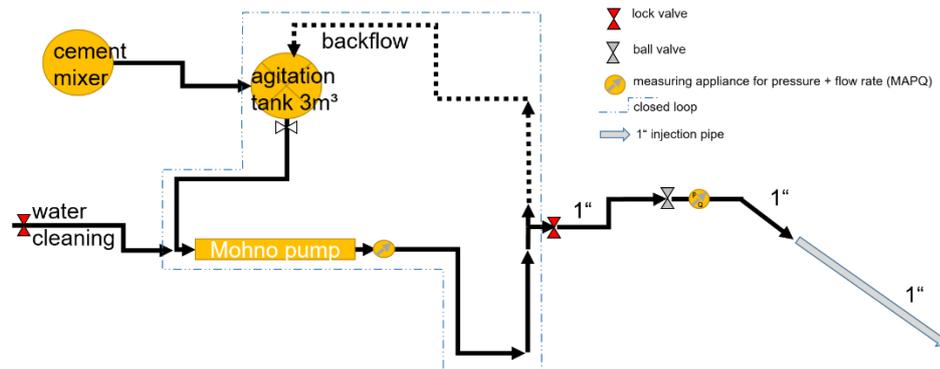
Fig. 8. Scheme of cavities backfill injection with Mohno pumps and closed loop circuit.

This injection phase was conceived as low pressure backfill of the cavities within the fallen rock mass, through a bundle of small diameter PE hoses, staggered along the hole. Injection was done using screw Mohno pumps with a closed loop circuit (Fig. 8). Grouting started from the deepest hose and proceeded upwards once grout communication with the upper hose or with the surface was detected. The backfill injection was subdivided into primary, secondary and tertiary holes (P,S,T sequence). One sequence was only started after completion of the previous one.

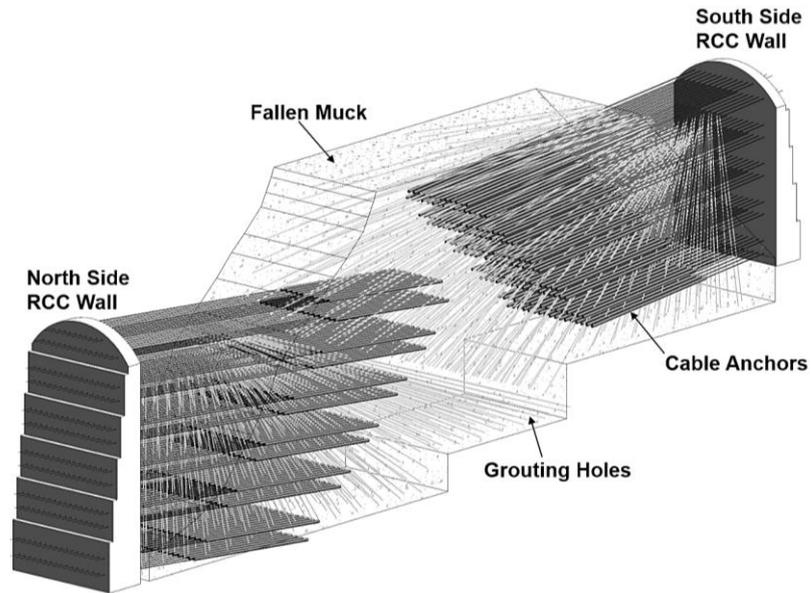
Fig. 9. 3d view showing grouting holes and permanent cable anchors

In parallel with the cable anchor installation, BAUER has been requested to execute the drilling of rock bolts in the cavern upstream and downstream walls (Fig. 9 & 10). In general, this rock bolts are being drilled in parallel with the cable anchor installation as benching down. Rock bolts are executed with 5° positive inclinations and 15m length.

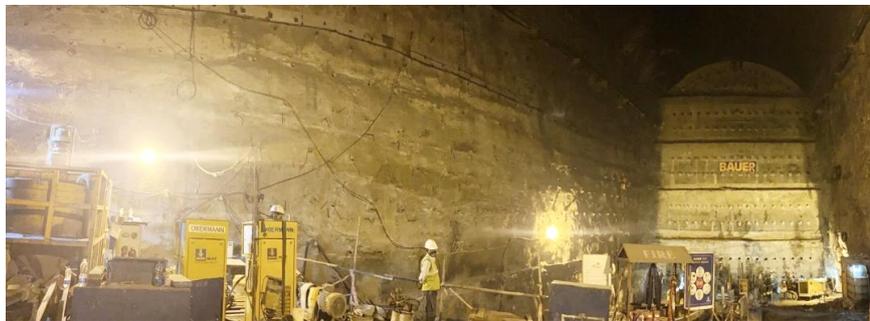
Fig. 10. Overview of cable anchor works at lower level

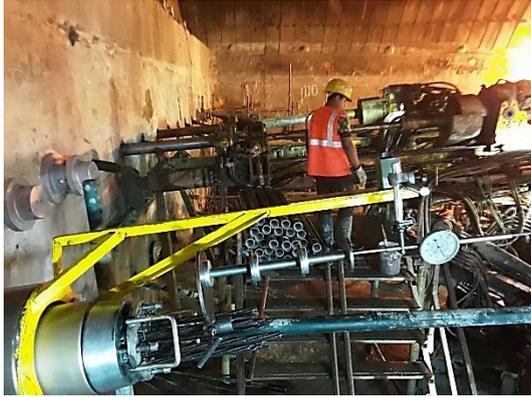
Fig. 11. Anchor tensioning and hole drilling

Prefabricated strand anchors were manufactured in Germany by Spantec GmbH, shipped to Bhutan and finally assembled on site (Fig. 11 & 12).

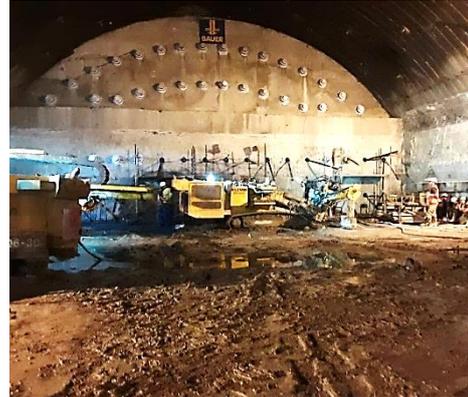
Fig. 12. General view and details of anchor heads
