Indian Geotechnical Conference

IGC 2022

Use of Geosynthetics for Protection of B-Dyke in Dhakuakhana along the River Brahmaputra, Assam -A Case Study

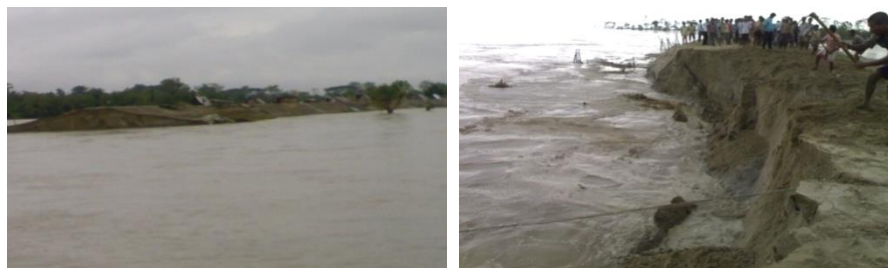
Fig. 1. Breach and Flood problem before execution of Geo Dyke

During the flood of 2007, matmara area was disturbed due to a major breach on the flood embankment causing enormous damages in Dhakuakhana division. Due to non-availability of good quality of soil, the embankment breached at many locations. The entire stretch of land area is covered by river sand & silt and construction of bund extending a length of 5 km is not sustainable. Figure 1 shows the breach and flood problem before construction of Geo-dyke. Basically the materials available for earthen embankment especially on the northern bank area of the River Brahmaputra consist of vast track of sandy & silty soil, which often do not possess required cohesion and stability. However, these materials form an excellent filler material for use in geotubular mattresses, geotube containers and geotextile bags.

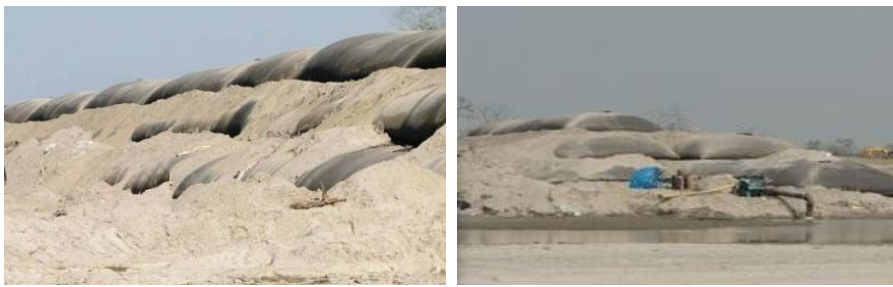
Fig. 3. Installation of geotubes (1:2:3) as core of the embankment

Construction of Embankment using Geotube as Core (Geo-Dyke): Good quality of soil for embankment construction was not available in the vicinity of the project. Hence geotextile in the form of geotube mega containers filled with sand/silt was used

in the core of the embankment with adequate soil cover to provide a trapezoidal shape having stable slope of 3H:1V as shown in Figure 1. This is the main body of protection work. The formation of geotube dyke for closing the breach of 5 km length consisted of mainly 6 tubes i.e. 1 over 2 over 3 nos. Geotube installed for a length of 5 km embankment was 200 nos. per line and therefore total nos. of geotubes for 6 lines consisted of 1200 nos. The length of geotubes used were 25 m long with fill height of 2.5 m. Minimum 3 stages were required to complete the tube filling. In every stage, pumping of slurry inflated the tube to its full capacity, then pumping was stopped until the water comes out from the tube. Such stages continued until the fill height achieved is 2.5 m. The height of the embankment was kept 7.5 m, consisting of 3-2-1 formation of geotubes stacked one above the other to form the required slope as shown in Figure 3 [1]. Height of embankment is selected with respect to high flood level to prevent flooding on the country side.

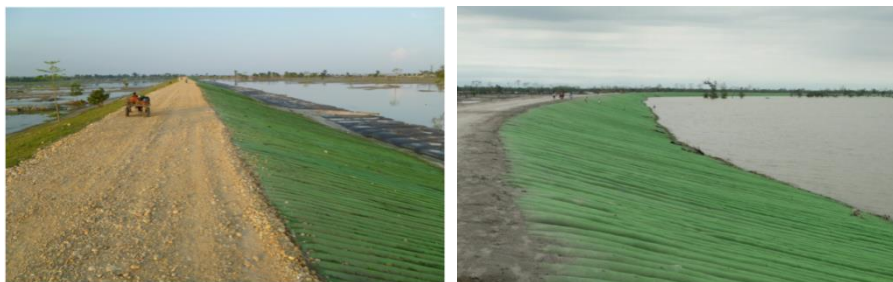
Fig. 4. Installation of Geotubular mattress as revetment

Construction of Revetment using Geotubular Mattress: For providing revetment, slope of the embankment on the river side is dressed at least up to low water level (LWL). Geotubular mattress filled with sand (200 mm thickness) is laid on the slope to protect the slope from getting damaged due to the rain cuts etc., and due to flood water. It also served the dual purpose of preventing bank erosion and bank sloughing due to seepage of country side water which is filtered out by the sand filled mattress. Geotubular mattress is anchored at crest and bottom toe (near LWL) of embankment slope by bending the mat into the trench of size 1.5 m x 1.0 m and filled with earth materials. Trench at the bottom slope also acts as toe-key for the revetment and apron. Revetment work [1] is shown in Figure 4.

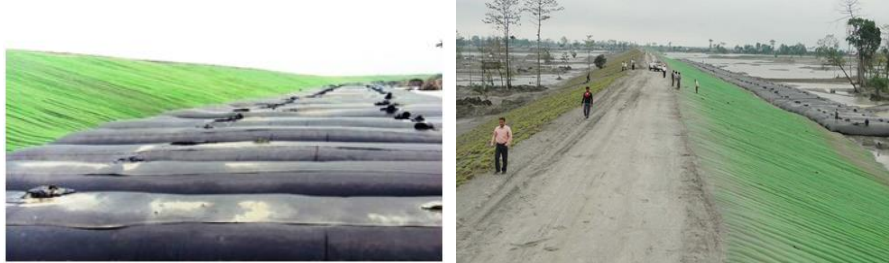
Fig. 5. Installation of Geotube as scour apron at Matmara geo-dyke

Construction of Scour Apron using Geotube: Construction of scour apron is carried out near LWL using geotube mega container of dia. 0.9 m. It is filled in place by pumping sand water slurry, allowing the geotube to fit the contour of uneven river bed. It is placed on the river side ground and extends from embankment toe-key to

wards the river for a length of 12 to 16 m as scour apron to prevent scouring of the river bed. The structure also protects the scouring of embankment toe-key by dampening the velocity of the flow approaching towards it. Figure 5 shows the installation [1] of geotube as scour apron at Matmara geo-dyke.

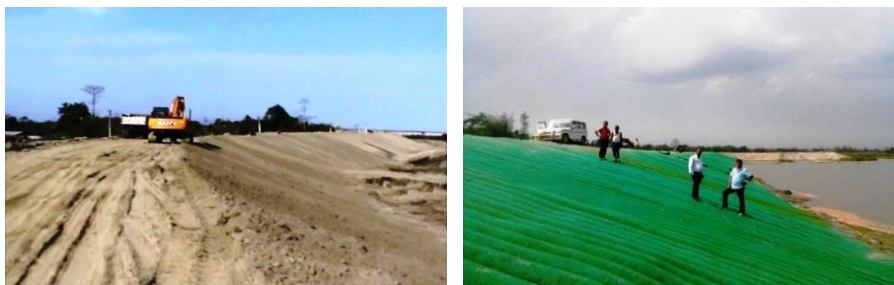
Fig. 6. Installation of Geotubular mattress

After successfully completing 5 km breach portion with Geo-dyke at matmara in the year 2010 as discussed above, Dhakuakhana WRD implemented similar work in the year 2015-16 under FMP with nomenclature “Protection of B/dyke from Sissikalghar to Tekeliphuta at different reaches from Lotasur to tekeliphuta from the erosion of River Brahmaputra with annual benefit cost ratio of 3.47:1. Out of 27.15 km B-dyke, strengthening of remaining portion was started in 2015. Protection of B-dyke was done using geotubular mattress all along the length on river side and geotube mega containers, each 0.9 m fill height and 10 m length was applied in the critical portion. Geotubular mattress was installed on the slope of the embankment as revetment [1], as shown in Figure 6 and geotube mega container was installed at the toe portion as scour apron. Geosynthetics materials for above scheme were evaluated for their quality at CSMRS, New Delhi [14-15]. The protection work was started in 2015 and completed in 2019.
