BANK EROSION PROBLEMS IN RIVER BARAK – A CASE STUDY

Fathima Israr Khan¹ and Ashim Kanti Dey²

¹Research Scholar, Civil Engineering Department, NIT Silchar

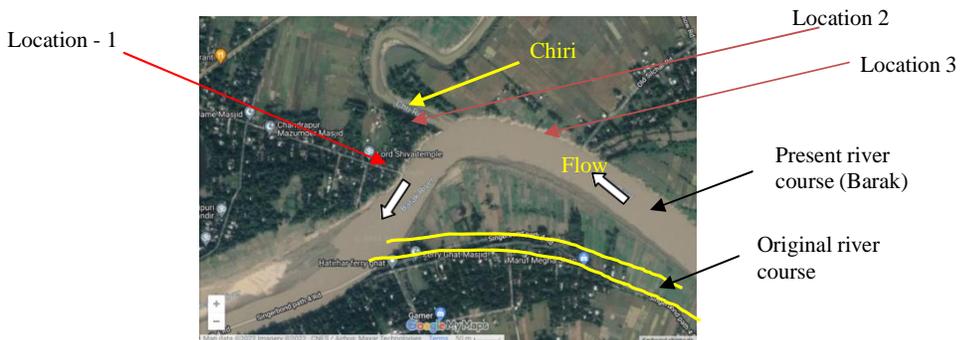
Fig.1. Google image of selected location at Chirimukh

Out of many erodible sites, one site at the confluence of a tributary namely Chiri was chosen for the present study. The local name of the site is Chirimukh and shifting of the river in this site from its original course is shown in Fig.1. Three locations at the Chirimukh site were selected; a photograph is also shown in Fig.2. The erosion at the banks of these three locations is shown in Fig. 3.

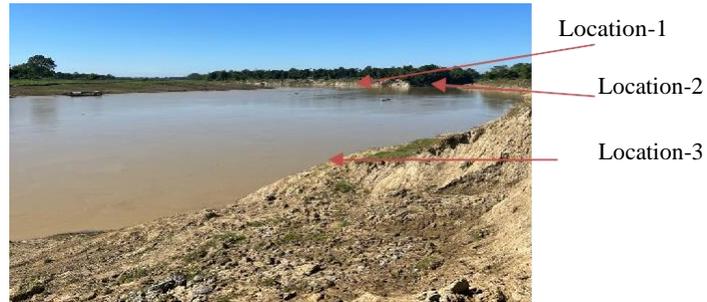
Fig.2. Various selected locations at Chirimukh site

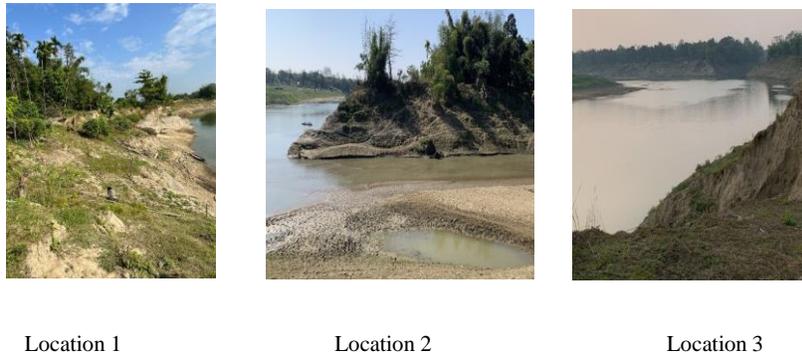
Location 1

Location 2

Location 3

Fig.3. Eroded Banks at three selected locations
