**Indian Geotechnical Conference
IGC 2022**
15th – 17th December, 2022, Kochi

A Case Study on the Corrosion Mitigation and Sealing of Crack/Porous Concrete of a Bridge with Epoxy Grout/Monopol High Molecular Weight Polymer (LV Grade) Grout

In this project a study was made regarding the latest corrosion mitigation technologies and retrofitting of corrosion damaged Dima River bridge at Buxa forest in Kalchini area of Alipurduar, West Bengal.

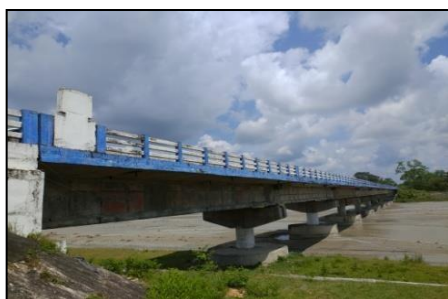
This bridge is built on Rajbhatkhawa - Jaygaon Road at Ch. Km. - 4.50 in the district of Alipurduar. This bridge consists of nine (09 Nos.) main spans of length 21.7m with a total length of 196.00m. This superstructure consists of RCC I girders. From visual inspection, this bridge is considered as a distressed one.

Fig. 1. Dima bridge

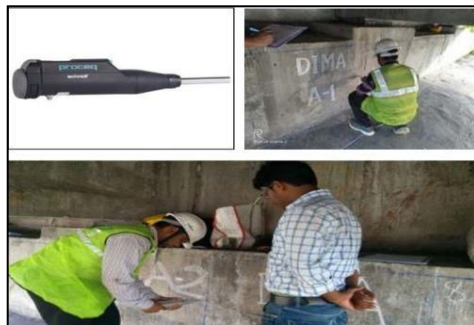
Rebound Hammer test is widely used as a Nondestructive test method to assess the strength of concrete. Schmidt hammer is used for the testing of existing concrete structures like bridges, buildings etc. The hammer is pressed against a smooth surface & the plunger strikes with an impact energy which yields a rebound value. The rebound values are corrected & plotted in a conversion chart to get the corresponding compressive strength of the concrete surface. [5]

Fig. 3. Rebound Hammer Test

2. From rebound hammer tests, it is seen that the concrete in this site have varying surface hardness with the rebound numbers ranging from 19 to 59. Sudden drop in rebound values have mostly been observed around the repaired area in girder of span-9. The corresponding strength values are in the order of 13 to 27 MPa.

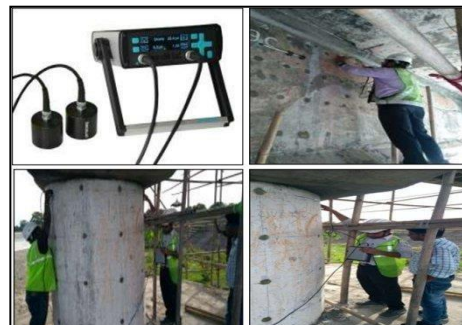
Ultrasonic Pulse Velocity test is carried out for assessing the elastic properties as well as concrete quality. This method could be used to establish the followings: 1) The Homogeneity of the concrete. 2) The existence of voids, cracks and other defects. 3) Change in the structure of the concrete which may occur with time. 4) The quality of concrete in relation to standard requirement. 5) The quality of one element of concrete in relation to another. [5]

Fig. 4. Ultrasonic Pulse Velocity Test

3. UPV test indicates the variation of density and homogeneity of concrete within zone of influence. From Ultrasonic Pulse Velocity tests, the concrete at this site is found to be in good quality in general. However, at different places of girder in span-9 low pulse velocities have been observed near the cracks.

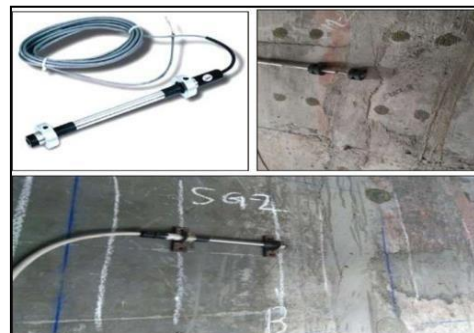
Strain Gauge and Crack Meter Measurement: A Strain gauge is a sensor which records change in strain due to change in load in periodic intervals through a data logger.

Vibrating Wire gauges were used in this site. The sensor produces an output signal in the form of an alternating current when electronically excited. The frequency of the alternating current can then be readily converted to a change in strain. These strains are recorded through a DT85 logger. Due to the instrument's long life and high reliability, vibrating wire strain gauge are the most robust solution to monitor strain in concrete and metal structures. On the other hand, a crack meter directly measures change in length across a crack. These instruments can give the data for monitoring opening and closing of cracks, but not the absolute length or width of cracks. [5]

Fig. 5. Strain Gauge and Crack Meter Measurement

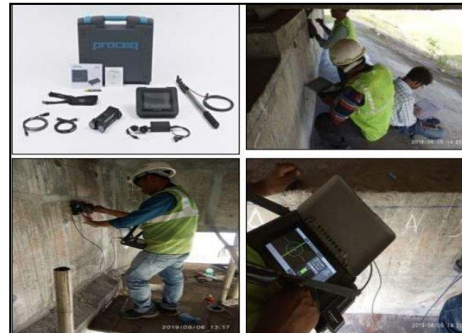
Fig. 6. Profometer Scan Test

Profometer Scan test: For old structures, when the detailed drawings are not available, it becomes very difficult to compute the strength of the structure which is required for the strengthening scheme of the structure. To overcome all these problems, Profometer, a small versatile instrument is used for detecting location, size of reinforcement and concrete cover. This instrument is also known as Rebar locator. For evaluation of new as well as old structures this equipment can be used adequately. Both for quality control as well as quality assurance the method can be used effectively. [5]

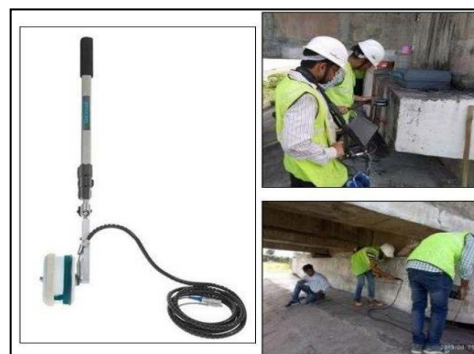
Fig. 7. Half Cell Potential Test

The half-cell potential test is the corrosion monitoring technique standardized by ASTM. It is used to ascertain the probability of corrosion within the rebar in reinforced concrete structures. In reinforced concrete structures, there is a natural protective film that forms on the surface of the bar and prevents it from corroding. With time, chlorides (from de-icing salts or marine exposure) and CO₂ penetrate the concrete and breakdown that protective layer. Profometer Corrosion One Wheel Electrode is used for this test.[5]

5. Profometer and Half Cell Potential tests give the idea of the reinforcement condition in present concrete. The results of profometer scan are presented later in this report. In all the tested structural elements of the present site, clear cover has varied widely; as in case of Pier P8 the clear cover value varies around 23mm to 99mm. On the other hand, from the half-cell potential test it is observed that the potential difference is varying from (-)604 mV to 134 mV. Overall, the corrosion probability is high.

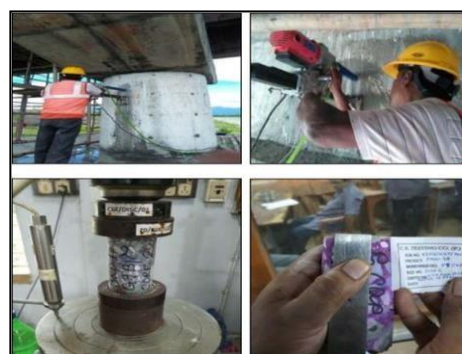
Fig. 8. Drilling of Concrete Cores

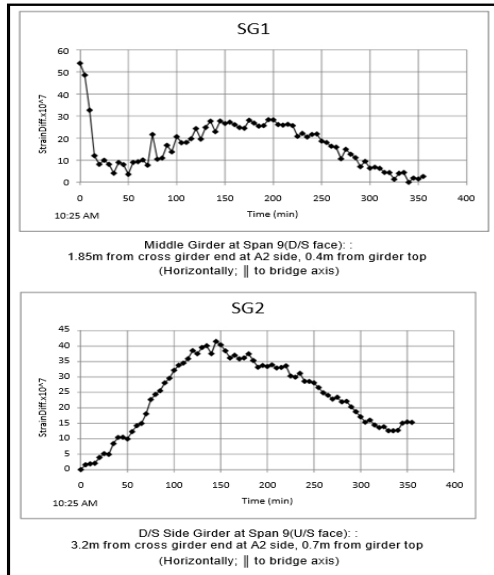
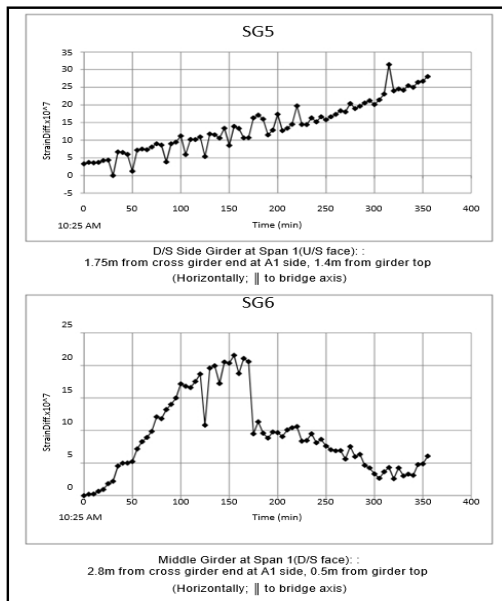
Fig.9.Strain Gauge Measurement

Fig.11.Strain Gauge Measurement

4. Crack depth measurement done at the present site reveals that the depth of crack is varying from 8.2cm to 11.7cm which is much more than the observed cover value and requires immediate attention. Change in strain and crack width is monitored to record the response of the bridge with variation in live load. It has been found that the strain

is varying in the order of 1.1 micro-strain to 9 micro-strain and crack width is varying between 0.09mm to 0.23mm.

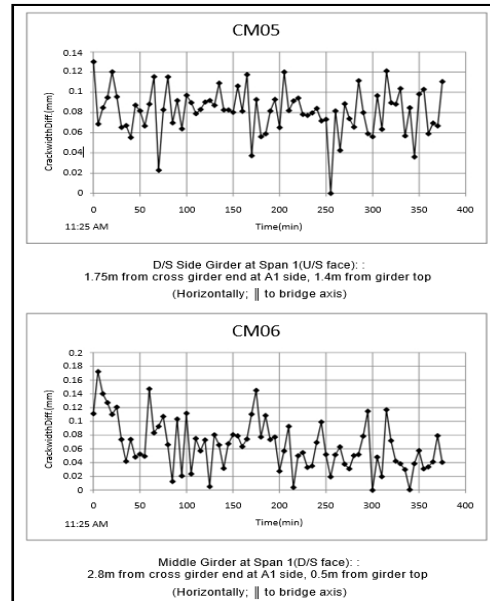
Fig.10.Crackmeter Measurement

Fig.12.Crackmeter Measurement

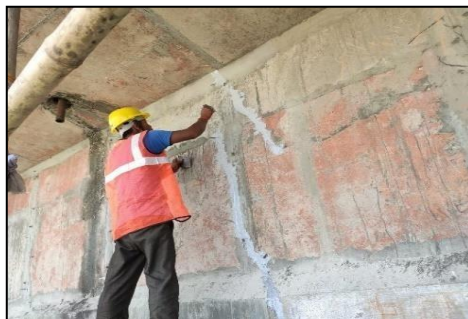
Fig.14. Cracks sealed with putty

Injection of cracks on horizontal / vertical slabs: Injection flange / nipples are fixed along the crack line at an approximately 25 cm center-to-center distance with Sikadur®-31. Crack mouth should be unfurled and sealed with Sikadur®-31. Sikadur®-31 epoxy mortars or a suitable cementitious Sika mortar should be used for sealing the crack penetrating slabs to their soffit and also on the underside. Injection pump, such as Aliva AL-1200, AL-1250 or the Sika® Hand Pump, should be used for injecting mixed Sikadur®-52 through injection ports under pressure. As soon as injection resin oozes out of the next injection port, the first port is sealed and injection process is continued from the next port. In case of horizontal cracks, injection should start from any

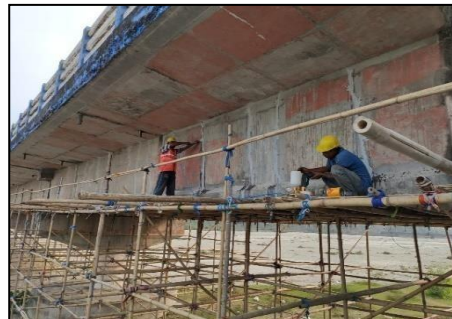
Fig.15. Grouting application procedure

of the ends and to be continued and completed till the last port is used. On the other hand, for vertical cracks, injection should start from the lowest port and continued upwards. After completion of the injection process, the injection ports as well as the sealing materials between the ports are removed.
