## Forensic analysis of recent building collapse in India and Review of a case study on foundation failure.

### 5.1 Three story building collapse in 7th main road of lakkasandra in Bengaluru.

## 5.2 Four storey building collapsed in Kurla, Mumbai.

### **9. At 14<sup>th</sup> and H streets Northwest Washington D C**

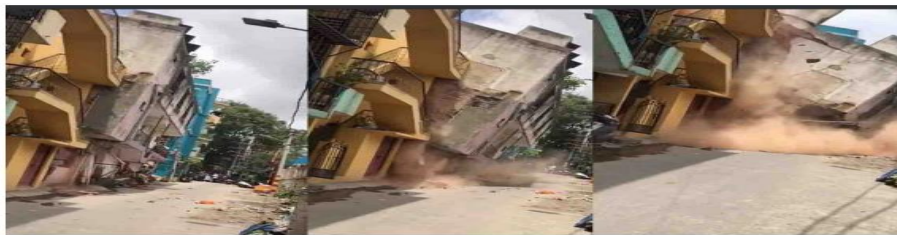
**Fig.1.** Tilted building

- a) The building is very old building which was constructed in 1960, and also this was constructed using soil as a mortar along with poor quality traditional bricks.
- b) Since they have not used any binding materials like cement, it is prone to collapse.
- c) Structure foundation rested on different kind of soil, which has different bearing capacity and unequal load distribution will result in unequal settlement

that is differential settlement. The building was undergone slight differential settlement 2 years ago (2019).

- d) According to some observers, the soil behaviour is effected due to rise in ground water table.
- e) The old building was not properly maintained and hence it was deteriorated.
- f) Due to lack of structural design and geotechnical investigation, the building collapsed suddenly.

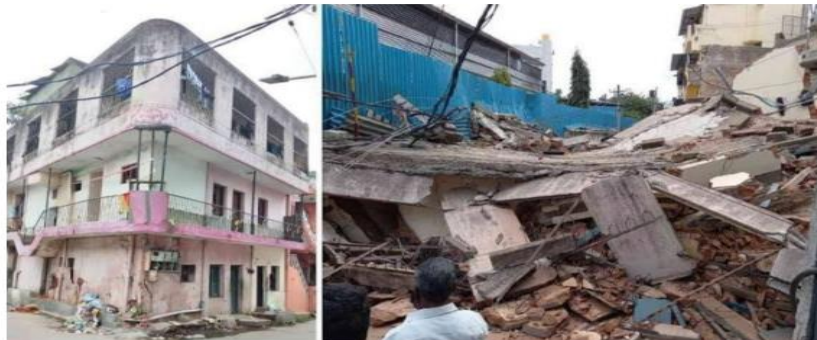
**Fig.2.** Collapsed building

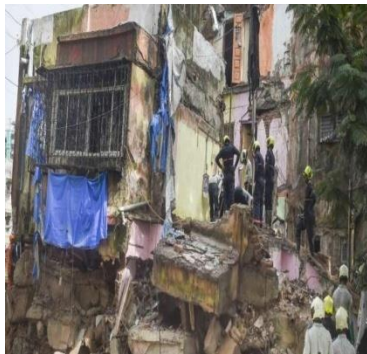
**Fig.3.** collapsed building

- a) The main reason for the building collapse can be due to poor structural design, poor compliance with specifications, poor quality control, faulty control methodology, insufficient foundation strength and corruption.
- b) In india, during monsoon seasons (june-sep) heavy rains weakens the poorly built foundation of the structures.
- c) The raise in ground water table loosens the soil and reduce bearing capacity of the soil and rapid falling ground water table causes the ground subsidence due to increased over burden effective stress.
- d) The improper structural maintenance and improper construction sequels was also main reason for failue.

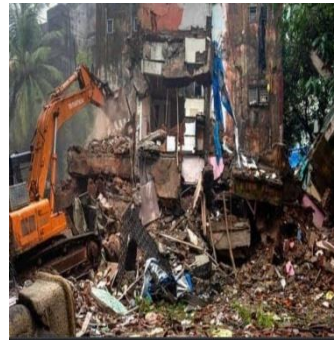
**Fig.4.** Demolition of the building

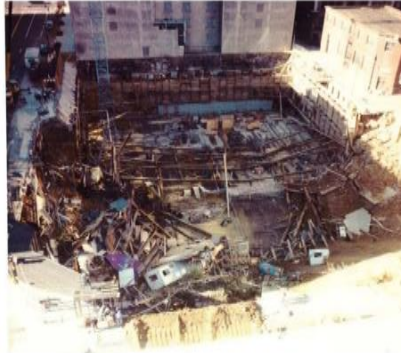
**Fig.1.** Collapsed site (sighted from west)

- Resistance offered by the internal supporting system not able fulfil the soil load.
- Lack of design parameters regarding structural members which include the insufficient inter connection between the members.
- The spacer beams, their inter connections and the sloping wale were recognised as most stressed members and connections of the support system which lead to collapse.

- The soldier beams were significantly twisted during driving at northeast corner, where a gravel layer was encountered.

- a) Excavation collapsed due to the failure of internal structure supporting members at north and south walls, and the external support system like tiebacks, soldier beams and wales which were in place on the west wall.
- b) Subsequent to the collapse, all soldier beams, rakers and pin piles continued to remain embedded below the final subgrade.
- c) Structural connections between three tiers presented in the north and south wall are not up to the mark to resist expected load.
- d) Reasons behind immediate cause of the collapse is that the load of failure and soil pressure which is lower than the expected or designed load.
- e) Overestimation done by shoring contractor regarding movement of passive earth resistance.
- f) Contribution part of collapse is considered as both construction deficiencies and the ground water fluctuation.

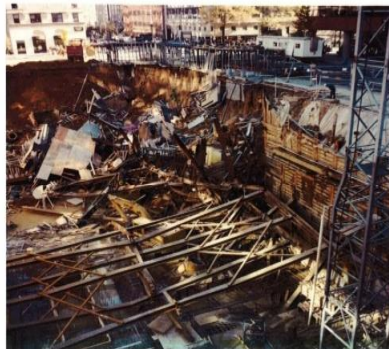
**Fig.2.** Collapsed site (sighted from east)
