*Proceedings of Indian Geotechnical Conference 2020  
December 17-19, 2020, Andhra University, Visakhapatnam*

## **Geotechnical Assessment of Building Damaged by Tunnelling Works and Suitable Remedial Measures – A Case Study**

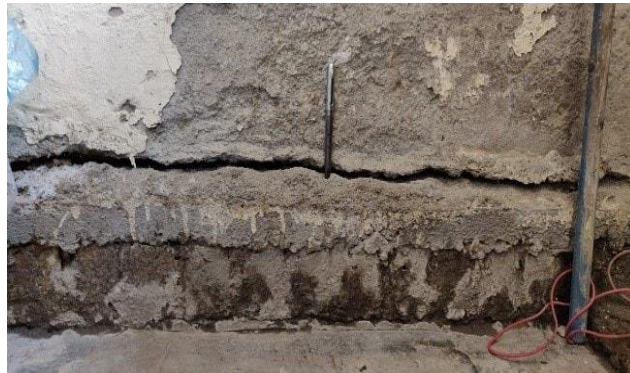
One of the buildings had an old non-operational bore-well which was left unplugged and foam like substance came through it when tunneling activities was carried out right below the building. Only after this, major crack developed in the building and visible settlement of wall in the courtyard has been observed (refer Figure 1) and the bore-well was plugged immediately. In another building, such incidents were not

**Fig .1.** Settlement of Wall in the Courtyard of Building

Based on the numerical analysis and analytical method, it was found that the cracks in the building were not the result of tunneling activities. The settlement could be due to the presence of some loose pockets below the building. Grouting was proposed below and adjacent to the building in order to fill the loose pockets and to strengthen the ground.

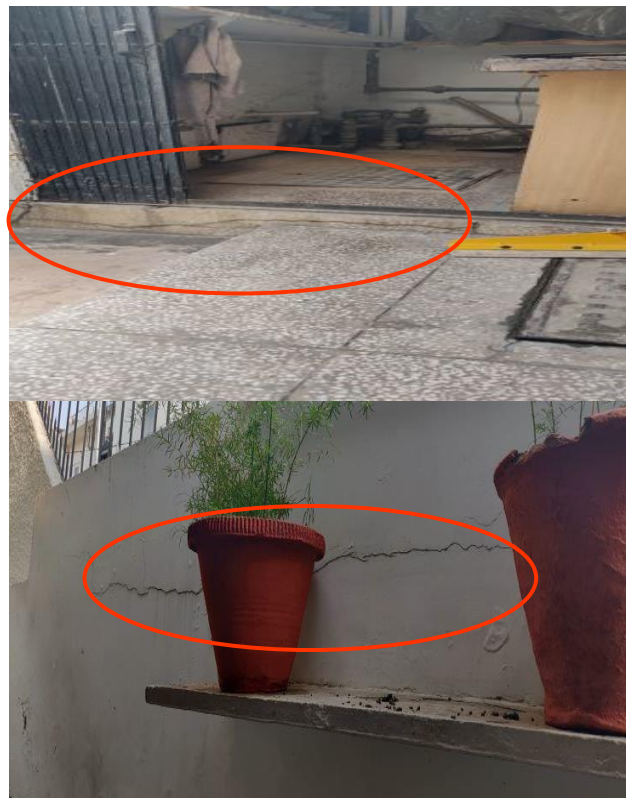
Two buildings developed thin to wide cracks in the ground floor and thin to medium cracks in the first floor. The buildings were 34 years old, load bearing type and with G+1 and G+2 storeys.

observed but minor to major cracks are seen in many locations. In-order to address these issues settlement analysis due to building load and tunneling activities has been carried out using the nearby borehole data. Based on analysis suitable remedial measures have been suggested in the following sections.

**Fig.2.** Photographs of cracks in the building

In-order to fill the voids below the buildings B1 and B2 and to strengthen the ground, compensation grouting was proposed below and adjacent to the buildings. Compensation grouting was suggested in critical locations where excessive settlements has occurred. The criteria considered for grouting are based on the in-situ soil conditions like void ratio and the overburden pressure at each layer. Since the site predominantly consists of fine sand/ sandy silt, the permeability ranges from  $10^{-4}$  to  $10^{-7}$  m/s (CIRIA Report - Groundwater control - design and practice C515). A Cement - Bentonite grout with water cement ratio in the range of 1 to 2 was suggested. Grout spacing adopted was typically on the order of 1.5m to 3m to reasonably assure overlap and coverage. Based on the subsoil profile provided in the soil investigation report, loose pockets are likely to be present up to a depth of maximum 5m to 6m beyond which soil is dense to very dense. Hence grouting needs to be carried out up to this depth. However, the detailed design and execution of grouting is beyond the scope of this paper.

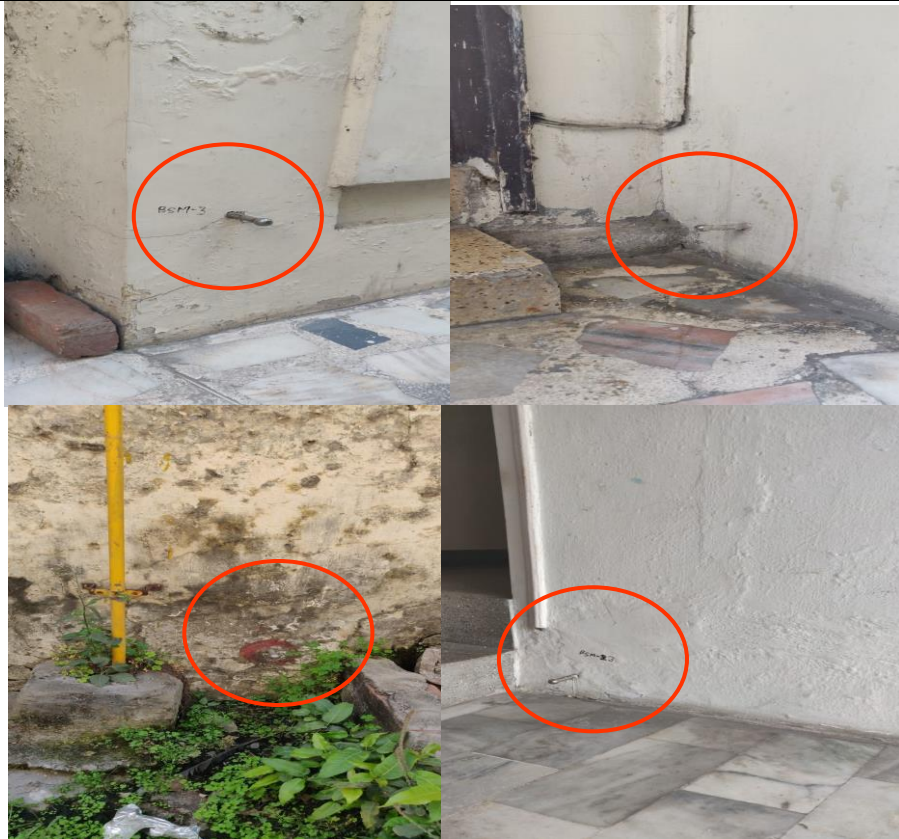
Settlement monitoring has been carried out in 12 different locations, 3 in the front side and 3 at the back side of both the houses respectively. The photographs showing settlement markers in buildings are shown in Figure 5.

**Fig. 5. Building Settlement Marker Locations**
