Analysis of Slope Stability using SLOPE/W Software

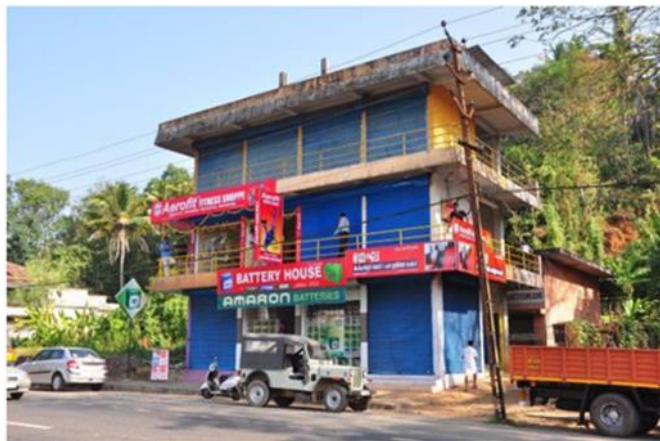
Fig.1. Study location before landslide on 27th June,2015

The study was conducted at Kormala near Muvattupuzha at Ernakulam district in Kerala. It is located between 9°59'32.2" N, 76°34'29.4" E and 9°59'35" N, 76°34'26.8" E. The area had undergone a devastating landslide on 27 June 2015. The incident resulted in the complete collapse of a three storied building and the debris got spread over a distance of 200 m. After the landslide, the building was reduced to a pile of rubble. The landslide occurred at an elevation of 16 m and the roof of the structure landed in the middle of the road. The site location before and after slope failure is shown in Fig 1 and Fig 2. The present condition of the Kormala slope is shown in Fig 3.

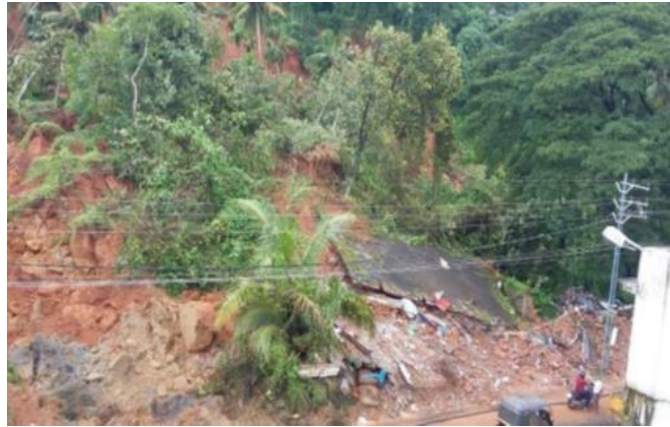
Fig.2. Study location after landslide on 27th June,2015

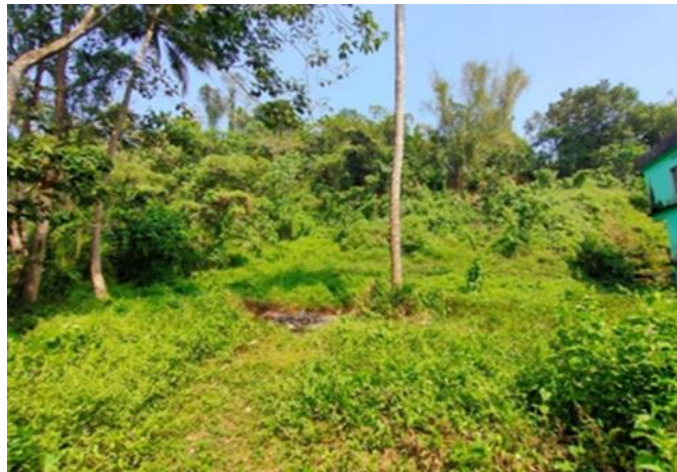
Fig.3. Present condition of Kormala slope

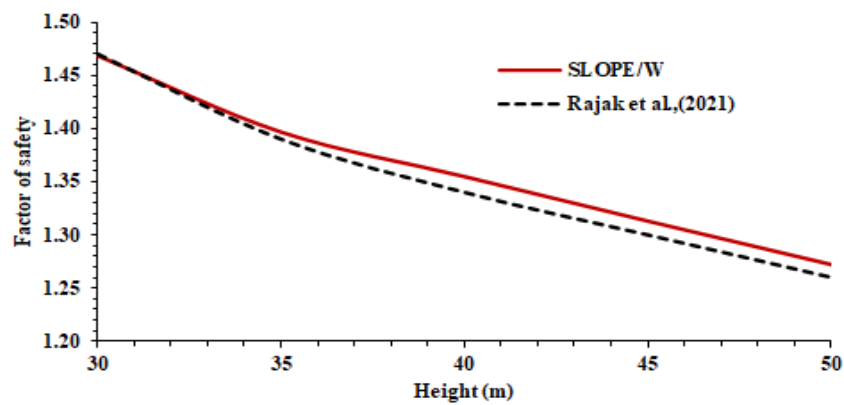
Fig. 4. Variation of the factor of safety for different heights

Model validation has been carried out using SLOPE/W. For validating the model, a case study of stability of mine overburden dump stabilized with fly ash (Rajak et al., 2021) was considered. The study was conducted at the open cast coal mine of Mand Raigarh coalfield, Raigarh, Chhattisgarh where the slope height has been varied from 30 m to 50 m at an interval of 5 m. The variation in the factor of safety is shown in Fig 4. The percentage error between the original analysis and current study is less than 2%, which is acceptable. Thus, it is evident that the numerical procedure adopted in this study is capable of carrying out complex slope stability analysis.

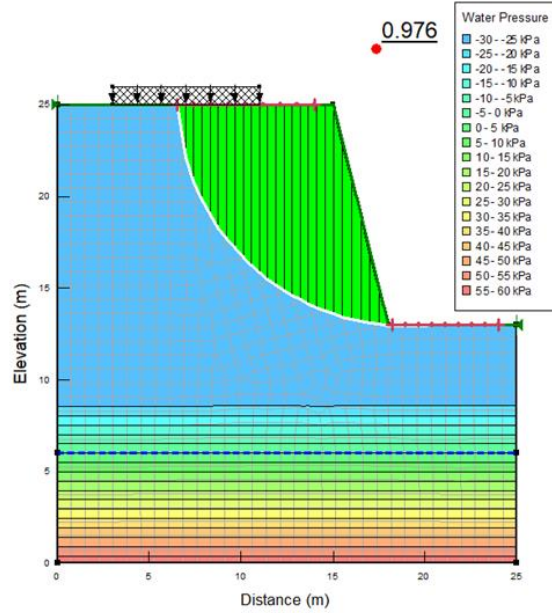
Fig. 6. Model geometry used in SLOPE/W (Sample 1)

The results obtained from the stability analysis of sample 1 and sample 2 are shown in Fig 6 and Fig 7.

The factor of safety obtained on stability analysis on sample 1 and sample 2 are 0.976 and 0.949 ($FOS < 1$) respectively. A factor of safety less than unity indicates an unstable slope. A comparison of results obtained on stability analysis of sample 1 and sample 2 reveals that the slope is unstable. From Fig 6 and Fig 7, it is clear that the slip surface intersects the toe of the slope, hence it can be concluded that there is a possibility of toe failure at Kormala slope. In general toe failure is observed in steep slopes when the soil mass above and below the base is homogeneous (Ranjan, Gopal, and A. S. R. Rao, 2007).

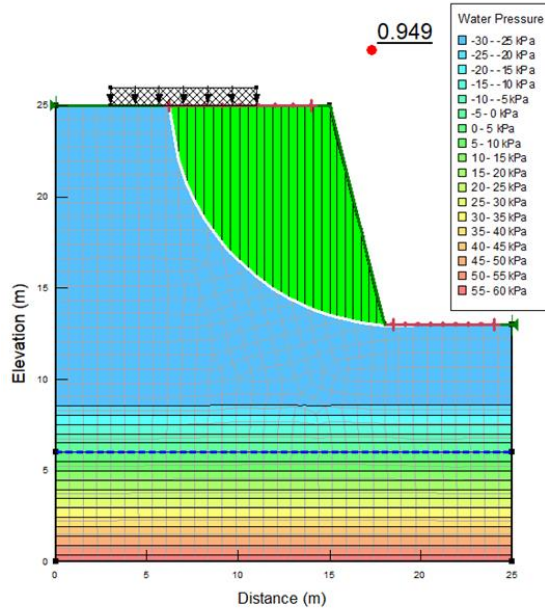
Fig. 7. Model geometry used in SLOPE/W (Sample 2)
