A CASE ON ENGINEERED SOLUTION FOR DEEP EXCAVATION IN RESTRICTED SPACE

Abstract : This paper discusses the methodology adopted in soil support for deep excavation carried out for installation of press foundation in live working mechanical shop with space restriction and variable soil conditions. The method adopted was cheapest of available alternatives.

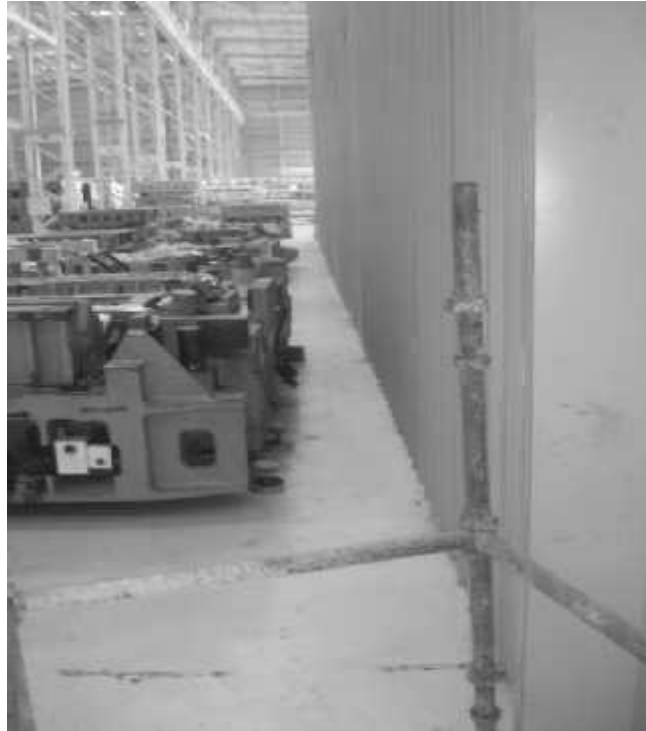
Fig. 1 : Dies Stored Close to Proposed (New) Press Area

The existing Press Shop facility was constructed and put to operation in the year 2010 with four Press installed at a place. A Press is a heavy and huge automatic equipment which gives the required shape to automotive body components and forms an important function in the automobile manufacturing process. Subsequently, under expansion program, another Press was proposed to be installed in the existing facility. The existing facility with one Press (Press no. 1) has numerous activities going on with variable heavy weight dyes, storages and conveyance equipments all around it which serve as paraphernalia. (See Fig. 1).

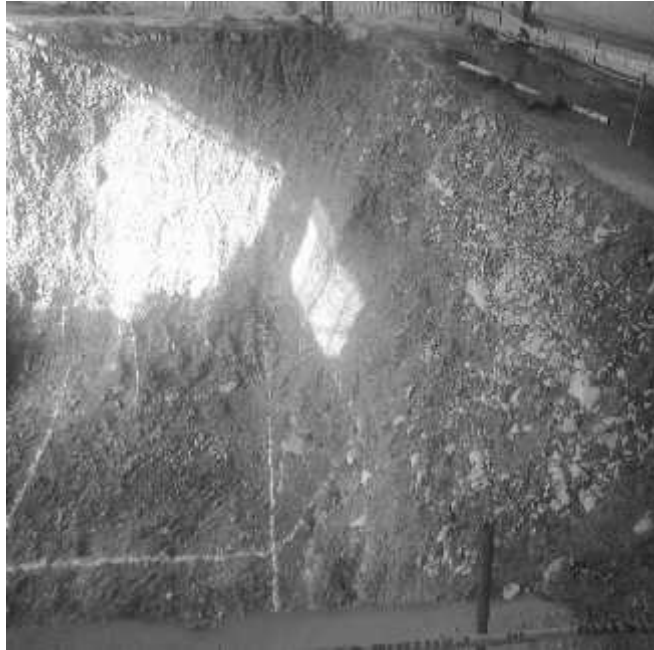
The area where the new Press foundation was proposed to be installed was made up ground with murum and boulders. Only top about 1.5m was compacted. But, it was not known before as to what extent compaction is done. A loose material with boulders has tendency to slide more easily and very prone to caving. (See Fig. 2)

Fig. 2 : Soil Condition

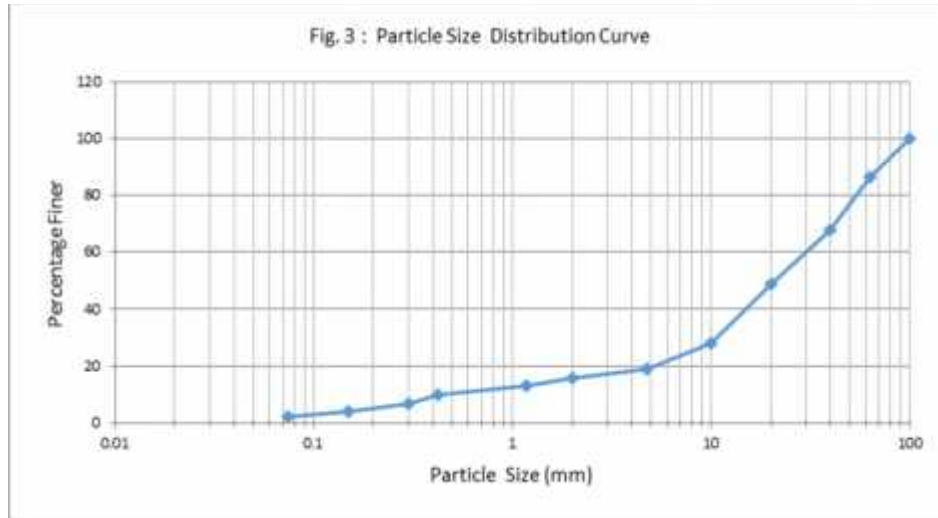
Grain size analysis for a soil sample (depth 0.6 m) worked out and presented in the table 1 and Fig. 3 below :

Fraction	Content
Gravel (coarse & fine)	81.00 %
Sand (coarse, medium & fine)	17.00 %
Silt & Clay	02.00 %

Fig.3 Grain Size Distribution Curve

Groutability ratio (penetrability of cement in in-situ soil) = $29.91 > 25$

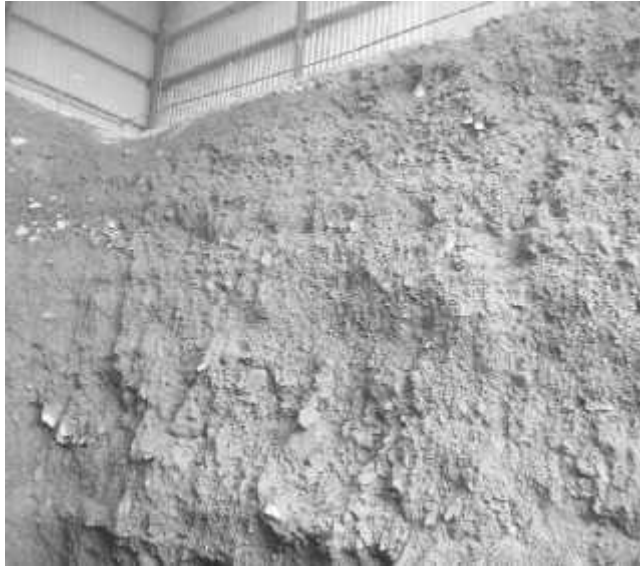
After a gap of 7 days excavation from central size of 11.5 m x 11.5 m started. Initially excavation up to 6 m depth done. During vertical excavation side collapses took place. After reaching to 6 m depth, side unstable material removed to get natural slope. In order to stabilize and strengthen this slope further, cement slurry applied along slope and then cement sand mortar in proportion 1:1 applied manually on surface along the slope.

Fig.4 : Mortar Application on Slope

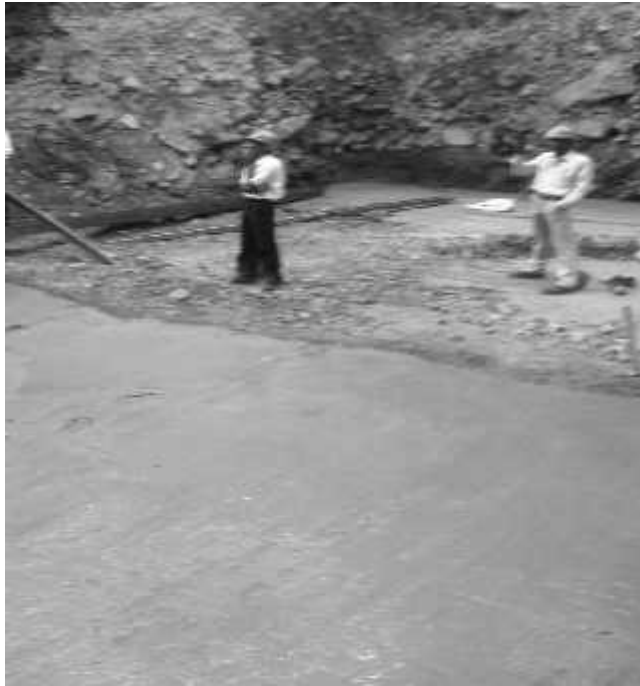
Natural virgin ground met at about 10 m depth. Further excavation was very much required in order to reach to rock strata. The weight of Press along foundation is more than 2000 tons. Such heavy machine foundation had to rest on strong and stable strata. Further 2 m excavated to reach to rock strata. This 2m depth excavation was very risky due to presence of boulders above in fill layer along three sides. Labors refused to work at that level. Therefore, as an addition measure to safeguard labor and create confidence in their mind, steel mesh was laid all along the slope. Considering risk of boulder collapse, it was decided to excavate partly and immediately fill the excavated portion with plum concrete so that toe of slope of fill material will not remain unsupported for long period. Accordingly, part excavation done and filled with plum concrete. Then remaining portion excavated and filled with plum concrete to complete the square portion. After excavation immediate concreting done, concrete was kept ready while excavation going on. Day-night work continued till got completed. This worked to our satisfaction without any side collapse.

Fig.5: Plum Concrete Laid in Part Area
