Strengthening of Equipment Foundations on Loose Soils of a Power Plant in Eastern Uttar Pradesh

Abstract. Small equipment foundations of a power plant placed on a 5-6-m thick poorly compacted fill underlain by rock experienced excessive settlements. Strengthening measures adopted included installing micro-piles extending to the top of rock and filling large voids in the fill with a thick grout of cement and sand. This highlights the importance of proper compaction as well as the need to test the bearing strata adequately before constructing foundations on fill.

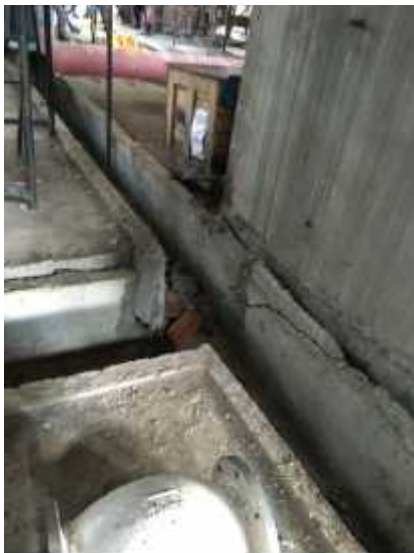
However, the compaction of the backfilled soil was inadequate. This resulted in excessive settlement of several foundations even before the equipments were made operational. The failure was triggered by the seepage of rainwater into the loose soils. The measured settlement of various foundations ranged from 16 mm to over 180 mm.

**Fig.1.** Cracks in the seal oil foundation

Micro-piles of 150 mm diameter with casing extending to the top of the underlying rock were installed below and adjacent to the equipment and structurally connected with existing foundation. Prior to piling, the concrete floor slab was cored using a diamond cutter. Boring was done to top of rock and the reinforcement was lowered into the hole. PVC pipe of 150 mm diameter was inserted into the hole to the top of rock. Concreting was done using coarse aggregate of 10-12 mm size to allow flow of concrete into the pile bore. The reinforcement at top was bent and welded to the existing reinforcement of the foundations.

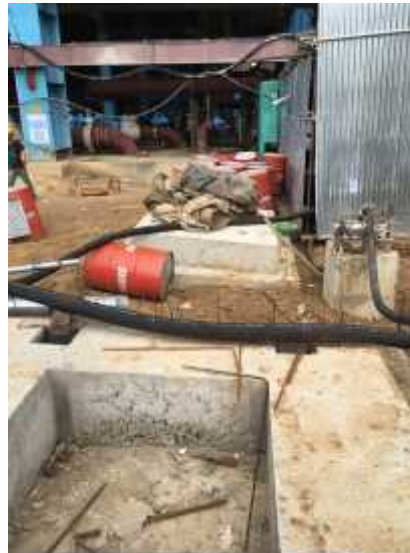
Foundation settlements were higher towards the TG side where the backfilling depth is high as compared to the opposite side. Due to foundation settlement, few cracks in the nearby area paving slab was also observed.

**Fig.2.** Tilted foundation due to settlement

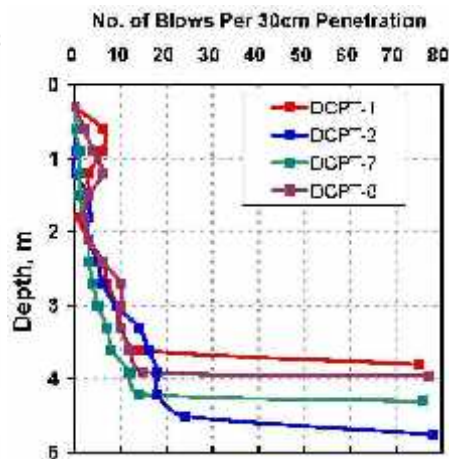
Dynamic cone penetration tests (DCPT) were performed in accordance with IS: 4968 (Part 2)-1976 RA 2007 [2]. DCPT blow-counts (N_{DCPT}) generally range from 0 to 4 to about 3.5 m depth. Refusal was met at the soil-rock interface. Fig. 4 presents results of plots of N_{DCPT} versus depth.

Fig.4. Typical DCPT plots

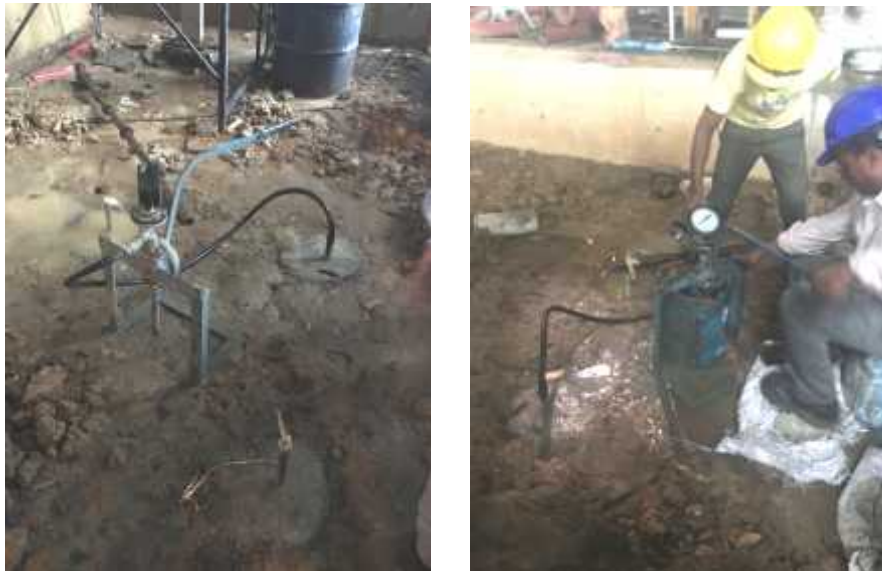
Initially, trial cement grouting was done all around the foundation to the top of the rock so to form a grout curtain. This shall provide lateral confinement to the soils and restrict further settlement. The grout was prepared by mixing 1 bag of cement with 100 litres of water and pumping into the grout hole until refusal to further grout intake was met under a steady pressure of 1.5-2 kg/cm² (Sanjay Gupta, et al. 1997 [4]). The intake of cement grout was 60 to 950 litres of grout (0.5 to 9 bags of cement) per grout hole. Typical photograph of the grouting in progress is illustrated on Fig. 5.

Fig.5. Trial grouting in progress

At places, due to presence of large voids, adequate pressure did not build up even after pumping large quantities of grout. At such locations, soil investigation after grouting did not show much improvement in soil conditions suggesting that the voids were interconnecting and the grout was flowing in an uncontrolled manner.

Considering the uncertainties in grouting in very loose soils, likelihood of high cement consumption and uncontrolled flow direction of grout, grouting adjacent to the foundations was not considered as a preferred sure-shot option.

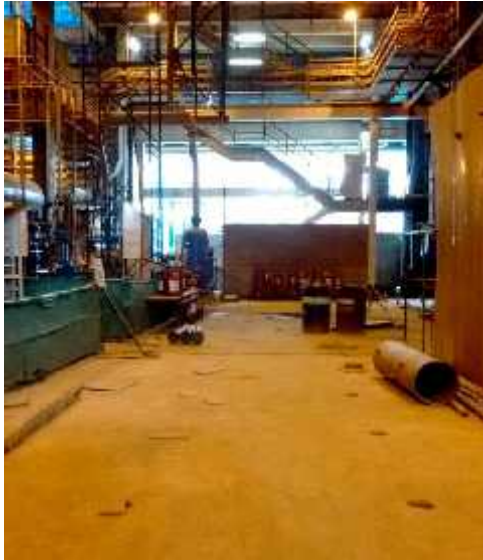
In areas where large voids were observed beneath the floor slab (formed by settlement caused by seepage of rainwater through the loose soils), a thick grout of cement plus sand was pumped to fill the voids. Fig. 9 shows the concrete flooring between equipment cored for grouting purpose.

Fig.9. Holes cored in between equipment for grouting Fig. 10. Schematic of grout hole

This was done as a preventive action around all the foundations and paving area which are placed over insufficiently compacted back filled soil in the main power house area especially all around the TG foundation where the depth of back filling is more. Improvement of soil using grouting was envisaged to avoid further possibility of settlement.
