Experimental Study of Ugat Canal Soil for Slope Stability

Abstract: Slope stability is one of the major aspects of geotechnical engineering and plays significance on large scale infrastructure projects such as high-ways, railways or canals. Slope failure is the major problem in earthen canal due to seepage problem. Due to excess imposed loads, discharge forces, erosion, and gravity forces, drainage and irrigation canals may suffer from a full or restricted slope failure. Side slope failures of irrigation at Ugat canal located near Jahangir Pura, Surat will possibly suffer from heavy catastrophes with destructive damages to public lives and belongings. The reason of canal slope failure is due to piping in salt influenced or distributive soil, discharge forces in soft clayey or sandy soil, deficient standard of the soil mass mound same as in black cotton soil i.e. soft clay or loose sand, and accordingly dissolution due to immoderate use of irrigation water or utilizing surface irrigation method at places near to the bank. There is no generalized method of restoration for slope failures because of the distinctiveness of the attributes and situations of each site. Hence, based on cha

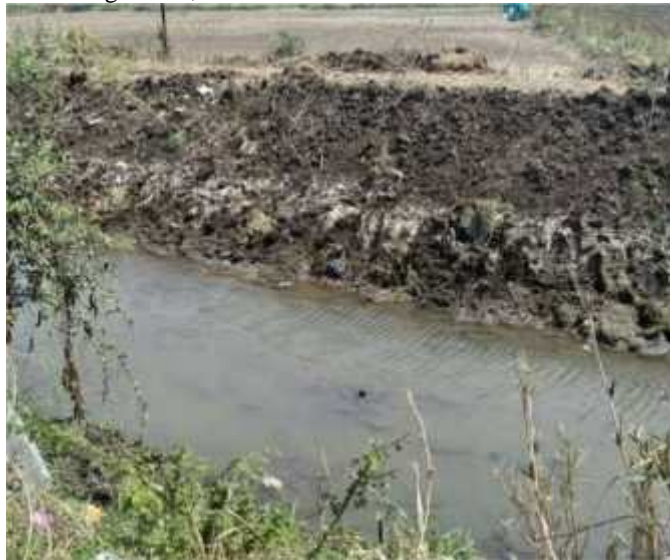
Fig. 1. Canal Slope Failure

To prevent canal slope failure, the side slope of the embankment is strengthened by coconut husk i.e. polymer fibers as a partial replacement of soil which reduces slope failure in earthen canal. This study focuses on the reinforced earth slope stability of canal using coconut husk. The experimental study of canal slope strengthening is selected to study the different characteristics of soil mass. The canal is situated on the Ugat Road, near Jahangir Pura, Surat.

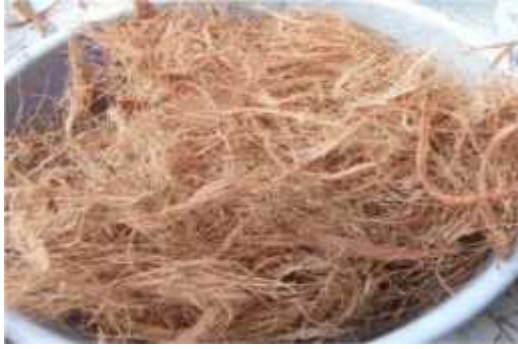
Fig. 2. Coconut husk

Coconut fibers are the natural fibers taken out from the coconut husk. It is widely utilized in products like doormats, floor mats, sweeping brushes and mattresses. Coir is the stiff coarse fiber from the outer husk of a coconut. It is the knotty kind of mate-

rial seen between the interior shell and the outer coat of a coconut. Brown coir is made up from ripe coconut. They are further used in covering, crafting and cultivation. White coir is gathered from unripe coconuts, utilized for preparing sweepers, strings, strands and fishing mesh.

Fibers are light in weight, strong and elastic. Based on experimental work performed in M-Test Laboratory, Udhana, Surat, various parameters were studied of coconut husk. The properties of coconut husk are derived from tests performed by the authors and the results are mentioned here.

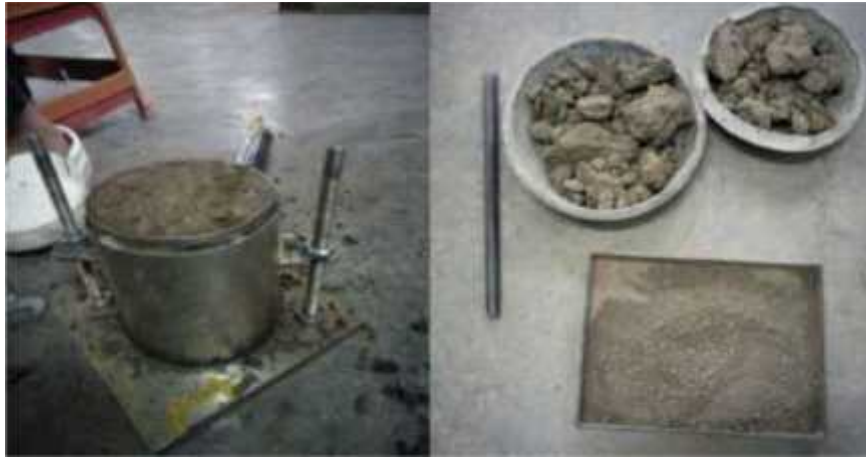
Fig. 3. Proctor Compaction test set up

In present experimental study, diverse soil samples have been studied i.e. normal soil sample i.e. 0% replacement, 0.5 % replacement, 1.0 % replacement and 1.5 % replacement of Coconut Husk by weight of soil. The testing of mechanical property i.e. shear strength was conducted by Triaxial shear test.

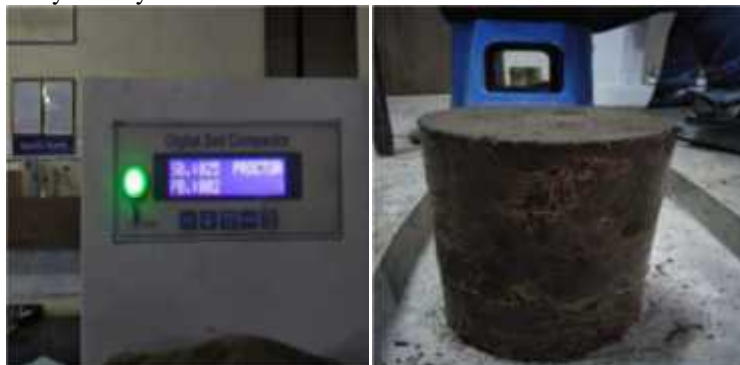
Fig. 4. Proctor Compaction Equipment

Proctor Compaction Test is the most common test to evaluate the optimum moisture content at which a tested soil sample become most dense and attain the relevant maximum dry density.

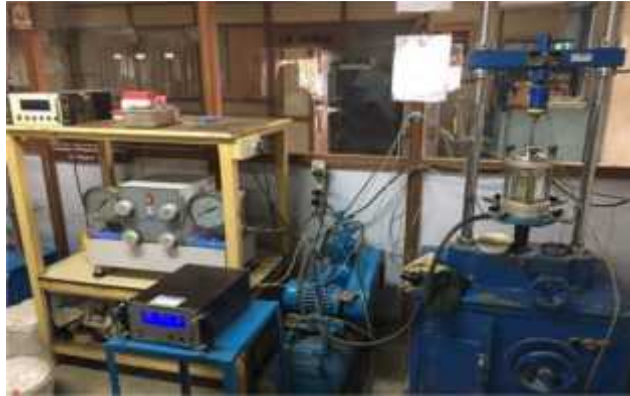
Fig. 5. Triaxial shear test set up

Triaxial shear strength test is the most common test i.e. widely recommended and suitable for all kinds of soils. It used to assess the mechanical properties of the soil sample. In this test, soil sample is subjected to stress, in such a manner that the stress generated in one direction will be different in orthogonal direction. The material properties of the soil i.e. shear resistance (angle of internal friction), cohesion and the dilatancy stress is evaluated from triaxial shear strength test. And from that, shear strength is evaluated.

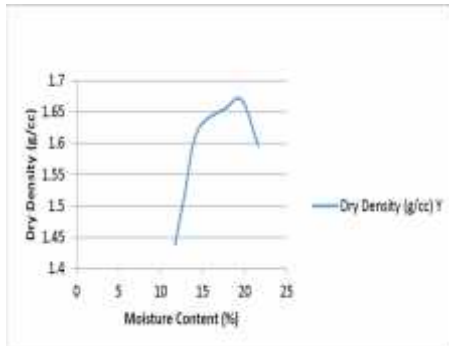
Fig. 6. Proctor Test Results of untreated Soil Sample

A research work on canal slope stability was performed to assess the shear strength of treated and untreated soil sample to enhance stability at Ugat Canal Soil. The results of MDD and OMC of untreated soil sample are 1.67 gm/cc and 19.30% respectively as indicated in figure 6. Now, from figure 7, 8 and 9, MDD and OMC of treated soil samples are 1.774 gm/cc and 15.50% (for 0.5% Coconut Husk), 1.80 gm/cc and 17.75% (for 1.0% Coconut Husk) and 1.648 gm/cc and 13.00% (for 1.5% Coconut Husk) respectively.
