Stability Analysis of Slope in Kuranjeri During Kerala Flood 2018 Using Plaxis-3D

Abstract. Landslide or landslip is defined as a type of mass movement in which a mass of rock, debris or earth down a slope under the direct influence of gravity. In this study Kuranjeri of Thrissur district have been selected where landslides occurred during 2018 Kerala floods. In this case landslide was triggered by incessant heavy rainfall followed by mass movement of debris. An investigation was carried out to discern index properties and soil parameters on the collected soil samples. Limit equilibrium method (LEM) is the most common approach for analyzing slope stability by investigating the equilibrium of a soil mass tending to slide down under the influence of gravity. As a powerful alternative advanced numerical method, Finite Element Method (FEM) quantify factor of safety against slope instability by Strength Reduction Method of Stability Analysis using Plaxis-3D. A comparison is then made between the results of LEM and FEM by in cooperating properties of in-situ soil on slope failures. The analysis result unveils that the infiltration of water into the slope resulted in the failure of the s

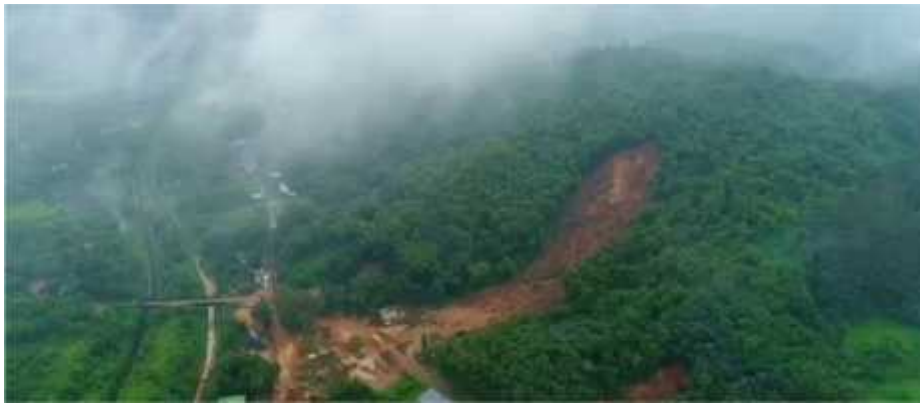
In this study, Kuranjeri of Thrissur district have been selected where landslides occurred for the first time in its history during Kerala flood in August 2018. Kuranjeri is a forest area situated in Thekkumkara/ Minaloor Panchayath of Thalapilly Taluk, Thrissur district, Kerala. The study area witnessed one of the largest landslides of the district. The site is located at a latitude of $N10^{\circ} 37' 41.2''$ and longitude of $E 76^{\circ} 13' 48.1''$. The failure area comprised toe of width 65m with an elevation of 63m. At an elevation of 128m subsidence occurred. During the landslide the soil got displaced to an extent of 500m and resulted in loss of 19 lives. In addition, 4 houses were washed away with severe damage to roads, crops, other material property. Figure 1 shows the landslide that occurred in Kuranjeri.

Fig. 1. Shows landslide at Kuranjeri on 16/08/18

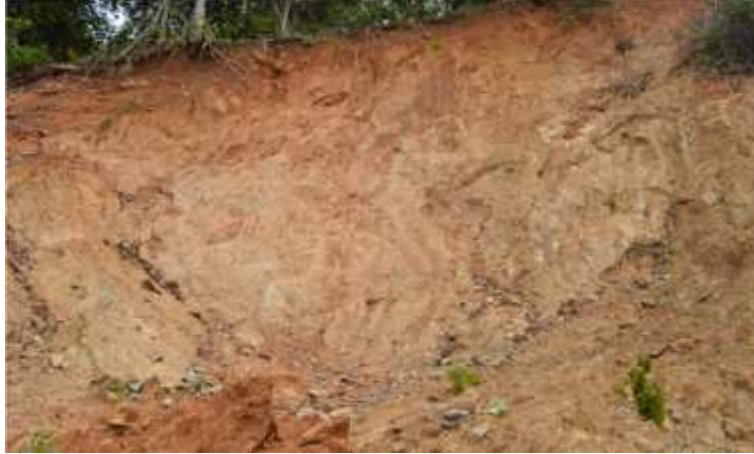
Geomorphology. The lithology of the terrain includes forest tree underlaid by forest soil followed by 4m thick laterite with fragments of weathered crystalline rock below which weathered bed rock was present as shown in Figure 2. Some clay patches were observed in the site. A newly formed under developed cracks were present just a few meters below the crest.

Fig. 2. Lithology at the site of failure at Kuranjeri

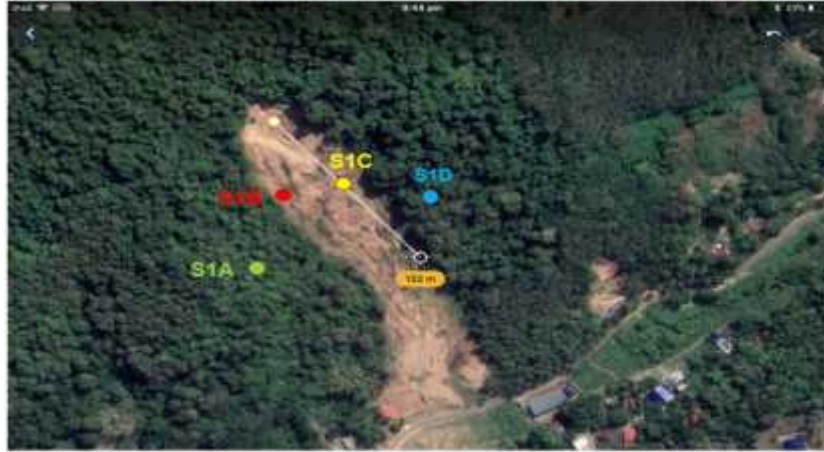
For this study a reconnaissance survey was conducted and all the necessary details were collected from the site as well as from the locals from the area. The samples were collected from four locations at 1m depth from ground surface that comprises two from the slide mass portion and two from the unaffected areas at a distance of 15m apart marked as S1A, S1B, S1C and S1D as shown in the Figure 3. Both disturbed as well as undisturbed soil samples were collected from four locations. The undisturbed soil samples were taken with help of sampling tube and was tightly sealed to preserve the natural properties of the soil while transporting. The field density of the soil samples was determined from the site itself. Detailed experimental investigation was conducted to determine the geotechnical properties of the collected soil samples in the laboratory using the standard procedures put forward by Indian Standard codes.

Fig. 3. Location of sample collected

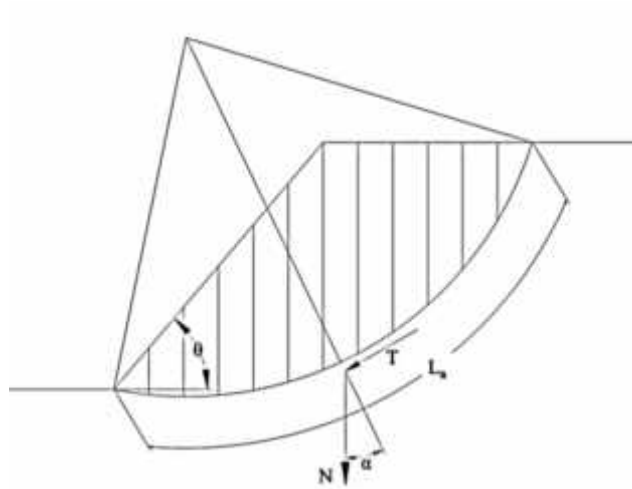
Figure 6 represents slip surface divided into 12 slices for Swedish circle method of analysis

Fig. 6. Swedish circle method of analysis

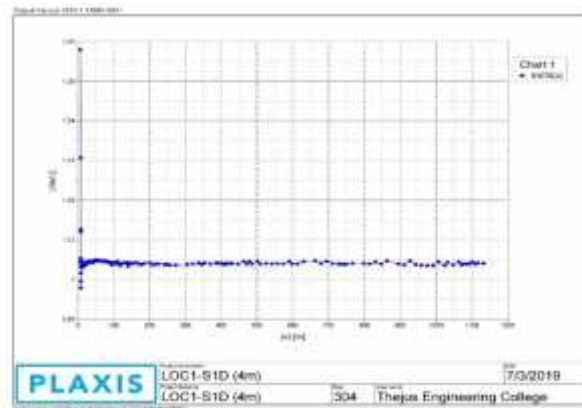
The decrease in factor of safety is comparatively more prominent from a depth of 4m to 5m. Figures 8, 9 and 10 represents the results of strength reduction analysis carried out in PLAXIS-3D without wetting depth and at depth of wetting 4 and 5m respectively for S1D.

Fig. 9. Analysis with 4m wetting for S1D using PLAXIS-3D

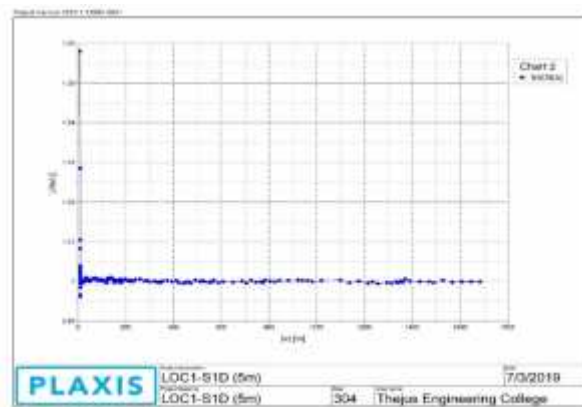
Fig. 10. Analysis with 5m wetting for S1D using PLAXIS-3D

By providing suitable conventional or bio engineering methods that couples with proper drainage for the diversion or collecting arrangement of the rainwater may help to reduce the future slope failures.
