Some Challenging Geotechnical Projects

Madhav Madhira

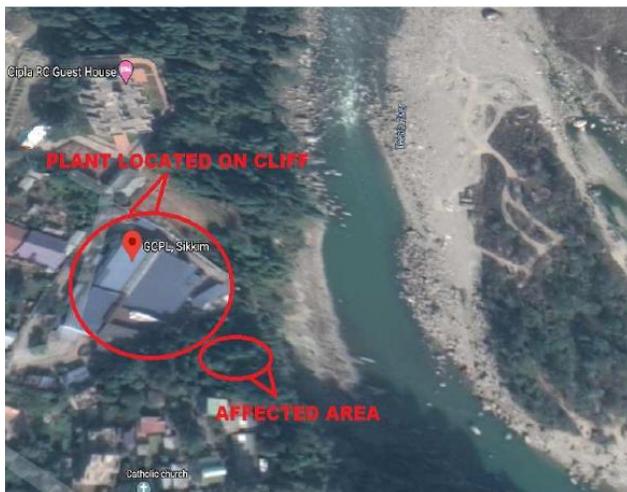
Fig. 1 Aerial View of the Site

An Industrial Unit is located on high ground about 100 m above the mean flow level adjacent to a fast flowing river in Sikkim. (Fig. 1). The lean season flow width of the river is 50 m and expands to 100 m in the peak rainy season with maximum flood level reaching 15 m above the mean flow level. The original slope of the cliff is 65° to 85° from the bed of the river. The layout of the industrial unit can be seen in Fig. 2. The boundary of the industrial unit is about 50 m from the river bank. The profiles and vegetation along the four locations along the slope were examined following collapse of the compound wall and part of the industrial area adjacent to the wall (Fig. 3). Vegetation was washed away following slope failure.

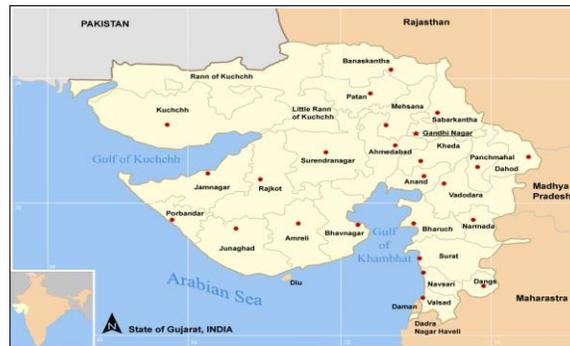
Fig. 6 Gulf of Khambat

Extreme coastal erosion was taking place in the Gulf of Khambat (Cambay) (Fig. 6) for years due to both natural changes and human intervention to the coastline. The tide was reported to be 5.5m to 6.0 m high and water velocity of the order of 5 m/s. It was reported that coastline was moving inwards (Fig. 7) at the rate of 10 to 20 m per year and damaging the boatyard (Fig. 8) and even some of the installations of ONGC a little farther inland. Attempts to prevent or control the rapid erosion with piles/sheet piles were unsuccessful.
