Geotechnical Problems in Dams: Case Studies

Case Study I: Geotechnical Problems, Design and Construction of Cofferdam on Narmada River for Indira Sagar Project in Madhya Pradesh.

Case Study II: Anchored RCC Diaphragm Wall Cofferdam for Bisalpur Dam Project in Rajasthan.

Case Study III: Restoration and Rehabilitation of Old Pagara Masonry Dam by Grouting Technique in Madhya Pradesh.

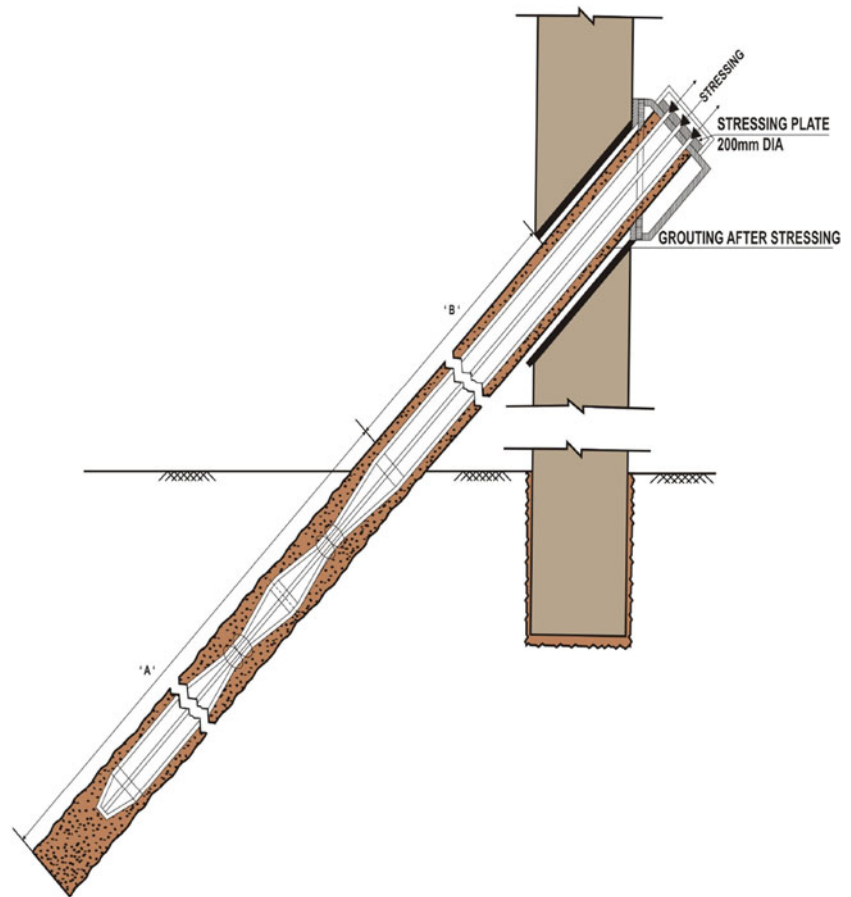
Fig. 38 Completed anchor through diaphragm wall

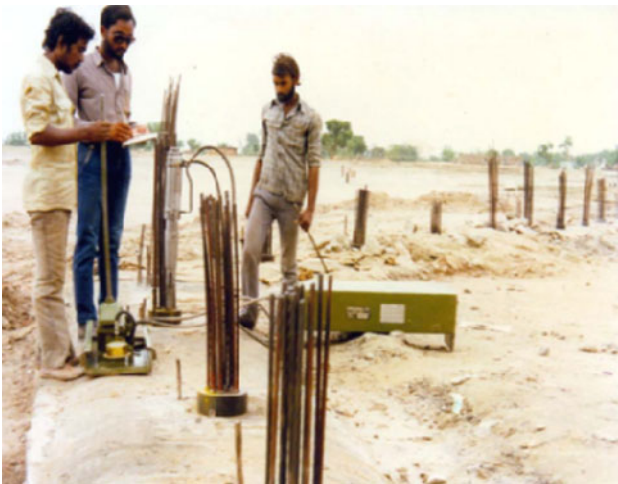
Fig. 39 Post tensioning of anchors

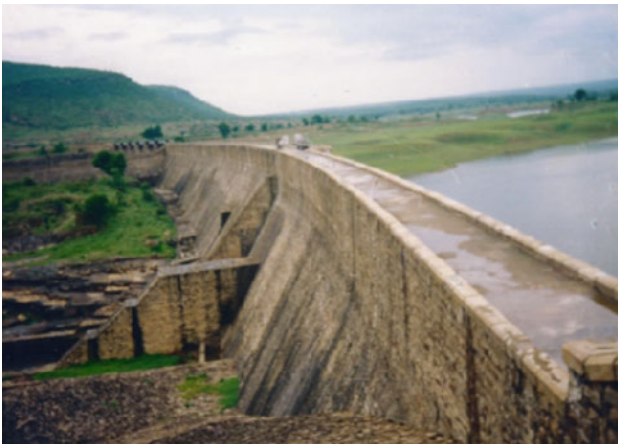
The spillway was fitted with 6 falling shutter type of crest gates of 12.19 × 1.83 m² which are in-operative and remain open it addition there is an open cut for a length of about 244 m on the right flank. There are two sluices located in the non-overflow section of the dam. One sluice fitted with a vertical gate of 0.91 × 1.83 m, size and another with a gate of 1.83 × 4.88 m size. Pagara dam is situated near village Joura, nearly 39 km from Morena town in north M.P. (Fig. 41).

Fig. 41 Pagara dam

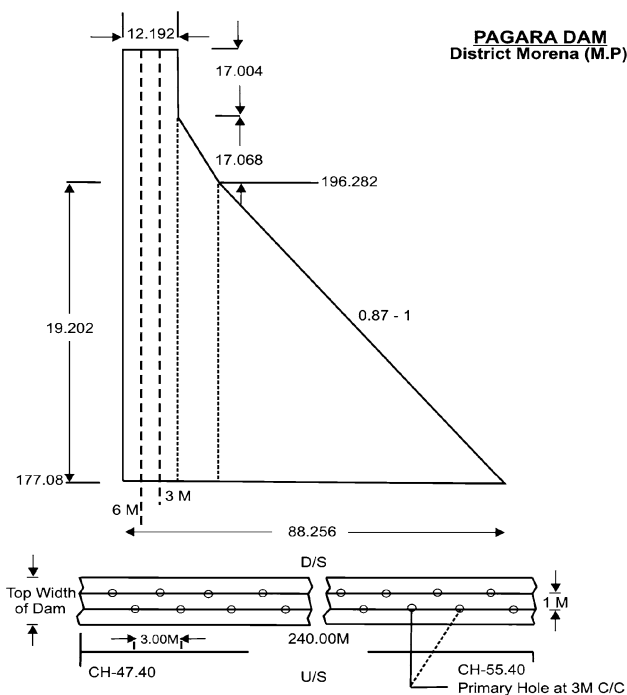
The test grout pattern is proposed in two rows 1 m apart and holes being spaced at 3 m c/c staggered. The first row of grout holes being one meter from the upstream face of dam. After test section, different reaches of masonry dam was proposed to be grouted accordingly. For layout of grout holes (Fig. 44).

Fig. 44 Pattern of drilling and grouting

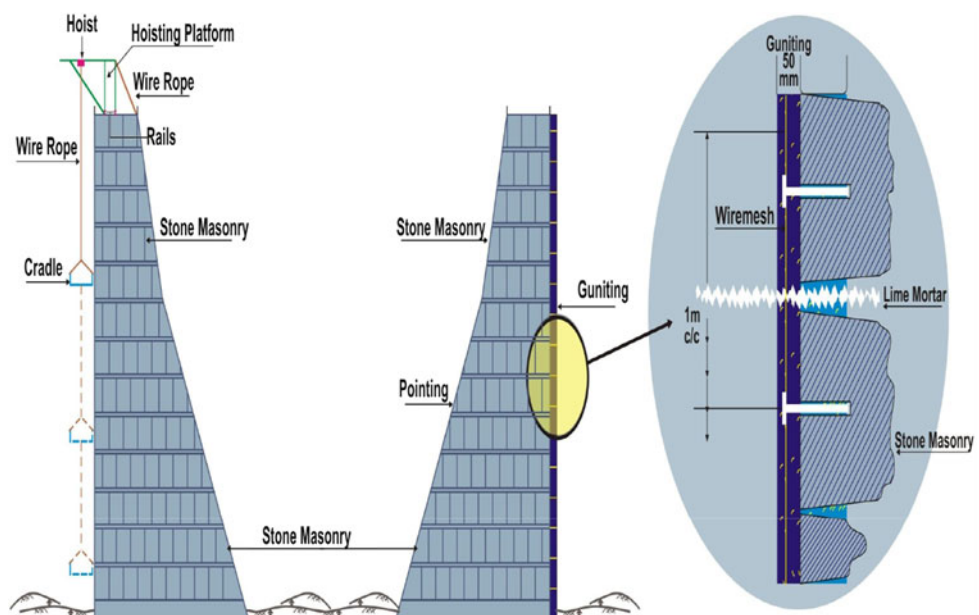
Curing for 28 days has been done by sprinkling water throughout the surface of the dam (Fig. 45).

Fig. 45 Raking, pointing and guniting of upstream face

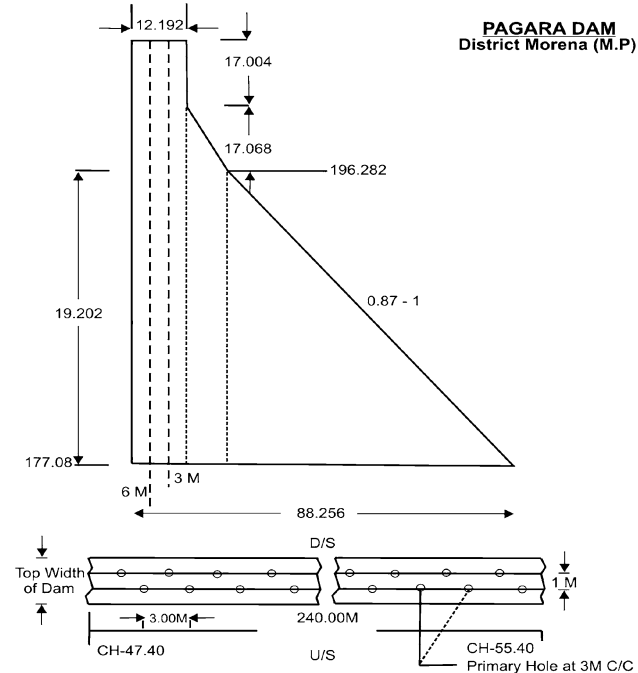
Drilling and grouting operations has been executed as below (Fig. 46).

Fig. 46 Pattern of drilling and grouting

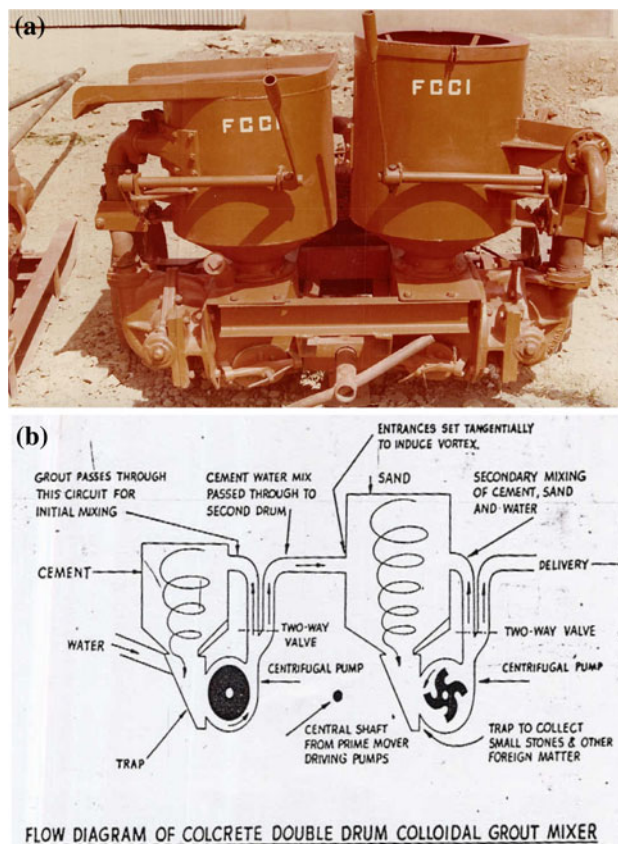
For mixing of cement with water, high speed mixers known as colloidal mixers are used (Fig. 47a, b). It is important to

Fig. 47 a Colloidal mixer, b colloidal mixer

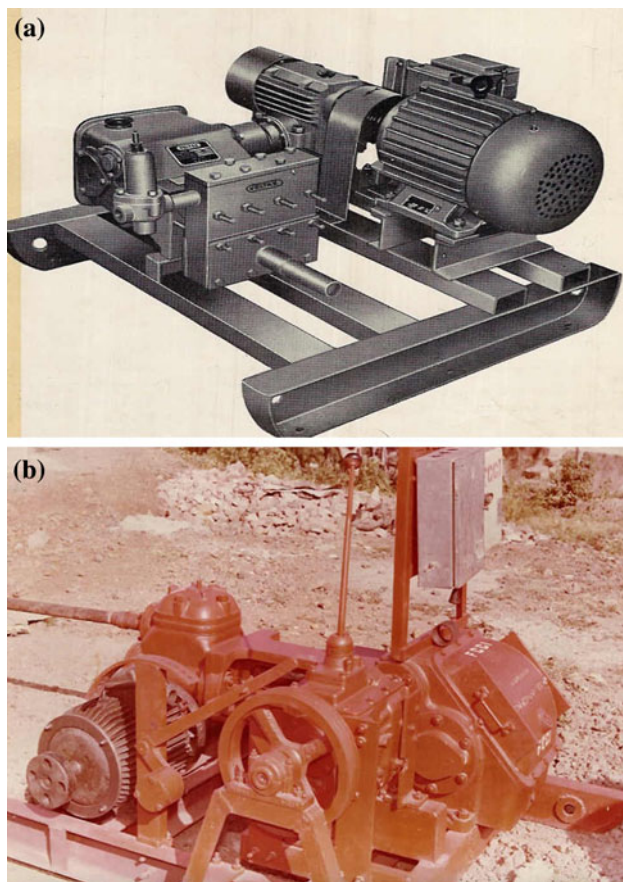
Electrically operated double cylinder pumps have been used to pump the grout in the hole. These pumps are reciprocating, piston type, capable of producing 4,904.13 kPa pressure and having a pumping capacity of 100–300 L/min liquid in the hole (Fig. 48a, b). From the agitator, grout comes to the pump and from pump it is injected in the hole through packer and grouting header fitted with a pressure gauge.

Fig. 48 a Grout pump, b grout pump

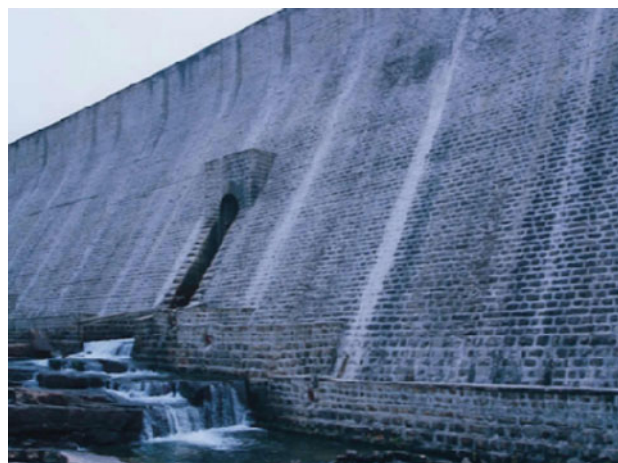
Near the sluices at Pagara dam, very loose masonry with lot of voids were observed which were taken care of by drilling and colgrouting 6 nos. drill holes, using sand cement grout with the help of colcrete mixture and colmono pumps (Fig. 49).

Fig. 49 Sluice of Pagara dam
