**Indian Geotechnical Conference
IGC 2022**
15th – 17th December, 2022, Kochi

Foundation Investigations in Thick Overburden Matrix Material of a Proposed Dam – A Case Study

Rajesh Khanna¹, Palani kumar A², Manish Gupta³ and R Chitra⁴

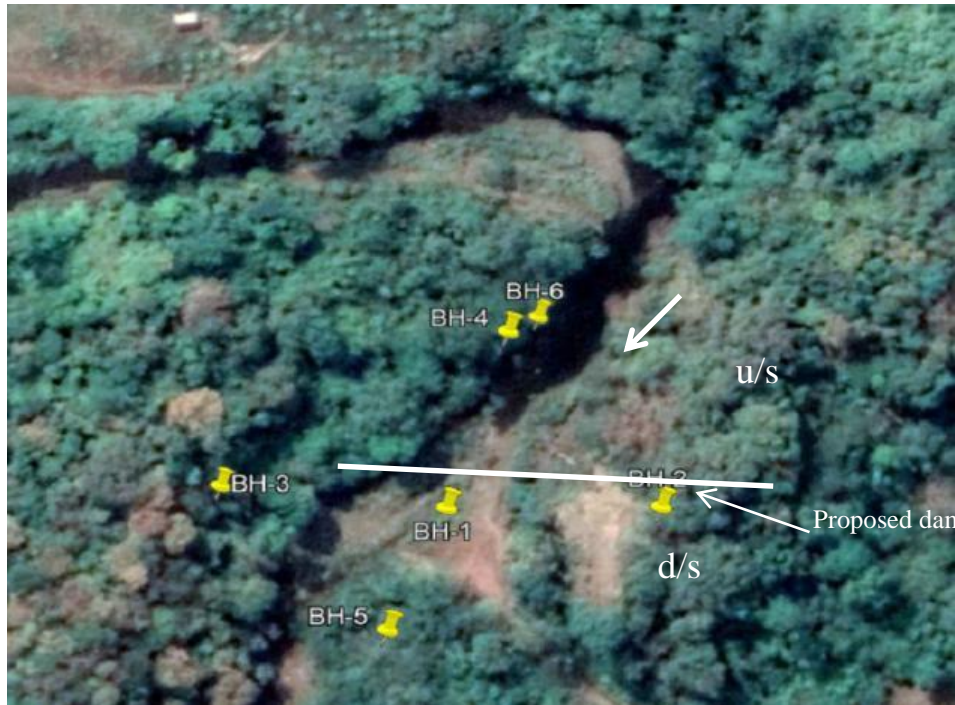
Fig. 1 Location Plan of bores holes at proposed dam

It is proposed to drill five drill holes at various locations such as dam axis, left and right abutments, upstream and downstream of dam axis. There was thick layer of about 6 m overburden of matrix material including boulders of different sizes mixed with sand silt and clayey soil at the dam axis and exposed rock could be seen at some locations.

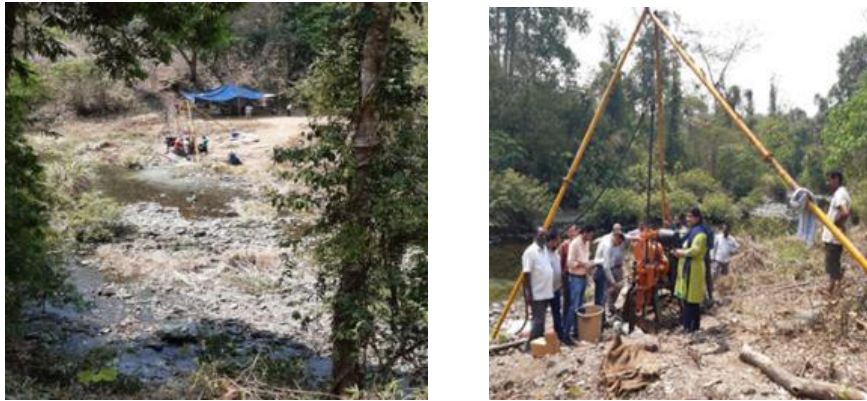
Fig 2 Drilling work in progress at dam site
