## Slope Repairing Methodologies in Railway Embankment

**Abstract.** The generalized methodology of slope repairing for railway embankment considering several case histories in northern India is presented in this paper. There are many available literatures to assess the reason of recurring slope failures and its preventive measures from construction point of view. However, there is no synthesized practical recommendations to overcome the issues of recurring slope failures and address the common methodology for already failed slope repairing system. The present study focuses on the slope repairing methodology under different scenario of rain-cut problems. The common issues like rainfall infiltration, slope height, soil types, fines content, level of compaction etc. Slope stability analysis has been performed for the respective sites with the already failed slope conditions to understand the requirement and utility of slope repairing techniques. About 7000 km of Indian railway track has been built on the weak formation it's inevitable to have slope failure and the high demand of high-speed railway track also support the requirement of long-term stable slope repairing methodology. Se

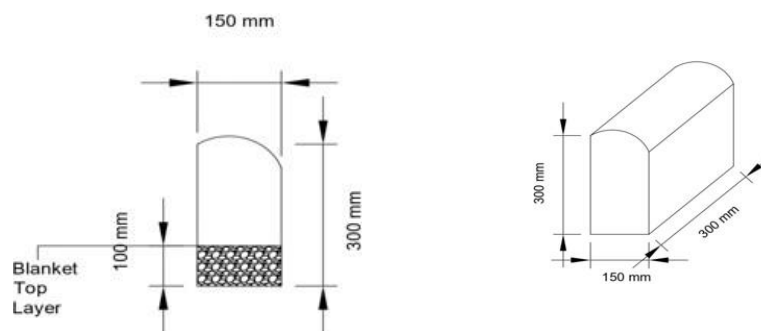
Fig. 4. Detailing of the proposed kerb.

Rain cuts are more prominent at the locations where blanket layer is completed. Velocity of rainwater increase on blanket surface and damage the formation even when rain fall is not heavy. Locally available soil is of Silty sandy nature which quickly loses

- The concrete kerb on both sides of formation top (blanket top) along with chute drain has to be provided at every 40-meter interval. First trial section of 250 m has been proposed nearby Faridabad section. After successful performance in terms of run off the solutions have been employed for rest of the whole stretch. The detailing of kerbs has been designed based on M25 grade concrete as shown in Fig. 4. The proposed formation has been shown in Fig. 5. The significant reduction in the soil erosion has been observed in the next monsoon.
