Indian Geotechnical Conference

IGC 2022

# Rehabilitation of a Distressed Vertical Cut in Lateritic Soil

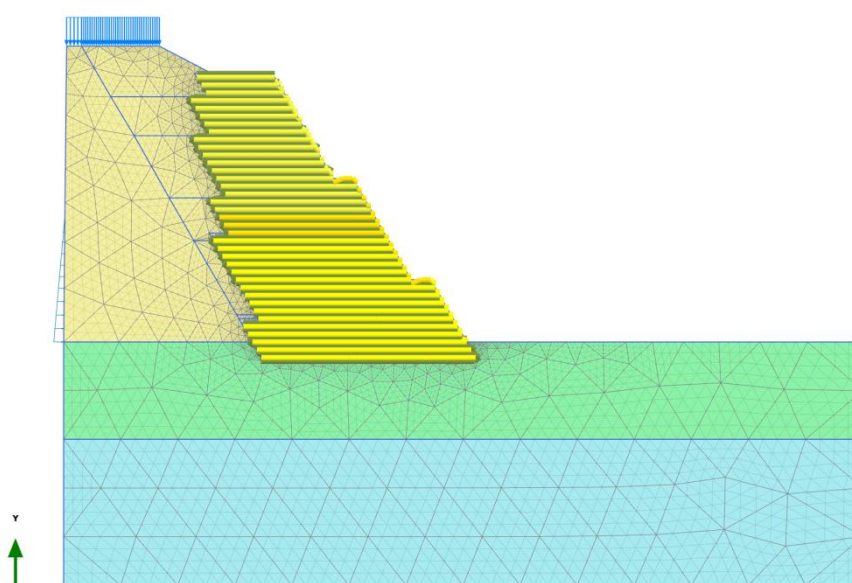
**Fig. 4.** Finite element mesh.

The slope was analysed with the maximum permitted spacing as per various standards. Figure 3 gives the dimensions chosen for the analysis. Two-dimensional non-linear finite element analysis was conducted for the proposed dimensional scheme. The material properties given in Tables 1 and 2 were taken. Figure 4 shows the finite element mesh. The excavation and stage-wise construction sequence were simulated.
