A Geotechnical Study on Breached Summer Storage Tank

Abstract. This paper presents some of the observations made as well as geotechnical testing carried out in search of reasons of breached out summer storage tank, which was about to be commissioned for supply of water especially during summer season to the villagers of Nuzendla mandal in Andhra Pradesh. The tank has about 10 acres of storage area and the levels of water in the tank are not the same throughout the area but varying from 3m to 5.5m. The breaching of tank was occurred, at a location where the water level is 5.5m high, and where two mutually perpendicular bunds are joining. The disturbed and undisturbed soil samples collected from the location where breaching of tank took place were tested in the laboratory to understand the basic characteristics of the soil used for bund construction. The grain size analysis, compaction control, free swell index, liquid and plastic limits, permeability and shear characteristics are determined. It is noticed that the locally available soil is used for bund construction and it is of medium to high plastic in nature. The compaction levels at certain places are found to be inappropriate

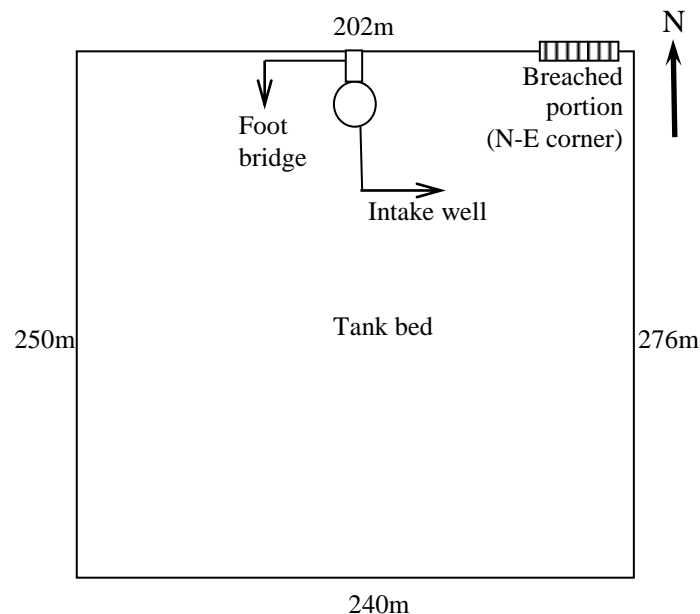
Fig.1. Line diagram of summer storage tank

The summer storage tank was built in an area of 10.8 acres in Nuzendla Mandal, Narasaraopet division, Guntur district, Andhra Pradesh state, India. Its storage capacity is 37580 m^3 . The highest storage level is 5.65m and this maximum storage level is spotted in the North – East corner of the tank. The plan area of tank is almost rectangular and its line diagram with salient points is shown in Fig.1. Also, the photographs of breached portion are presented in Fig.2. The bed is sloping towards North - East corner. The storage level in the South-West corner is 3m. As the nature of soil in the original bed is pervious and to control the percolation losses, the bed is covered with 0.5m thick clay layer which is of highly compressible in nature and its liquid limit and free swell index are 68% and 110% respectively. The tank is made up of earth bunds in all the four sides with a slope of 2.5(H):1(V) in both the upstream and downstream sides. The soil used for earth bund construction is almost homogeneous and is intermediate to highly compressible clay. The breaching of earth bund took place in the North-East corner of the tank, where the highest water storage level is 5.65m. The breaching of bund is occurred during filling up of water in the tank.
