# INFLUENCE OF LOW PERMEABILITY CAPPING LAYERS ON LIQUEFACTION INDUCED FAILURE IN STRATIFIED GROUND

Divyesh Rohit<sup>1</sup>, Siavash Manafi Khajeh Pasha<sup>1</sup>, and Hemanta Hazarika<sup>1</sup>,  
Takaji Kokusho<sup>2</sup> and Sukiman Nurdin<sup>3</sup>

<sup>1</sup>Kyushu University, Fukuoka 819-0395, Japan

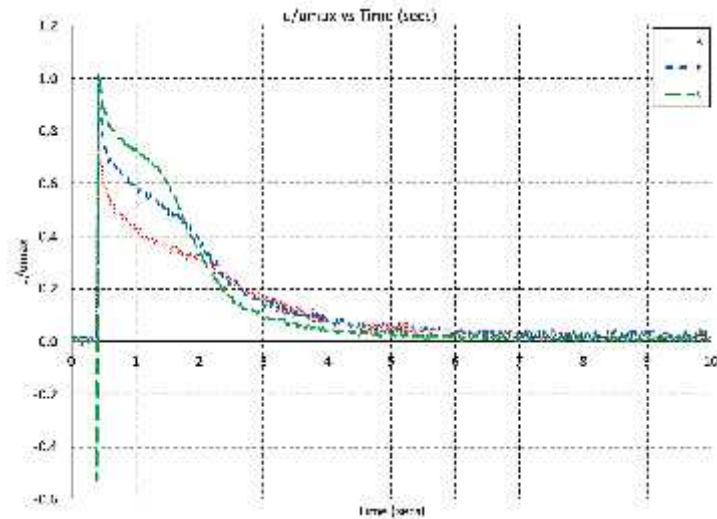
time (secs). The  $u/u_{max}$  value has been plotted against the duration to show the effect of clay seam on development and dissipation of excess pore water pressure in saturated sand under impact loading. Fig. 8 shows the plot for condition with no clay seam present (Case 1). Here in Fig. 8 it can be seen that the EPWP developed for pore water transducer C is higher than A and B. This may be due to its location at the bottom from where the dissipation of EPWP takes time, while at A the EPWP is dissipated quickly since it is near to surface. Further, at B, the EPWP is developed but gets dissipated quicker than at C due to shorter seepage path. Further in Fig. 9, the plot for case for clay seam sandwiched between sand layers is shown (Case 2). Here, the EPWP developed at pore water transducer B is highest due to presence of clay seam above which inhibits the dissipation of EPWP. It can also be observed that the EPEP at A is higher than at C which may be attributed due to a higher relative density at the bottom during sample preparation.

Figure 8: Plot of  $u/u_{max}$  versus time (secs) for Case 1 with pore water transducers at three locations across the height.

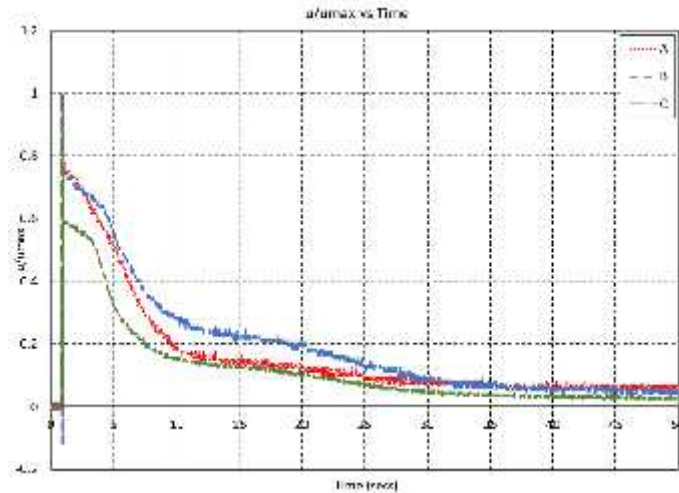
Figure 9: Plot of  $u/u_{max}$  versus time (secs) for Case 2 with pore water transducers at three locations across the height.

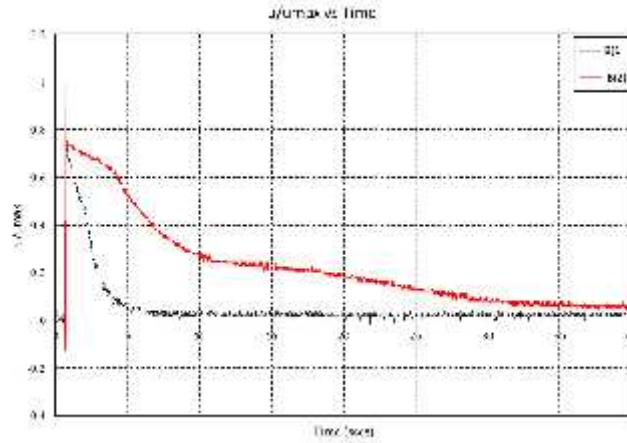
Further in Fig. 10, the plot for  $u/u_{max}$  versus time for transducer B is compared for both the cases (1&2). From the figure it can be observed that ratio  $u/u_{max}$  for B (2) takes longer duration to dissipate after reaching peak and still has a higher value while that for B (1) is dissipated. This implies the capping effect of clay seam which prevents the dissipation of excess pore water pressure in the sand layer below. In Fig. 11 the plots for  $u/u_{max}$  versus time for pore pressure transducers A and C are shown, where A is located above the clay seam and C is located at a distance of 15 cm from the bottom of the sand layer with  $D_r$  70%. Here for both the transducers the duration for dissipation of excess pore water pressure for sand with clay seam is higher than the condition without clay seam. This shows that the presence of a low permeability layer can not only hinder the dissipation of pore water pressure in adjacent areas but also in regions at a higher distance from the layer vertically.

Figure 10: Dissipation of excess pore water pressure versus time (secs) at pore pressure transducer B for Case 1 and 2 .

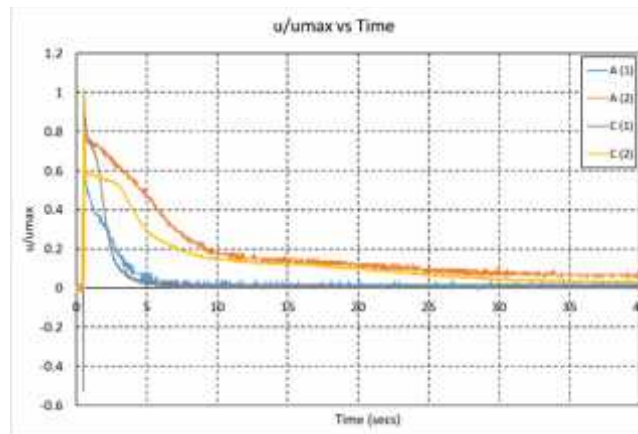
Figure 11: Dissipation of excess pore water pressure versus time (secs) at pore pressure transducers A and C for Case 1 and 2 .

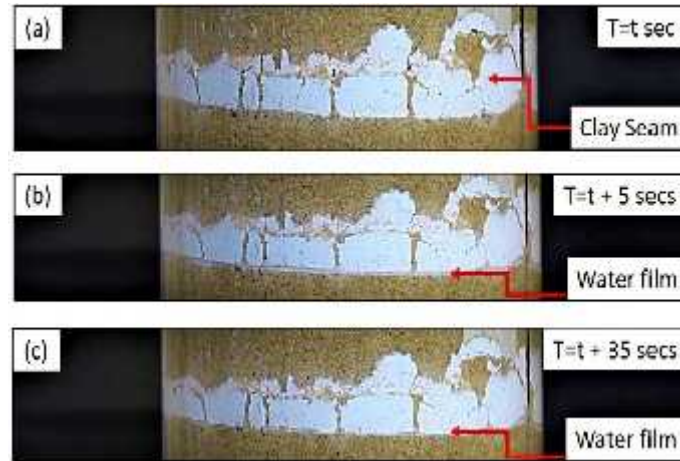
The pictorial evidence of the effect of clay seam in sand layer during liquefaction can be seen in Fig. 12. Here the development of water layer below the clay seam at different time frames is shown. Fig. 12(a) is recorded at  $T = t$  seconds when the hammer impact was made. Fig. 12 (b) depicts the maximum thickness of the water film at  $t + 5$  secs while Fig. 12 (c) shows the decreased water film thickness at  $t + 35$  secs. This shows how the water film dissipates slowly thereby influencing the dissipation of excess pore water pressure from the below sand layers by forming an impermeable capping layer. The water film thus created causes settlements in the clay seam after the overall dissipation of EPWP which can be seen in Fig. 13. Here in Fig. 13(a) the base of clay seam can be seen at 39.8 cm which settles to 39.0 cm after the hammer blow due to liquefaction as seen in Fig. 13(b).

Figure 12: Formation of water layer under the clay seam at different time durations: (a) Time ( $T$ ) =  $t$  secs, (b)  $T = t + 5$  secs and (c)  $T = t + 35$  secs.

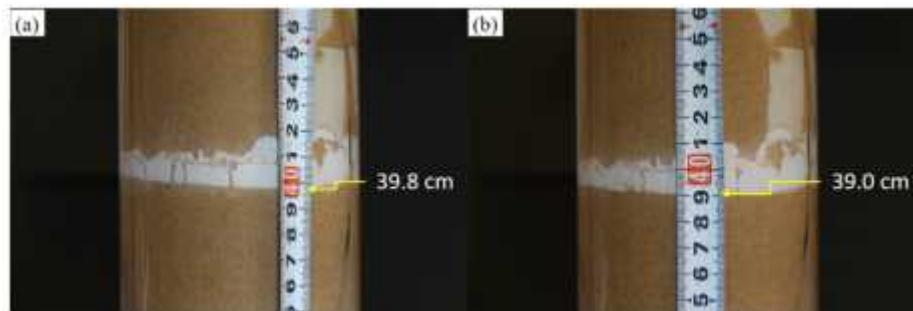
Figure 13: Height of clay seam (a) before liquefaction and (b) after liquefaction.
