# Retrofitting of Existing Earthen-Fly Ash Dam by Finger Drains & Gabion Wall

**Abstract.** Coal based power plant generates huge amount of fly ash as residual waste for ash ponds with significant dam heights have been constructed over a period of operation. Sometimes in long run, seepage may threaten the stability of dam due to internal erosion or clogging of filters. This paper presents a case study on fly ash dam where seepage and distress of dam section had a concern for the Owner. The entire pond had raised by up-stream method of construction with earthen as well as pond ash material. One stretch of dam settled including starter dam and moved horizontally under heavy seepage during monsoon. The root cause of problem had been identified through new geotechnical investigations and engineering solution was proposed to stabilize dam section. The rectification measures involved revival of old rock toe, strengthening of dam by constructing gabion wall at toe of starter dam with geotextiles and graded filters. The internal drainage was streamlined with provision of PVC perforated finger drain wrapped with non-woven geotextile material inside trenches filled with graded filters. The

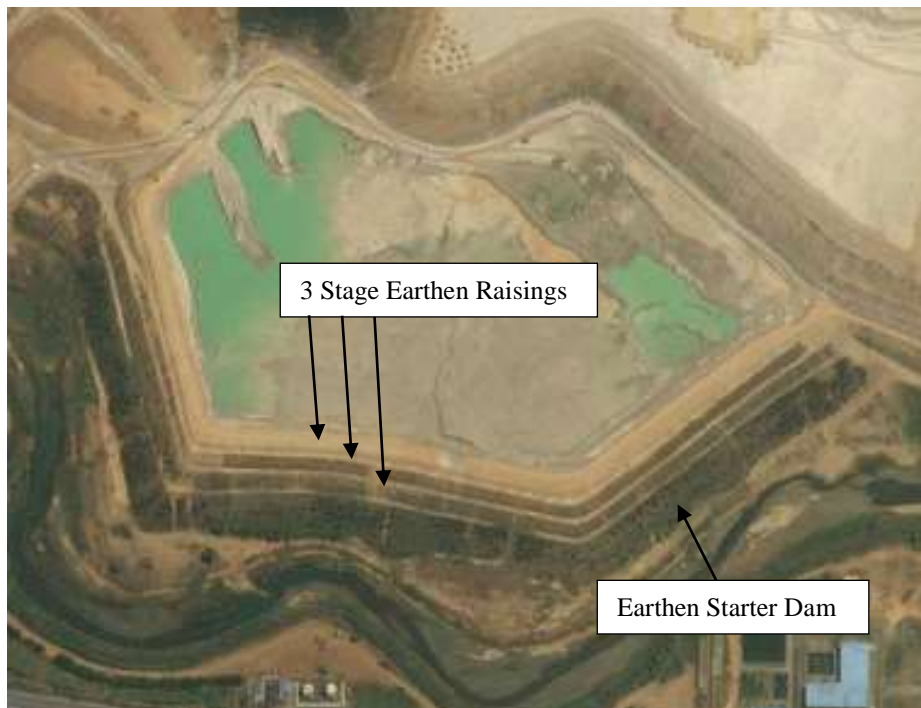
**Fig.1.** Ash Pond after 3rd Raising (Source Bing Satellite Image)

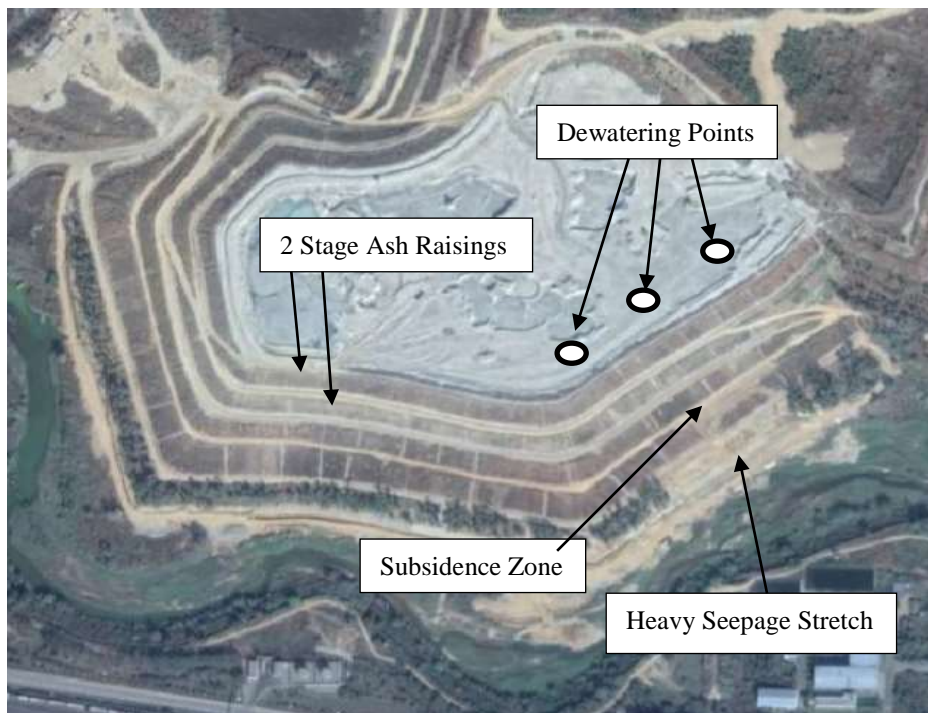
The pond was operated and filled up to the 5th stage raising. However, at the end of operation minor seepage were observed for a stretch of about 60m at the starter dam. The seepage continued to increase during the monsoon period. The situation was fur-

ther aggravated by subsidence of dam at top of the buttressing portion which resulted in horizontal sliding of mass at starter dam top. It was analyzed that part of the starter dam could be on the verge of collapse. Therefore, the total area was immediately covered with sand bags from toe up to the distressed portion. Three borewells were made inside the pond for dewatering purpose, but pumping was not fruitful due to less water in borewells. The seepage problem was caused by accumulation of water inside dam body due to choking of filters in chimney, relief well and sand blankets and further connectivity to existing rock toe.

**Fig.2.** Ash Pond after 5<sup>th</sup> Raising (Source Google Satellite Image)

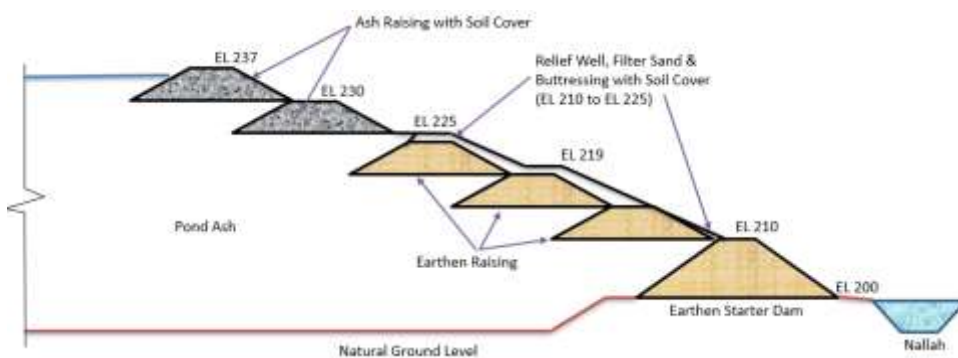
The starter dam of height 10-12m was built with excavated soil from the pond footprint area. It had rock toe at bottom, but no vertical chimney or horizontal blanket drains were found in the construction documents. Subsequent 3 heights raising of 4m each by up-stream method were done by using same earthen material without any internal drainage system. Pond was operated and filled up to the third raising and further 2-stage height raising of 6m each by up-stream method were planned. Before that buttressing with relief well, filter drain with soil cover along slope face connected to a small rock toe were done from starter dam top to third raising. Afterwards, dam was raised by pond ash material with soil cover all around including proper internal drainage systems with rock toe.

**Fig.3.** Schematic Diagram for Typical Cross Section of Dam (Not to Scale)

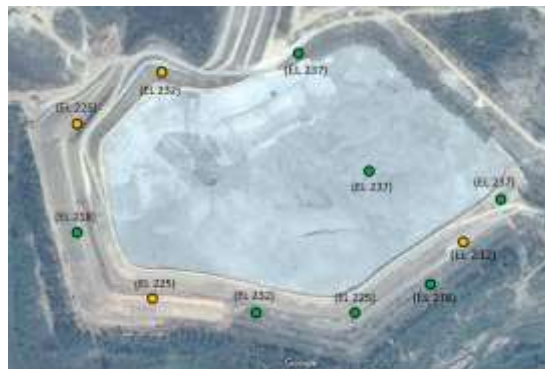
Existing drawing, contours and old geotechnical reports of the ash pond were studied for preliminary planning and design. Uncertainties in design inputs were eliminated by carrying out new topographical survey and geotechnical investigations. The field work was comprised of 11 augured boreholes of depth ranging from 27 to 40 m sunk at various locations along the dam and inside the pond. Standard Penetration Test (SPT) was conducted at every 1.5m intervals throughout the borehole up to termination depth. 18 nos of field permeability tests were carried out in boreholes at different depths. Laboratory tests on selected samples were carried out to determine moisture content, specific gravity, unit weight, Atterberg limits, grain size, strength parameters, consolidation-swell parameters and water quality. Additionally, 15 nos piezometers were installed at different elevations for entire dam section to monitor the phreatic surface within the dam. After detail analysis of the geotechnical report, the following parameters were assigned for various layers for carrying out slope stability analysis.

**Fig.6.** Approximate Location of Boreholes on Google Image

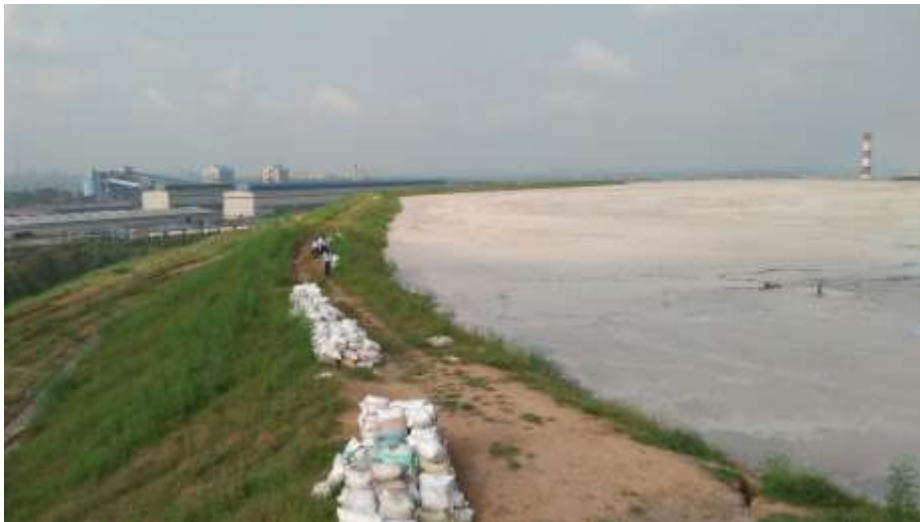
**Fig. 13.** View of Ash Pond Side above Gabion Wall

- Immediate dewatering of surface water from pond to decantation pond and safe channelization of surface run-offs of rain water away from the affected zone.
- Cleaning of existing rock toe from overburden soil, vegetation and rearrangements of rock ripraps to reduce pore water pressure.
- Excavation at toe portion and placing of finger drains with geotextiles and filters for safe channelization of seepage water through existing rock toe.
- Construction of gabion wall at starter dam toe with placement of graded filters up to the existing rock toe.
- Engineering fill above gabion wall with slope profiling with vegetation, boulder pitching.
- Installation of piezometers and settlement gauges at various benches for appropriate measurement of phreatic surface and further settlement.
