Indian Geotechnical Conference

IGC 2022

Drilled Displacement Column Technology for ground Improvement in San Francisco

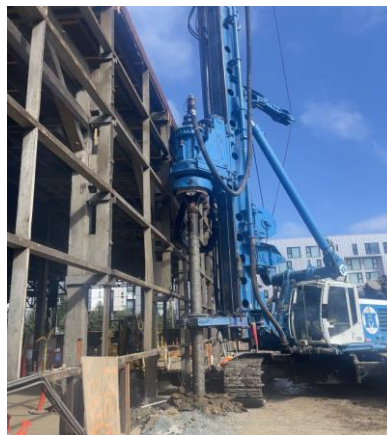
The tool and the pressure grout effect result in a coarse-sided sand-cement column. DDCs are high modulus/controlled stiffness grout columns typically installed through weak, highly compressible soils to reduce settlement and increase bearing capacity. The displaced soil causes cavity expansion, increases shear strength, density, and over-consolidation, reduces the void ratio, and increases the stiffness of the composite ground. This creates deep-ground improvement columns. Figure 2 shows the installation of DDC at site.

Fig.2. DDC installation at the site

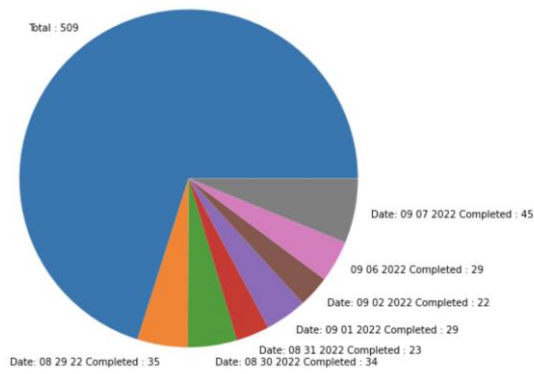
Fig.9. Installation chart

A total of 509 DDCs were installed for the ground improvement purpose of the parking garage. Each DDC has drilled a Bauer BG-28 drill rig with a 40-foot-long, 16-inch-diameter displacement auger. Once refusal or target depth is met, the depth is confirmed, and the contractor begins grouting. Refusal for this project is defined as the rig being unable to advance more than 6 inches for one minute and can be further verified by lifting off the tracks when full crowd force is applied to the drill. The installation data was analyzed and recorded. A typical analysis of the production pile installation is given below. A typical installation data analysis of 7th September 2022 is given below. Figure 8 depicts the actual v/s design length of the installed piles, Figures 9, 10 and 11 shows the completion chart, Grout Factor frequency and Design v/s actual grout volumes.

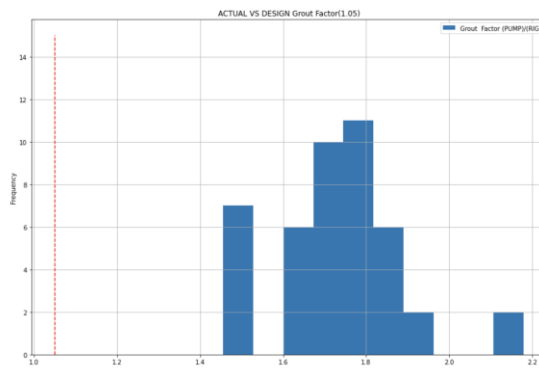
Fig.10. Grout Factor Frequency

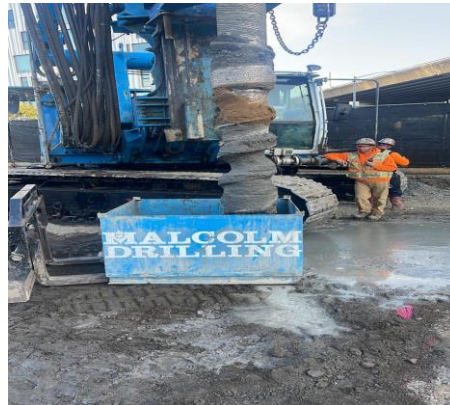
Figure 12 below shows the calibration process of the rig grout factor using a cuboid container for measurement. Figure 13 shows the auger used for the installation process and Figure 14 shows the lowering process of the rebar.

Fig.12. Recalibration of Rig grout factor

Each DDCs were inspected and checked that it has achieved the design depth or was terminated at refusal. The grout factor of the Rig and the pump was calibrated periodically
