Numerical Analysis on the Stability of Upstream Mine Tailings Dam under Seismic Loading

Abstract. Upstream tailings dam expedites the construction process while lowering disposal and operational expenses. However, these dams are susceptible to liquefaction-induced failure under seismic conditions. This study explores the possibility of reducing differential settlement of the upstream tailings dam under liquefaction by densifying strategic portions of the beach area. Finite Element analysis is conducted using UBC3D-PLM constitutive law to model the liquefiable soil. The model is validated with a published centrifuge model of clayey embankment resting on liquefiable sand. The vertical deformation and post-liquefaction factor for unimproved and improved upstream tailings dam are numerically analysed. For an unimproved upstream tailings dam, vertical deformation to the tune of 300 mm was observed after 100 seconds of the seismic load, while the post-liquefaction stability factor was 1.33. In order to enhance the stability of the upstream tailings dam, the portion of the beach under the raised embankment was densified at a relative density of 70%. The width and depth of densified porti

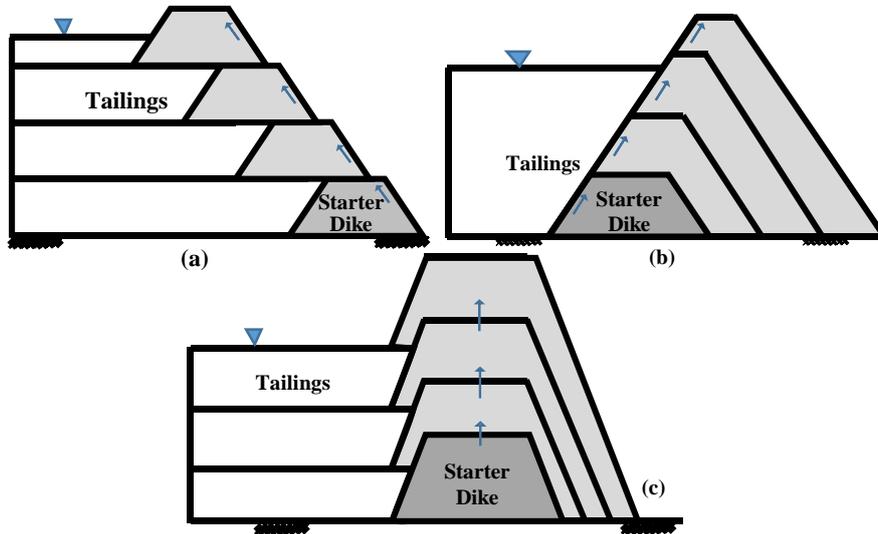
Fig. 1. Classification of tailings dam (a) Upstream (b) Downstream (c) Centerline

construction of tailing dams is different from water dams in a sense that, even after the construction of the starter embankment, these are raised to store the increasing quantity of mine tailings. This process thus continues up to the functional life of the mining industry. Based on how the raised embankments are constructed, tailings dam are classified as the upstream, downstream and center line, as represented in Figure 1(a-c).

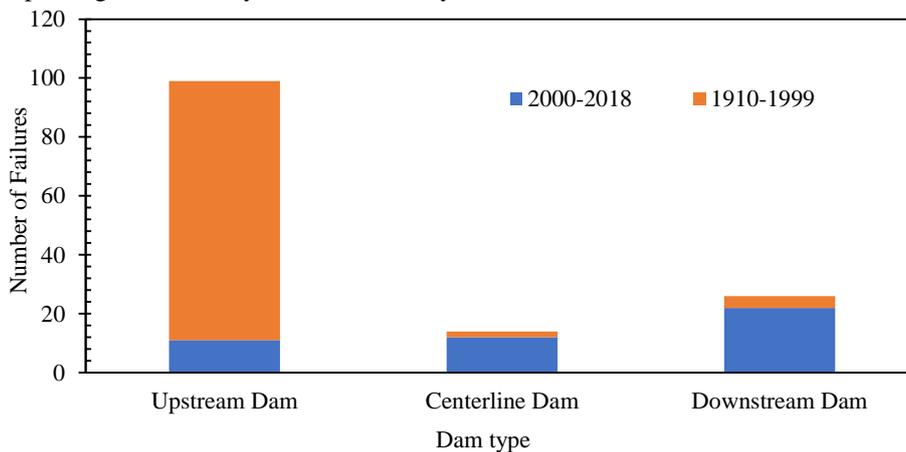
Fig. 2. Failure distribution of mine tailings dam based on dam type [10]

Among the three types of the mine tailings dam, the upstream tailings dam is cheap, easy and involves quick construction methodology. However, these dams are prone to failures due to liquefaction. Figure 2 demonstrates failure cases encountered based on the configuration of tailings dam. The raised embankment of the upstream tailing dam resting on the tailings undergoes liquefaction during seismic conditions, which results in the generation of excess pore water pressure, thereby reducing the strength of tailings and leading to differential dam settlement. This minimises the serviceability and functioning of the dam. These dams thus need an attention for improving their stability and serviceability under seismic conditions.

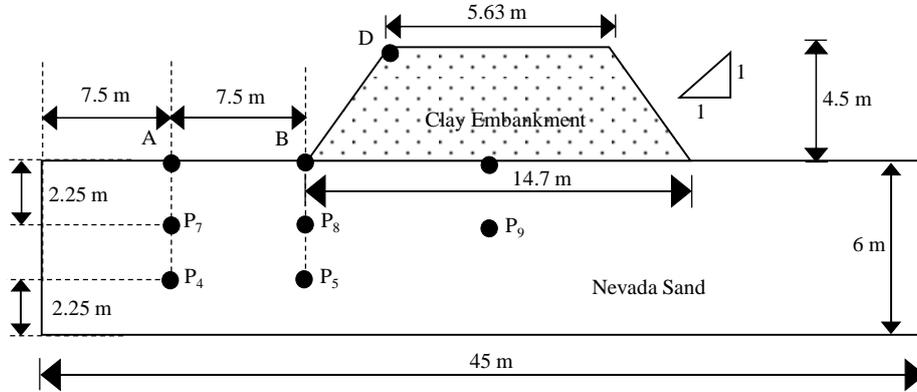
Fig. 3. Dimensions of a numerical model for validation with centrifuge tests [11]

For the validation of the developed numerical model, the centrifuge model tests [11] on clayey embankment resting on liquefiable Nevada sand at 75 g was numerically modelled in PLAXIS 2D. The liquefiable Nevada sand and clayey embankment were modelled using UBC3D-PLM and Mohr-Coulomb constitutive laws respectively. Details of the dimensions and boundary conditions of the numerical model are shown

in Figure 3 and Figure 4. A finer mesh size is adopted at the interface of the clay embankment and Nevada sand during validation study. The material properties of the clayey embankment and Nevada sand are presented in Table 1 and Table 2 respectively.

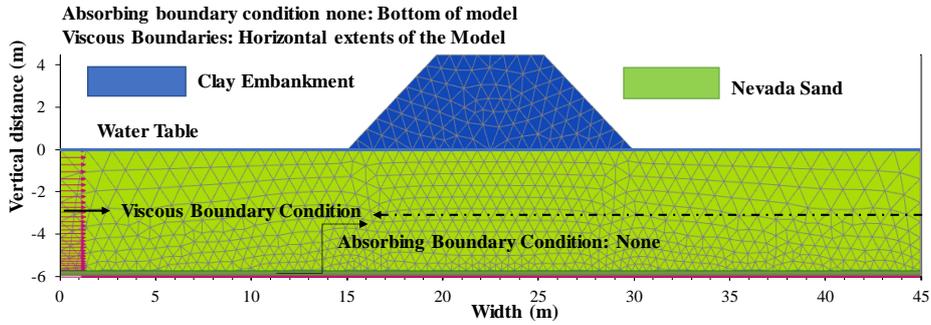
Fig. 4. Finite element mesh and boundary conditions for model prepared in PLAXIS 2D

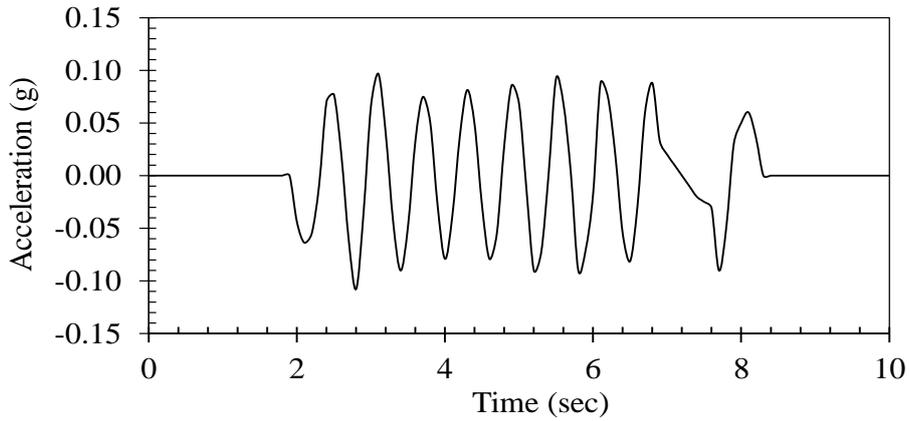
Fig. 5. Input motion provided at the base of the numerical model [11]

The numerical model simulating the centrifuge experiment was subjected to a cyclic load of 10 cycles of 1.6 Hz with a maximum amplitude of excitation of 0.09g, as presented in Figure 5. The excess pore water pressure (Excess PWP) was computed at strategic points and the results were compared at homologous points with the centrifuge model, as depicted in Figure 6, Figure 7 and Figure 8. It was observed that the time at which peak excess pore water pressure was observed at a particular point in the dam section corroborated numerically and experimentally. Moreover, the initial rise in excess pore-water pressure was similar in both models. However, the rate of dissipation of excess pore water pressure was higher in the numerical model than in the centrifuge model.

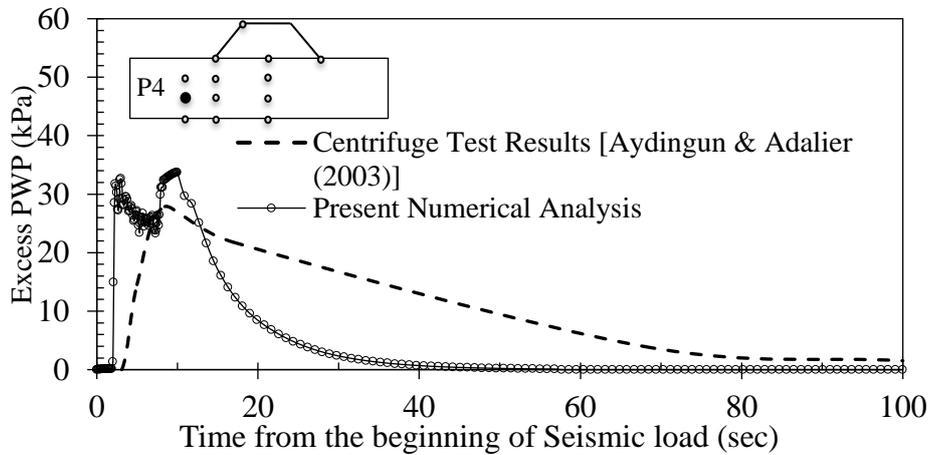
Fig. 6. Comparison of excess pore water pressure (PWP) between the centrifuge and numerical model

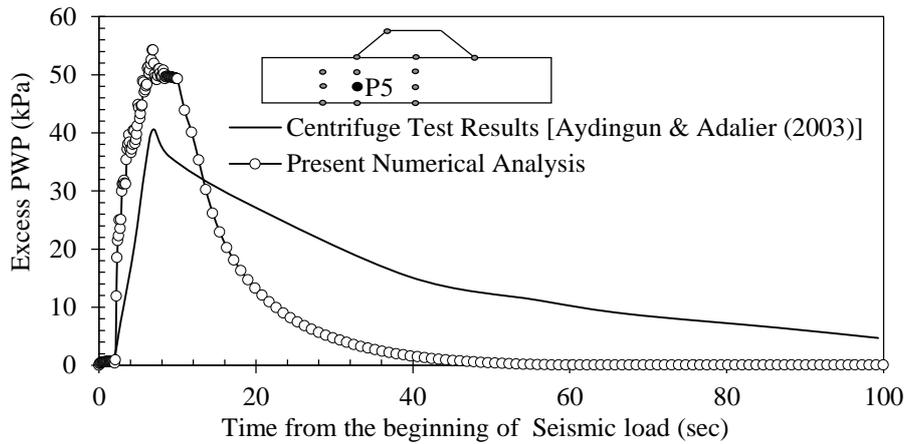
Fig. 7. Comparison of excess PWP between the centrifuge and numerical model

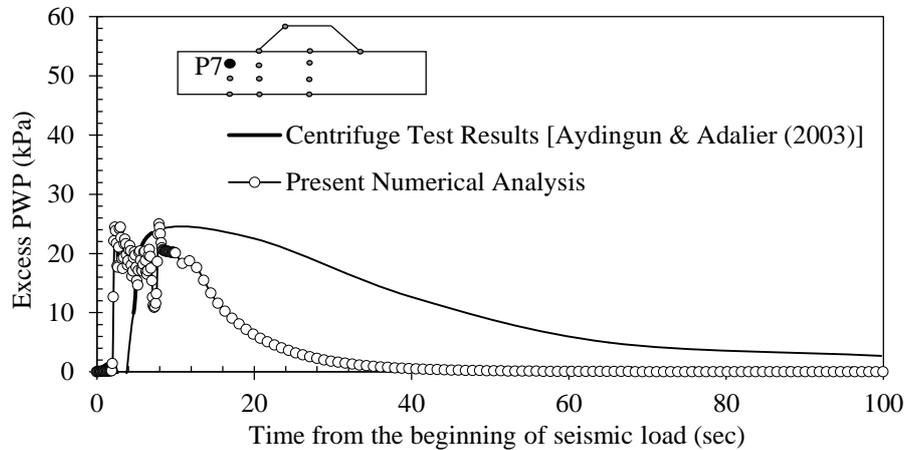
Fig. 8. Comparison of excess PWP between the centrifuge and numerical model

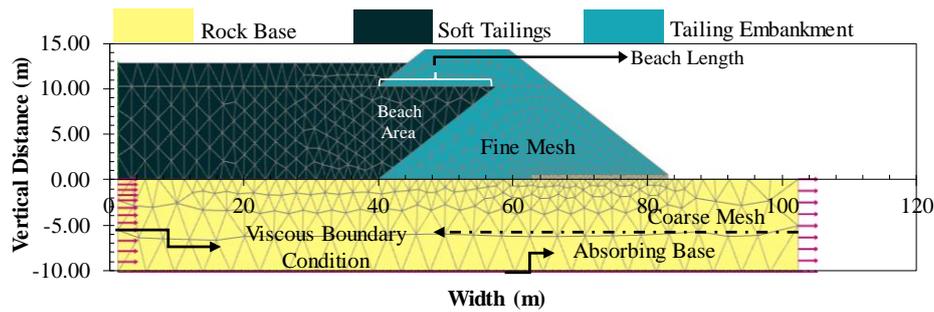
Fig. 9. Numerical model of upstream tailings dam without improvement

After the validation of the numerical mode, an upstream tailings dam was modelled numerically using 15 noded triangular elements and assuming plain strain conditions. The total height of the dam was kept at 14 m retaining 12.5 m high tailings with a phreatic level coinciding with the tailing level. The raised embankment was 4 m in height with a side slope of 1 vertical: and 2 horizontal. The initial embankment of height 10 m was provided with a drainage blanket of 0.5 m thickness and 23 m width, and the entire dam structure rested on a 10 m deep rock foundation. UBC3D-PLM soil constitutive model was used to predict the liquefaction and post-liquefaction behaviour of the tailing and tailings dam. In this study, a relatively coarse mesh was used for modelling the foundation material of the upstream dam, while a fine mesh was used for modelling the tailings, dam body and improved zones, as shown in Fig. 9.

Figure 9 represents the numerical model of the upstream dam without improvement. The improved zone was taken into account to analyse its influence on the behaviour of the dam under seismic conditions as shown in Figure 10. The dam was subjected to the same cyclic load which was used during validation. The width and depth of the improved zone were varied as a fraction of the beach length, L_o (a portion of raised embankment resting on the tailings pond) and their influence of the behaviour of the dam was studied. The improved zone was considered to be compacted at 70%

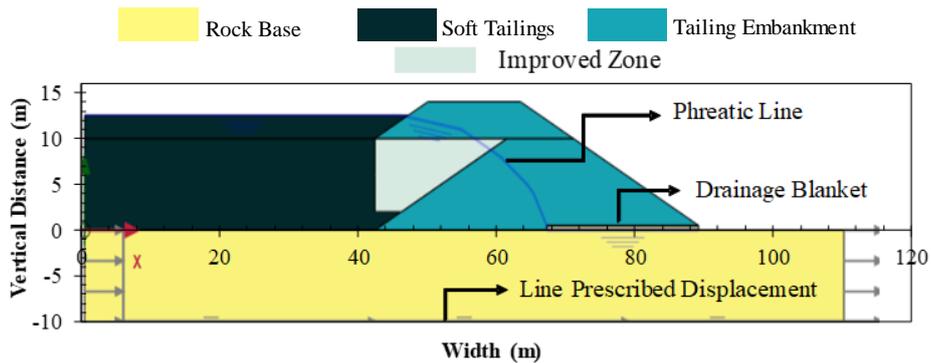
Fig. 10. Numerical model of upstream tailings dam after improvement

relative density, with length (mLo) and depth (nLo)] varying as a function of beach length. Here, “m” represents the ratio of the depth of the improved zone to beach length and “n” represents the ratio of the width of an improved zone to beach length. Vertical deformation at salient dam locations was compared before and after improvement. Moreover, the factor of safety of the upstream tailings dam before and after improvement was compared to determine the effectiveness of the ground improvement. Table 3 and Table 4 summarize the properties of the upstream tailings dam and improved zone respectively.⁴

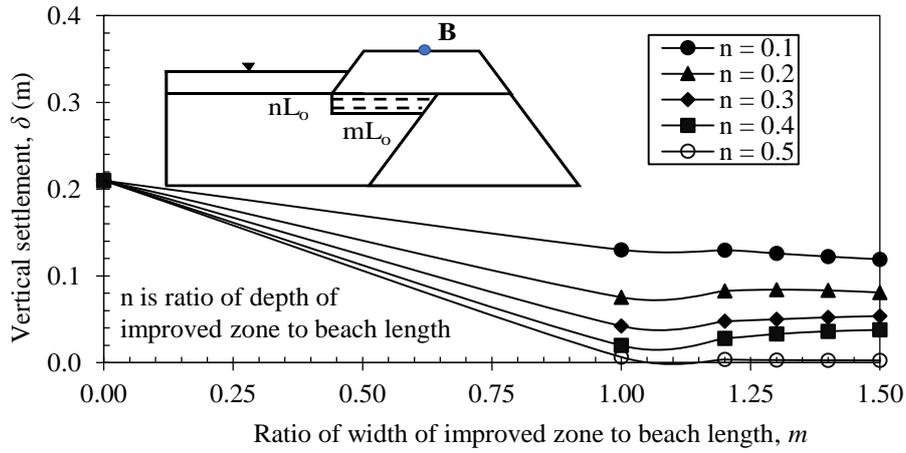
Fig. 11. Vertical deformation at point B after 100 seconds from the beginning of the seismic load

Vertical deformations at salient points B (mid-point of the raised embankment top surface), C (crest of the raised embankment) and E (mid-depth of the raised embankment) were analyzed in both improved and unimproved dams and have been presented in Figure 11, Figure 12 and Figure 13. It was found that initially in the unimproved dam, the vertical deformation at B, C and E were 209 mm, 300 mm, and 297 mm. The large magnitude of settlement at these points is attributed primarily to the fact that the portion of the tailings supporting the raised embankment undergoes liquefaction, thereby causing a significant reduction in strength and stiffness. This reduction in strength causes the raised embankment to undergo substantial settlement. It was further observed that the vertical deformation decreases with the increase in the width and depth of the improved zone. The least vertical deformation was observed when the depth of the improved zone was 0.5 times the beach length. It was also observed that beyond the case of improved zones of width 1.2 times the beach length, the vertical deformations remained almost constant.

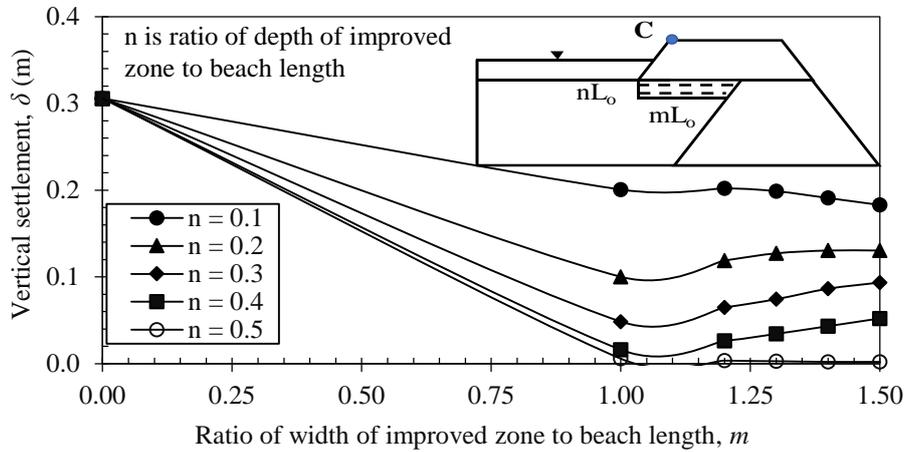
Fig. 12. Vertical deformation at point C after 100 seconds from the beginning of the seismic load

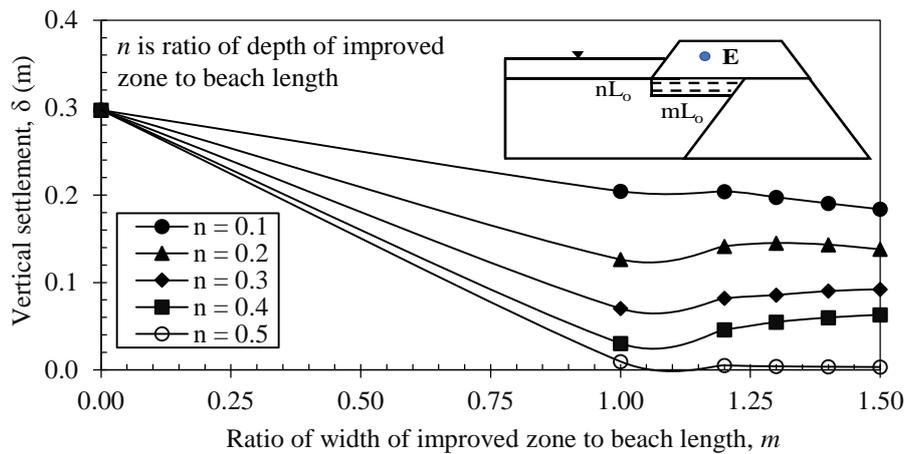
Fig. 13. Vertical deformation at point E after 100 seconds from the beginning of the seismic load

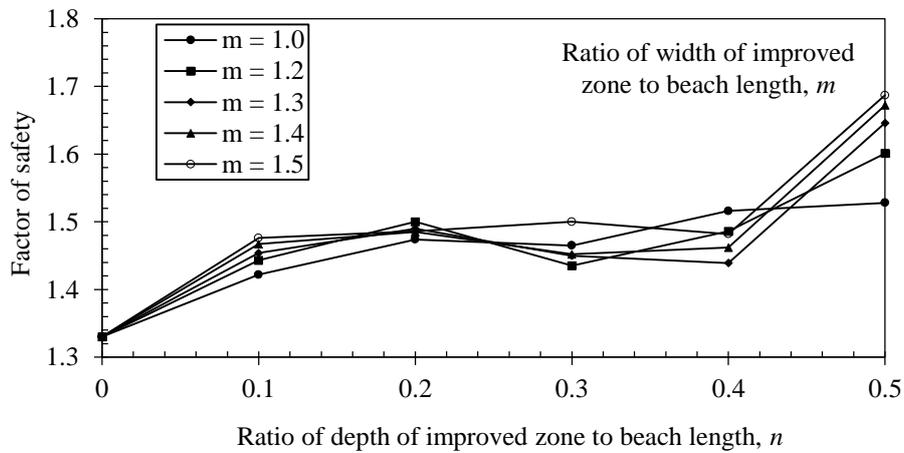
Fig. 14 Variation of factor of safety of dam

Post liquefaction factor of safety was obtained from the numerical analysis for both the unimproved and improved upstream tailings dam. It was found that the factor of safety increases from 1.33 to 1.687 with the inclusion of the improved zone. In general, the factor of safety was observed to increase with an increase in the depth and width of the improved zone. A factor of safety exceeding 1.45 was obtained for the width of the improved zone greater than 1.2 times the beach length and for depth greater than 0.2 times the beach length. It was observed that a maximum factor of safety of 1.687 was obtained when the depth of the improved zone was 0.5 times the beach length and the width was 0.5 times the beach length. The variation of the factor of safety with the width and depth of the improved zone has been presented in Figure 14.
