19th IGS Annual Lecture

Role of Geotechnical Investigations in Engineering Judgement*

M. D. Desai†

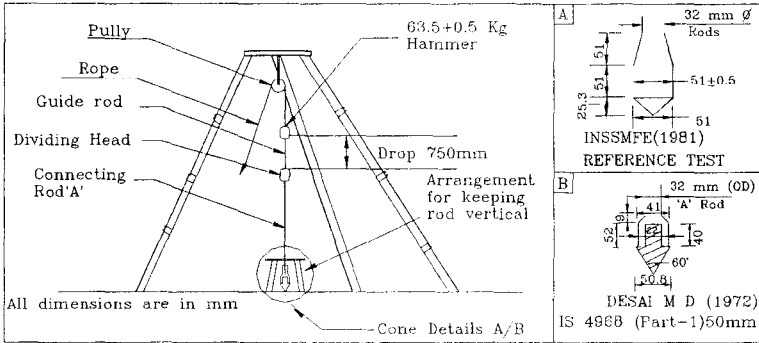
FIGURE 1 : Set-up for Dynamic Cone Penetrometer (DCP) Test showing Cones as per TC 16

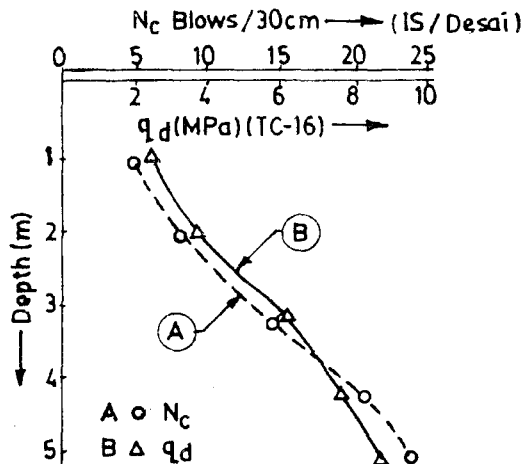
FIGURE 2 : Comparison of Trends of N_c and q_d for a site

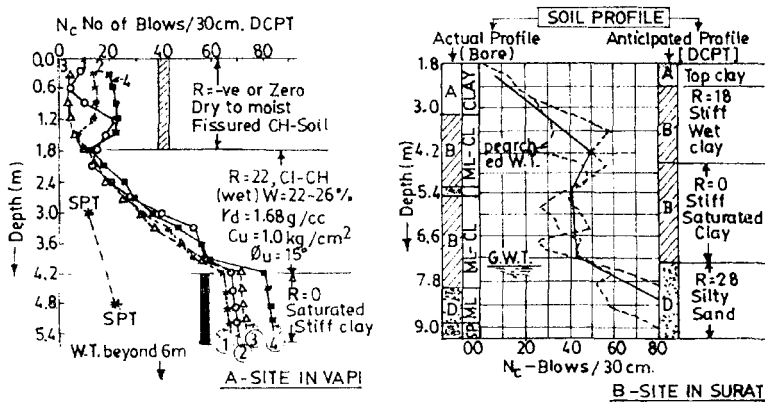
FIGURE 4 : Soil Profiles Developed by DCPT

Identification of Profile : For each of the zones a pilot soil profile is projected as shown in Fig. 4. R is ratio of change in N_c per meter or slope of N_c – depth plot (Pratima and Desai, 1989). $R = 0$ to 8 shows saturated to moist-wet fissured clayey soil. $R = 8$ to 20 indicates cohesive silts and normally consolidated clays and R more than 20 is non-cohesive sandy soils. Thus number of layers, thickness and its probable behaviour is evolved from pilot DCP tests. This interpretation by regular calibration, provides a code for a region.

Water Table Location : The depth to ground water table is predicted as per Fig. 5. Normally soil above water table has a sharp drop in N_c up to 40 percent and the same soil below water table shows sharp increase. Figure 4 shows even perched water table. The prediction is fairly accurate in medium to loose sands. The decrease of N_c at water table varies with denseness and over burden (Desai, 1970).

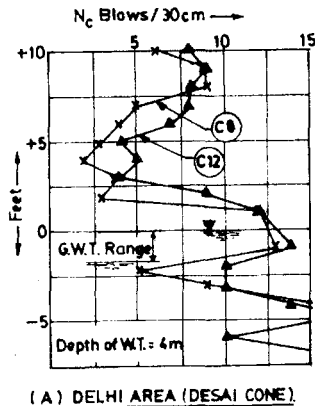
(A) DELHI AREA (DESAI CONE)

FIGURE 5 : Predicted and Actual Water Table

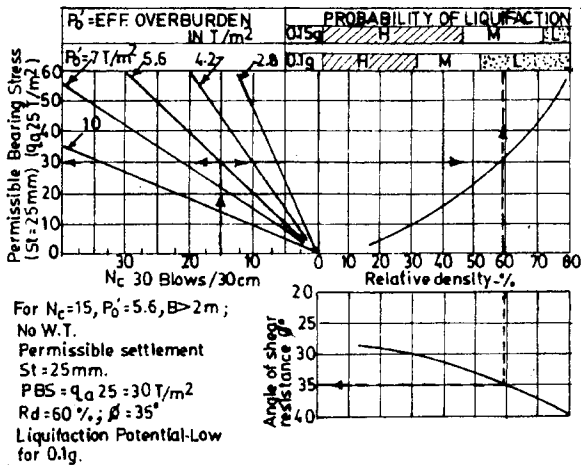
FIGURE 6 : Engineering Properties of Non-cohesive Subsoil by DCPT

For cohesionless soil, the N_c with corresponding effective surcharge pressure is used to estimate relative density, liquefaction potential, safe bearing pressure for a settlement of 25 mm and angle of shearing resistance using the information detailed in Fig. 6. Modulus of elasticity for different non-cohesive soils can be directly read from Fig. 7. CBR can be evaluated using Fig. 8 (Desai and Desai, 1979).

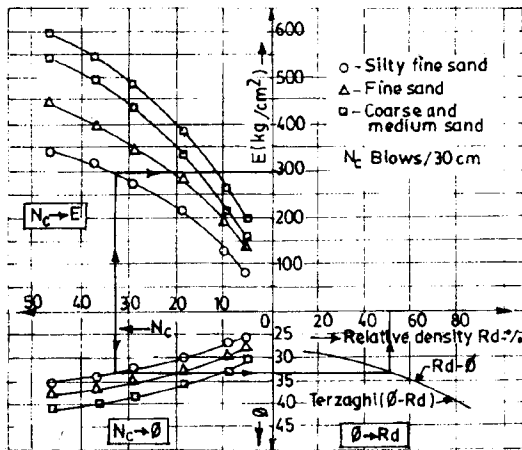
FIGURE 7 : Interpretation of DCP N_c for $Rd - \phi - E$ for Different Sands

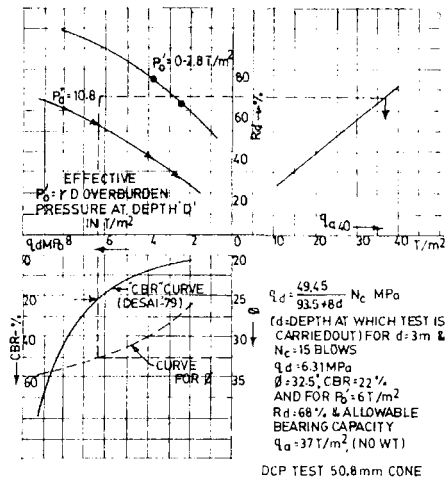
FIGURE 8 : Engineering Properties of Non-cohesive Soils Including CBR by DPSH

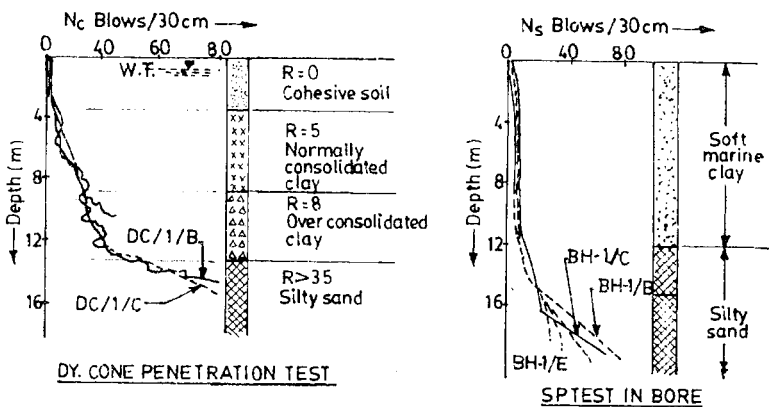
FIGURE 9 : Comparison of Soil Profile by DCP and SPT at Kandla Site

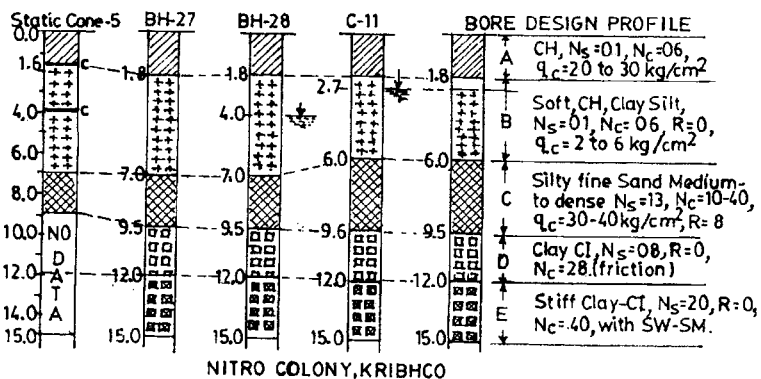
FIGURE 10 : Design Soil Profile Evolved by DCPT Modified by Bores and other Tests

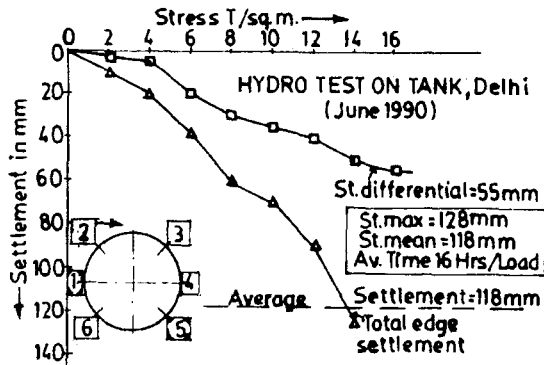
FIGURE 11 : Stress Vs. Settlement (St) of Tank near Delhi

- Notes:
1. Considering average settlement of 118 mm, B = 30 m dia, Mean Foundation Modulus E in-situ works out as 3100 t/m² against 1800 to 3900 t/m² estimated by different practices
 2. Tilt of 24 mm caused by heavy winds on 16/5 increased differential settlement.
 3. Incorrect applications and interpretations affects economy or safety hence survival of GE at end of 20th century.
 4. Permissible differential settlement criteria are very conservative
 5. 5 to 8 mm settlement per t/m² stress and rate of settlement indicate foundation behaviour of sand and not silty sand.

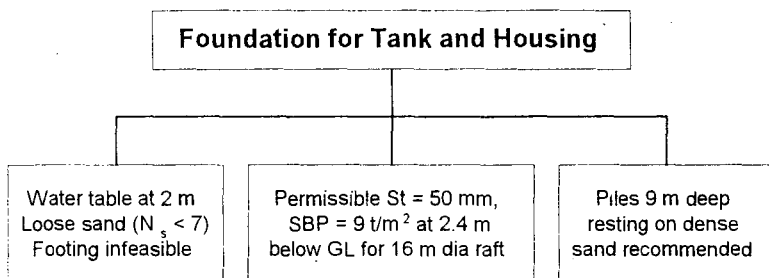
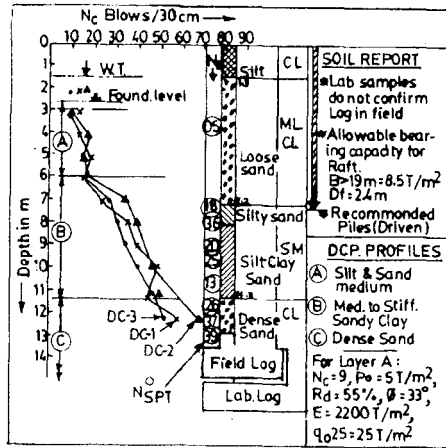
FIGURE 12 : Subsoil Characteristics for Ghaziabad Site for Buildings and Tanks

The relevant data from a soil report for a Ghaziabad site is compiled in Table 11 and Fig. 12. The analysis of SPT – Soil profile showed allowable bearing capacity of 8.5 t/m^2 for a raft foundation. The report therefore recommended 8 to 9 m deep driven piles as the foundation system. For the same data, the writer based on Table 12, obtained allowable bearing capacity of 20 t/m^2 and considered shallow foundation at depth of 2.2 m as technically feasible. The experience and judgement of ISBT and Yamuna Barrage at Delhi as well as other publications (Desai, 1970, 1972) formed the basis for such an opinion.

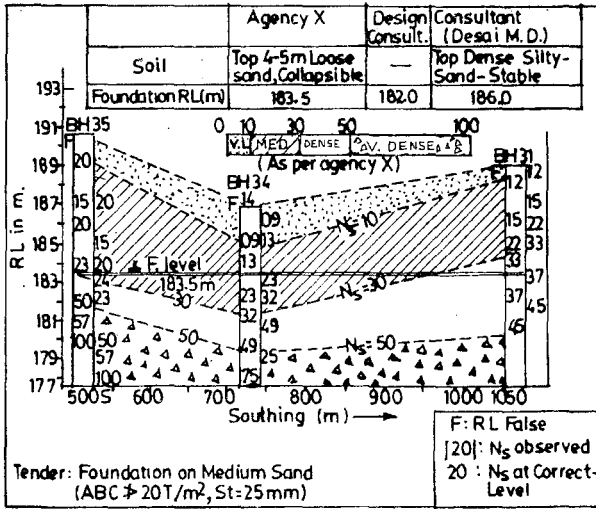
FIGURE 13 : Soil Profile based on Preliminary Exploration of Party X, Project Y with Errors in Levels.

The case studies with such predicament reminds one of Terzaghi's statement: "Soil mechanics is supplement to and not substitute for common sense combined with knowledge acquired by experience". Engineer has to use his judgement despite being fully conversant with principles of soil mechanics. Besides these, even non-geotechnical reasons such as errors in reduced levels (Fig. 13) subsequently corrected (Fig. 14) matter considerably in practice. The resulting influence on depth and consequently resulting economically feasible foundation system, is obvious as shown (Fig. 13). Raw data with over safe

interpretation, misled the consultant to place foundation at RL 183.5 (Fig. 13). The corrected levels and analysis of relative density by author indicate that foundation can be placed at RL 186 (i.e. 2.5 m above).

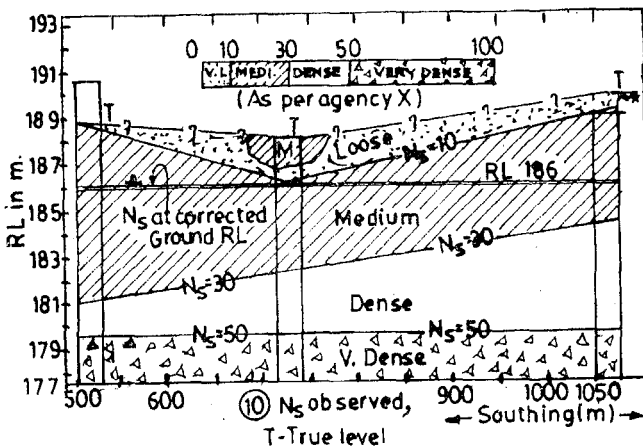
FIGURE 14 : Soil Profile based on Data of X Corrected for Levels and Review of N_s Project Y

Fig. 15. The entire misleading top loose layer of Fig. 14 vanished. At depth beyond one meter, the sand exhibits 70% or more relative density. The turn key tender specifies foundation to be placed on medium dense ($R_d = 30\%$) sand adopting maximum safe bearing capacity of 20 t/m^2 . Writer recommended a foundation level of RL 186 (2 m below ground level). If indirect criteria of N_s is adopted, the foundation levels recommended are as shown in Fig. 15.

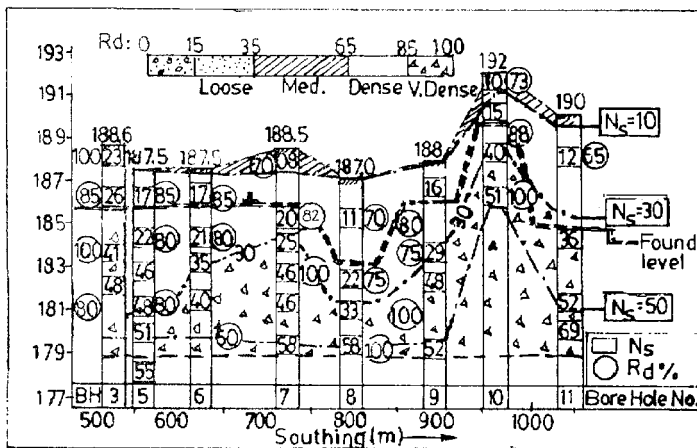
FIGURE 15 : Soil and Rd Profile, Data of Detailed Exploration by Party Z, Project Y

Detailed exploration and direct analysis : The contractor’s detailed exploration data and analysis for density using $N_s - P_o' - Rd$ are shown in

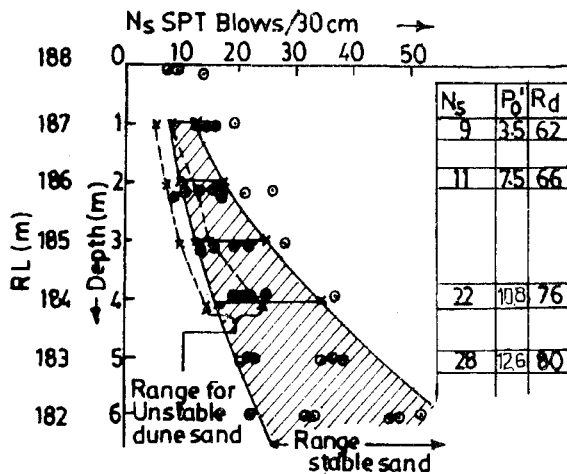
FIGURE 16 : Classification of Desert Sand into Stable, Unstable Groups. Data of Party X and Project Y

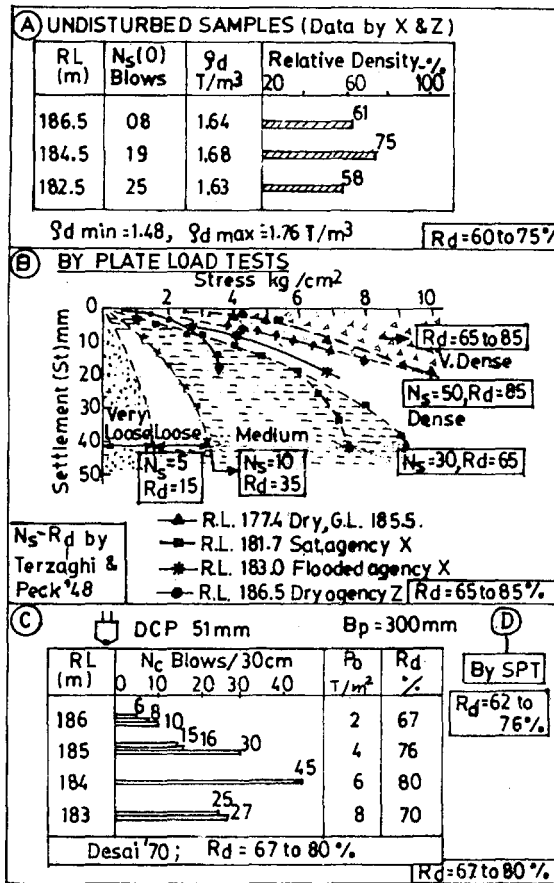
FIGURE 17 : Confirmation of Rd of Desert Sand by Sampling Plate Load, DCPT and SPT – Project Y

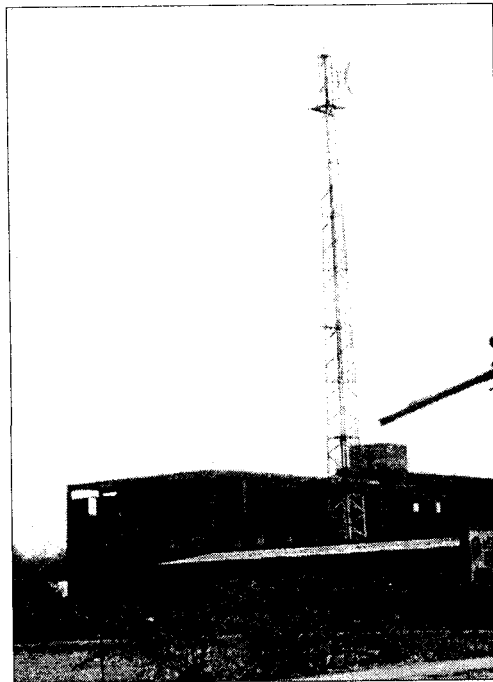
FIGURE 19 : Microwave Tower on SVR Foundations Olpad

The Olpad subsoil was explored by the author. The top 1.2 m CH expansive (DFI = 86%) soil is followed by saturated CI-CH soil up to 2.7 m (WT at 1.3 m). The soil below foundation is stiff clay, NBC = PL, $C_u = 6$ to 10 t/m^2 , Dry density = 1.7 t/m^3 , DPI = 35%. The safe bearing capacity was 20 t/m^2 . Figure 19 shows tower built as per design by author (SVR design). Foundation for a 40 m tower, evolved from type design is shown in Fig. 20. Using same notations, designs of Advanced Mast by author are shown in Fig. 21. The author considered part of the moment as countered by passive pressure. The maximum stresses are 14 t/m^2 and minimum being 0.7 t/m^2 (tensile). The financial implications are analyzed and presented in Table 16

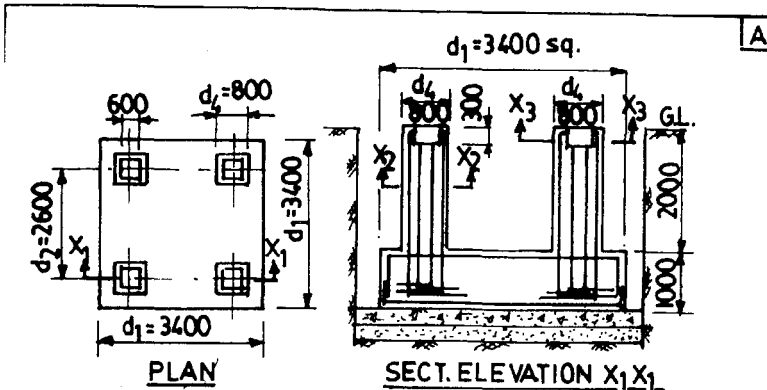
FIGURE 20 : Dimension of Foundation for Transmission Tower using Standard Table (SERC, Roorkee)

- M200 Grade of Concrete with super plastilizer for all concreting work.
- SBC after testing 15T/sq.m. at 3m below G.L (From soil report).
- S.V. Regional College. Design.

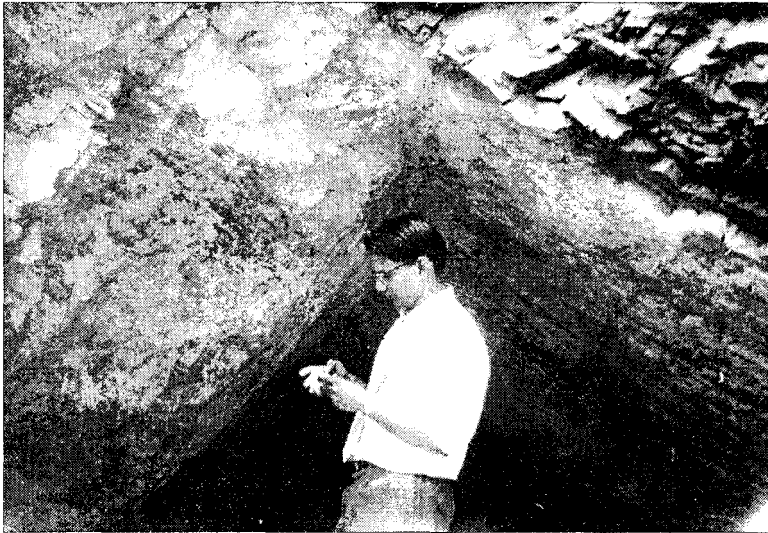
FIGURE 22 : Investigation of Difficulty Subsoil by Drift (Salal Dam)

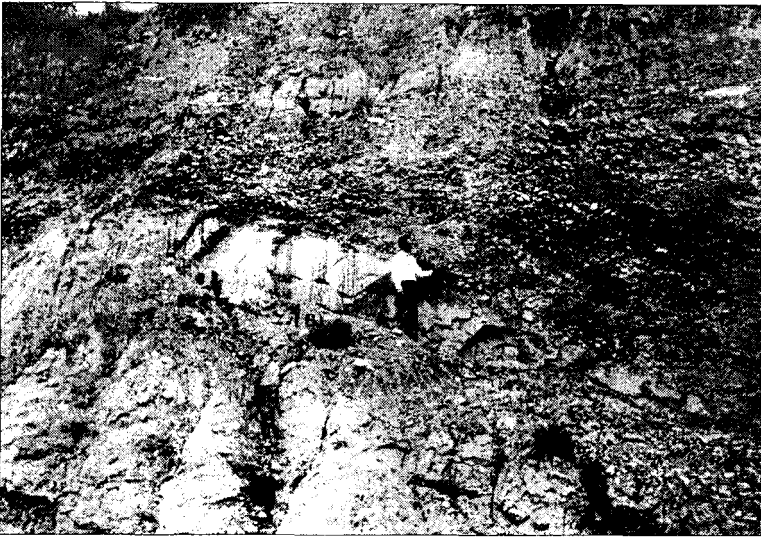
FIGURE 23 : Difficult Terrain Defying Usual Extrapolation of Profile (Ghaggar Dam)

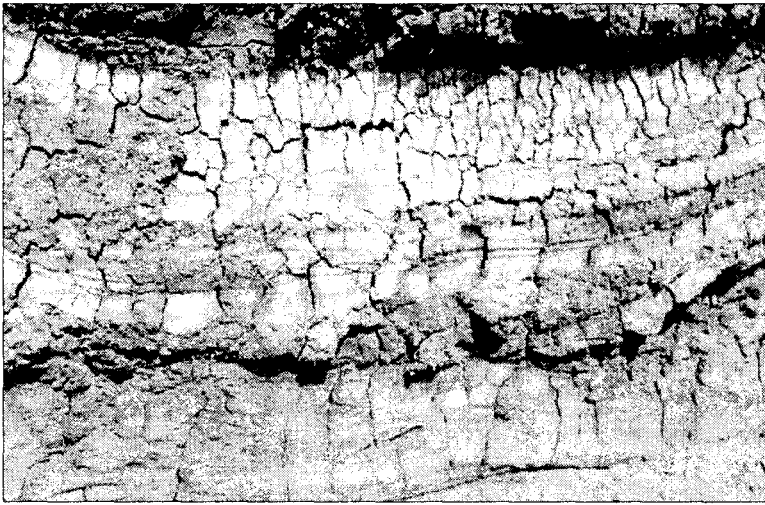
FIGURE 24 : Deep Desiccated Soil Difficult to Sample – Hazira

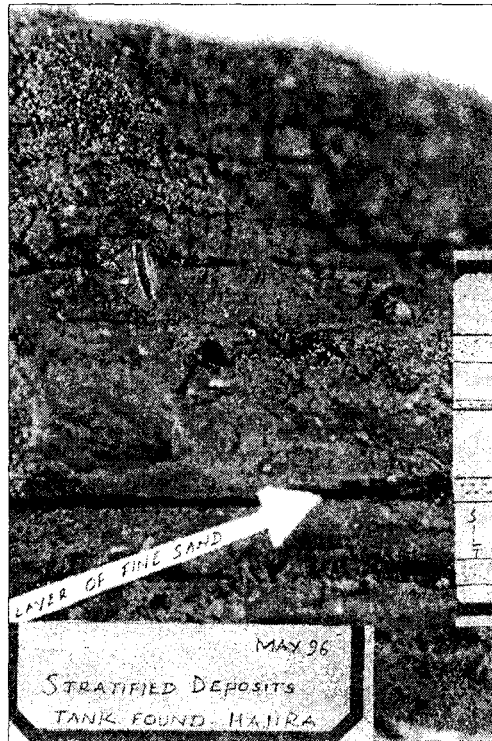
FIGURE 25 : Stratified Deposits at Site for Tank Foundation – Hazira

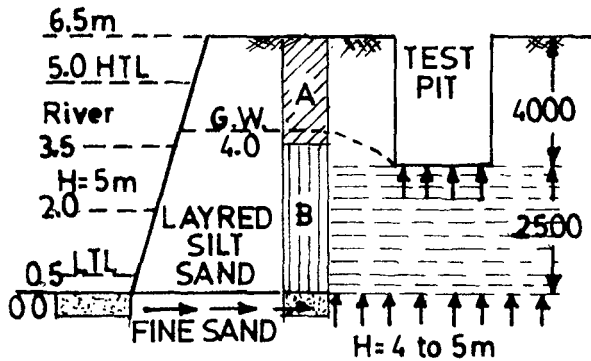
FIGURE 26 : Hydraulic State of Stress – Tank Site at Hajira

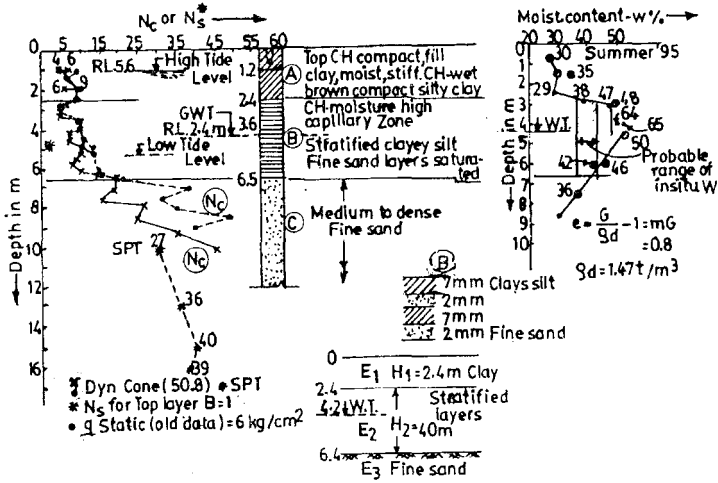
FIGURE 27 : Compilation of Soil Exploration Data – Tank Site Hajira

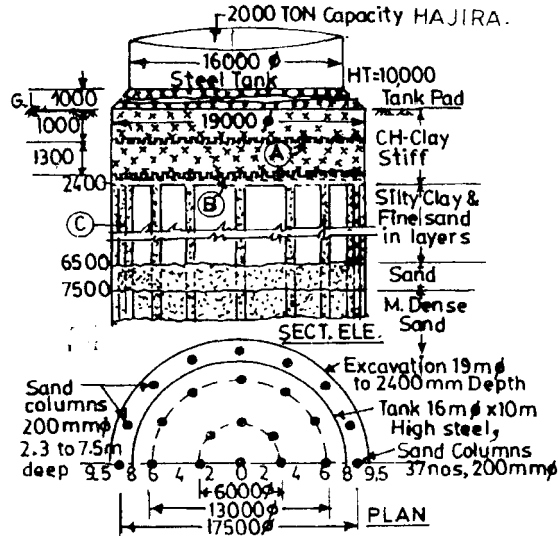
- Notes:-
- (A) Geogrid CE 121 Netlon in sand compacted in layers. R_D to be attained 66% \pm 6%.
 - (B) Geogrid CE 121 with Geofilter PP non-woven Charm CNPP 2 type over 300mm sand.
 - (C) Sand Columns filled with Rammed sand.
 - (D) Open pit below 2.5m depth shall be back filled with pana sand compacted up to excavation level.

Design of the Foundation : The stress analysis shows stress of 8.5 t/m^2 on a 9 m diameter sand pad. Even ignoring stiffness of geogrid reinforcement average stress on compressible clay zone will be 6.7 t/m^2 . This change of stress with overburden pressure of 4 t/m^2 , $m_v = 4 \times 10^3 \text{ m}^2/\text{t}$, $H = 4.7 \text{ m}$ may cause settlement of 50 mm. The permissible settlement of 100 mm will not be exceeded. The time rate

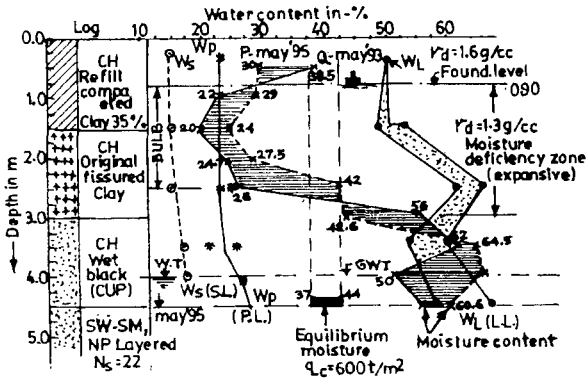
FIGURE 29 : Subsoil Data of Foundation for Dyke Wall – Hajira

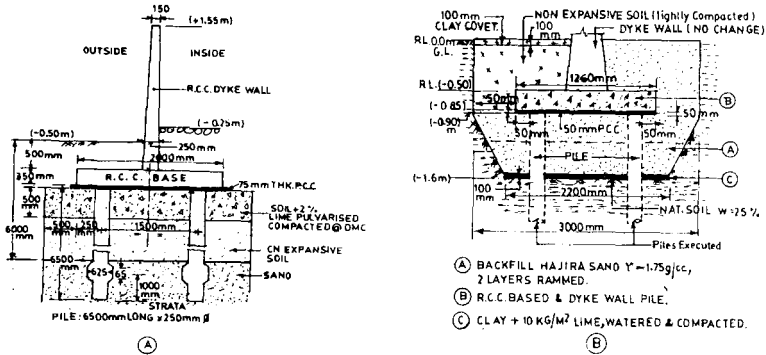
FIGURE 30 : (A) Conventional Design of Foundation; (B) Revisions by Writer during Execution for Dyke Wall Foundation – Hajira

The typical design of dyke wall with load intensity of 2 t/m^2 is shown in Fig. 30(a). Two meier wide strip with double undreamed piles extended up

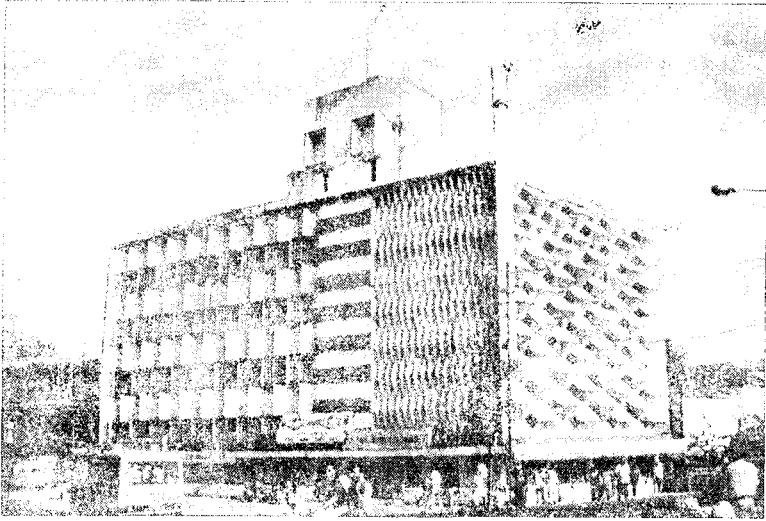
FIGURE 31 : Building showing Tilted Corner -- Cochin

First opinion : On the basis of spot levels within and surrounding the building, a maximum of 560 mm settlement is noticed near corner B, as shown in the sketch. These settlements are 470, 432, 420 mm from surrounding ground level from B to C. Since foundation level was 300 mm above present ground level, when constructed, actual sinking is 720 to 860 mm along north side of building (No data is available for B-A, A-D and G.L). Settlement was recorded at the end of 20 years of its existence.

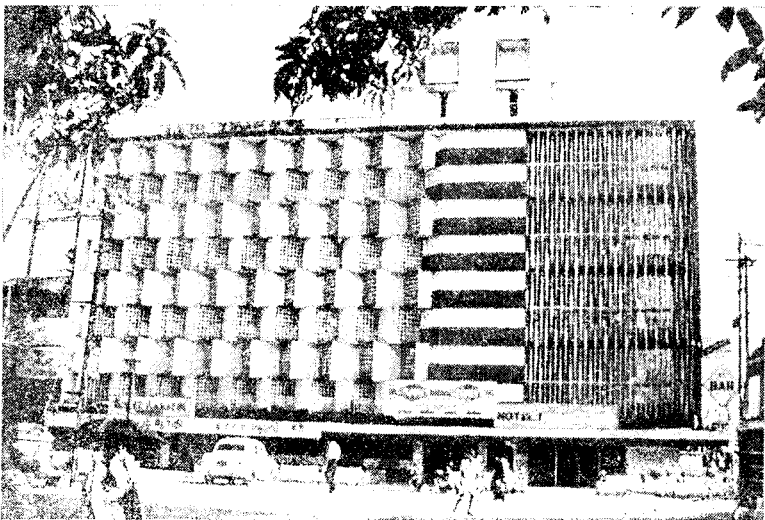
FIGURE 32 : North Face of Building Showing Tilt -- Cochin

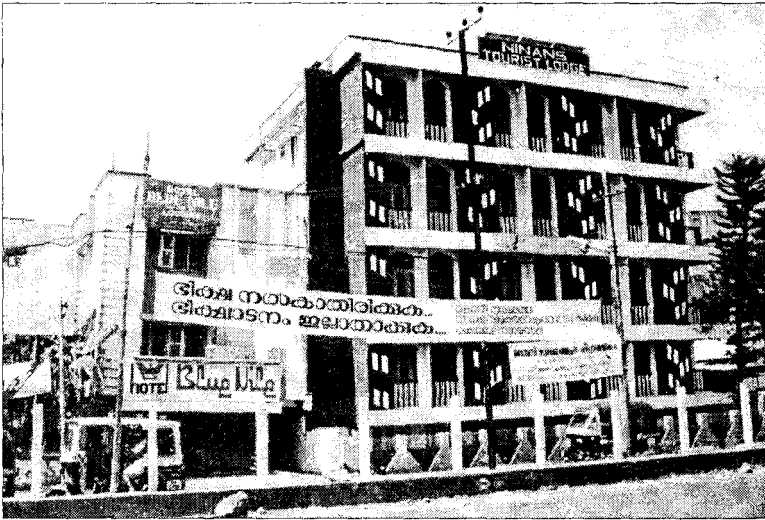
FIGURE 33 : Tilting of Other Building in Cochin

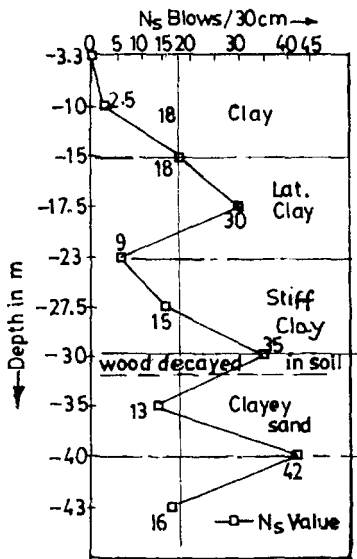
FIGURE 34 : Soil Profile for a Site near Building in Fig. 31

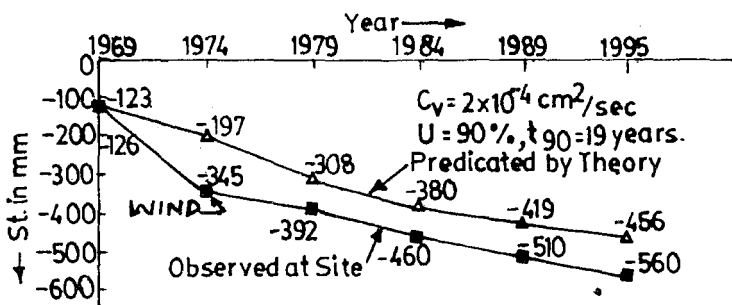
FIGURE 35 : Predicted and Observed Settlements for Building shown in Fig. 31

- The expected theoretical settlement is 456 mm while recorded value is 560 mm in 1993-94. In 1974 settlement was reported as 345 mm (against theoretical value of 197 mm). It is very likely that initial displacement (plastic flow) was high. It has shown equilibrium hence rate of settlement beyond 1995 has been negligible.

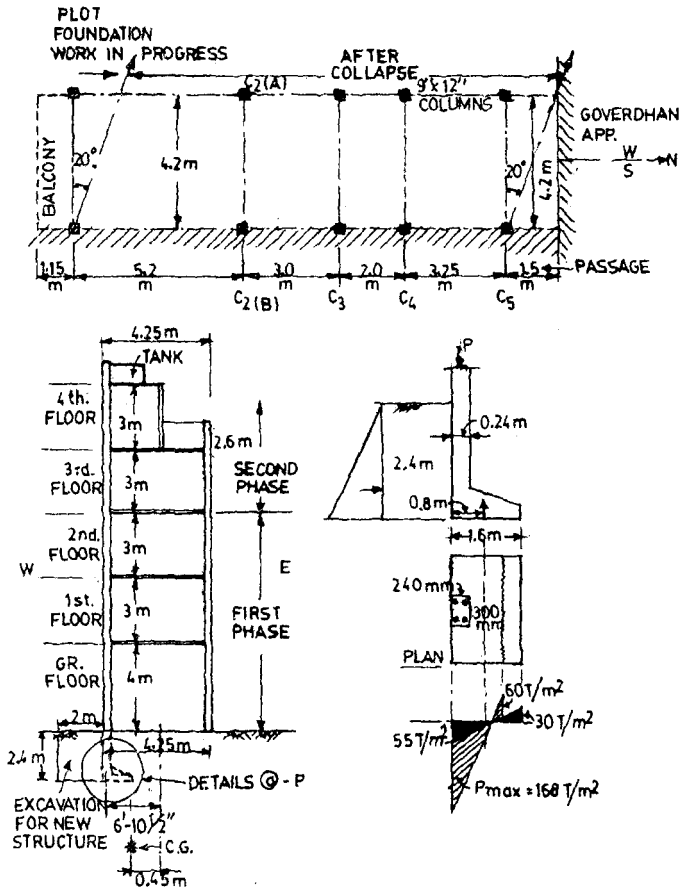
FIGURE 36 : Plan and Layout of Collapsed Building in Surat

The structural steel of 4 bars of 12 mm provided in column $9" \times 15"$, for ultimate load bearing, was inadequate. The redistributed stress shows that factor of safety against shear was just awaiting for an excuse to fail. The excavation for footing in open plot reduced surcharge factor and lateral support of about 10 T. Thus an expected claim of damages from neighbor

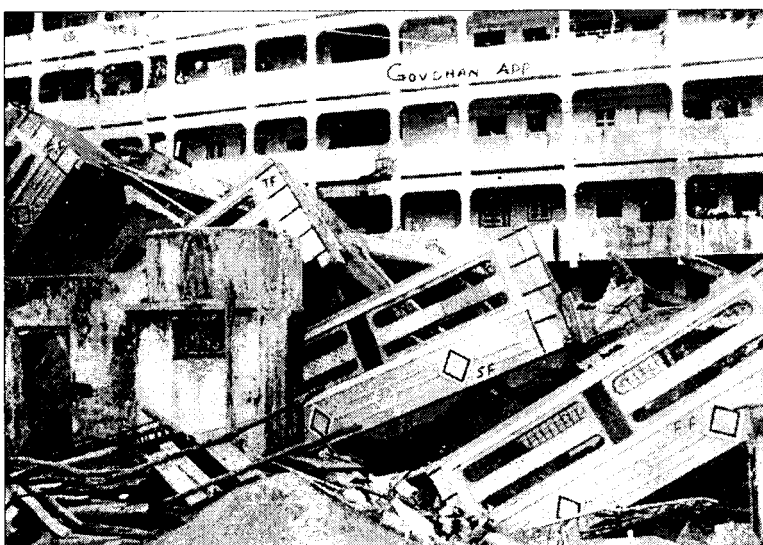
FIGURE 37 : Collapsed Building in Surat

could not be raised. It was proved that structure was unsafe by itself. The frame swayed around column C_2 or C_3 and failed. All west facing columns had lap joints just above the plinth level. 20° rotation and related torsion could be seen from figure.

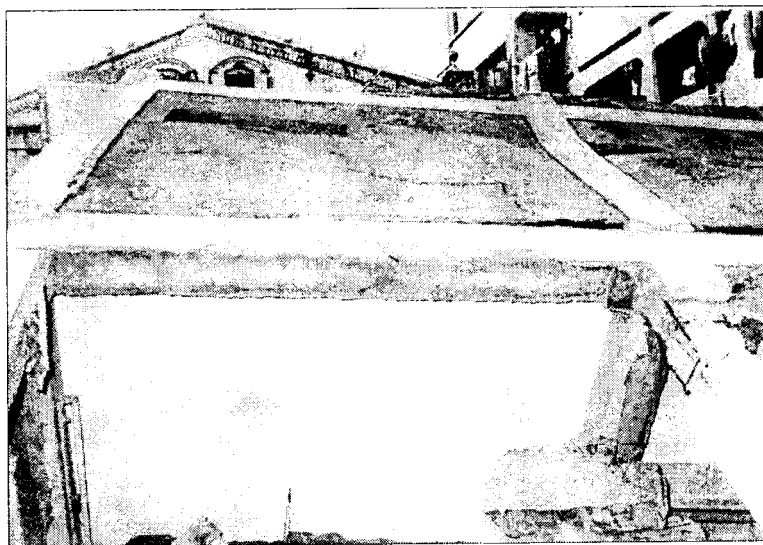
FIGURE 38 : Frame and Wall after Collapse in Surat

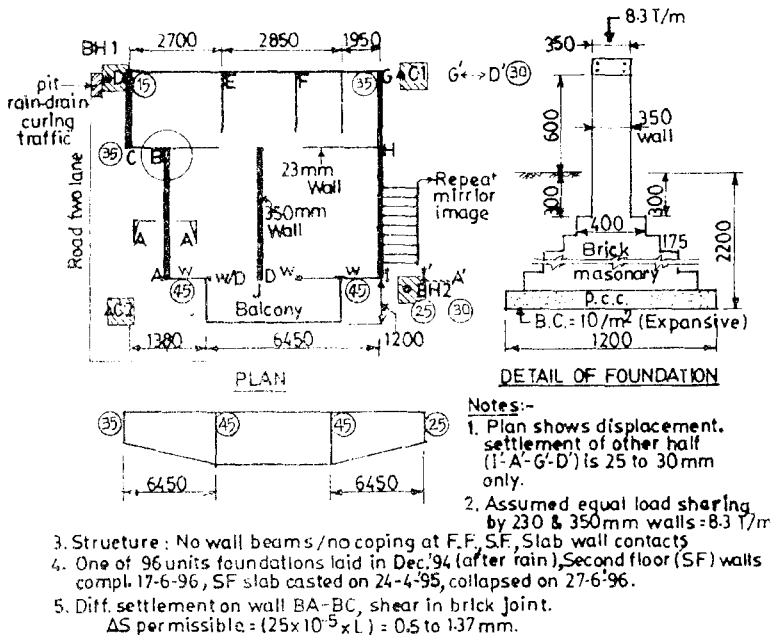
FIGURE 40 : Settlement of Plinth Recorded after Collapse of Building at Ankleshwar

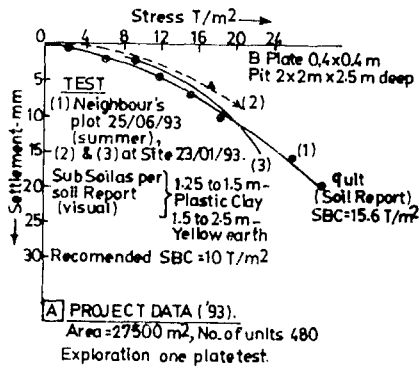
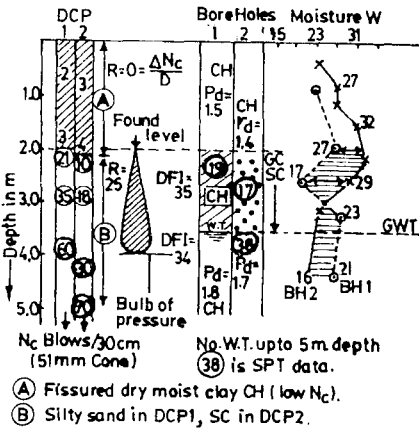
FIGURE 41 : Data of Old and Re-exploration by Writer after Collapse at Ankleshwar

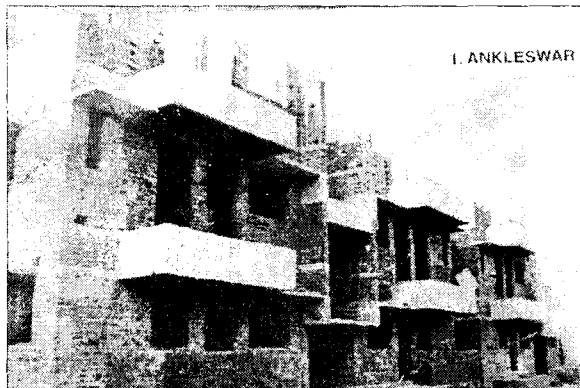
FIGURE 42 : Completed Structure

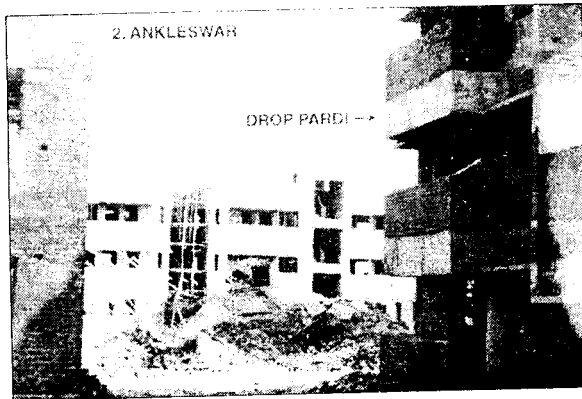
FIGURE 43 : After Collapse of Structure

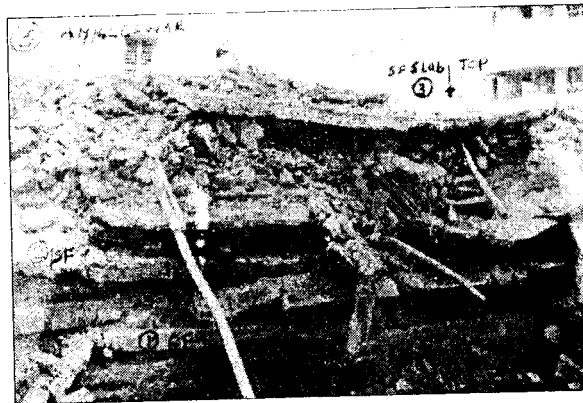
FIGURE 44 : Close-up of Collapsed Structure

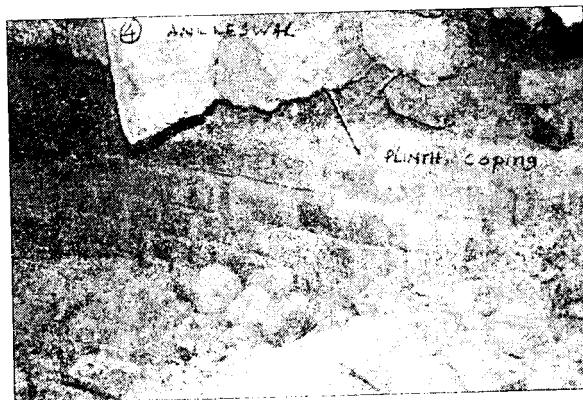
FIGURE 45 : Wall below Plinth after Collapse

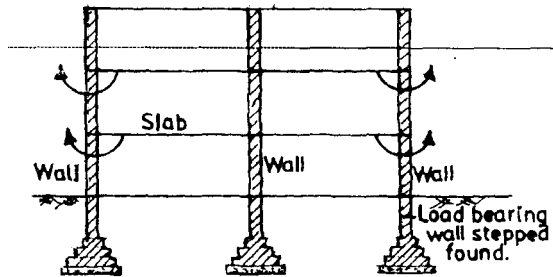
FIGURE 46 : Probable Failure Mechanism – Ankleshwar

Collapse Mechanism: Collapse shows one slab over other, with masonry walls (load bearing) thrown out as shown in Fig. 46. The settlement of 28 mm and

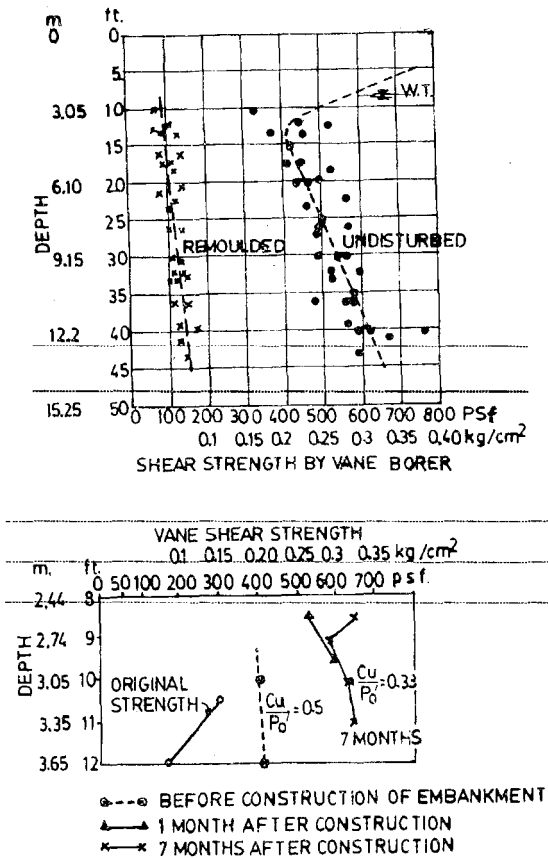
FIGURE 47 : Exploration Data of Vane Borer Showing Improvement of C_u below Test Embankment

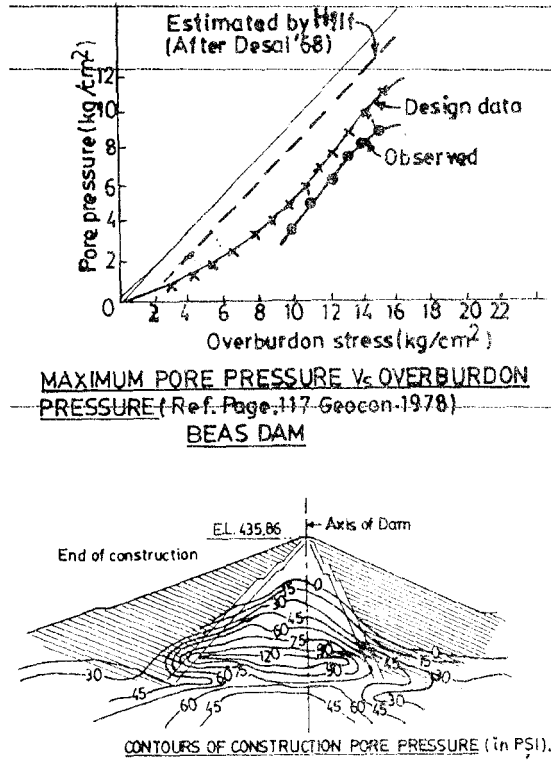
FIGURE 48 : Estimated and Observed Construction Pore Pressures at Beas Dam

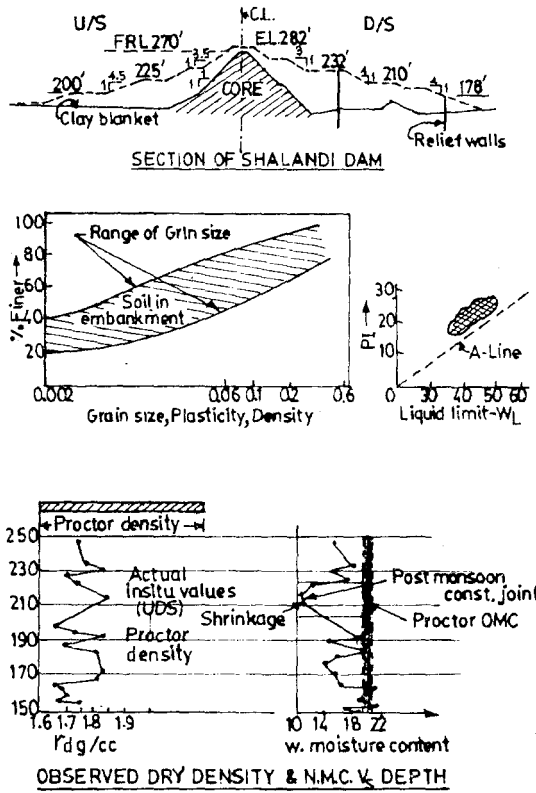
FIGURE 49 : Data of Earthfill based on Bores through Shalandi Dam

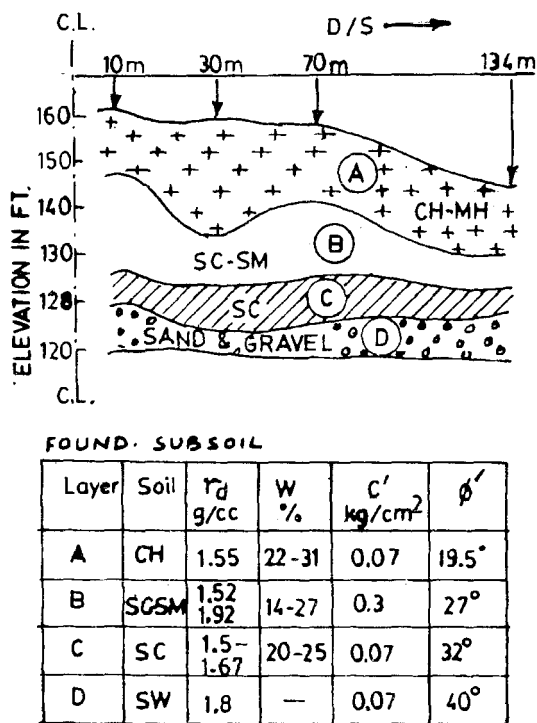
FIGURE 50 : Foundation Profile and Engineering Properties for Shalandi Dam

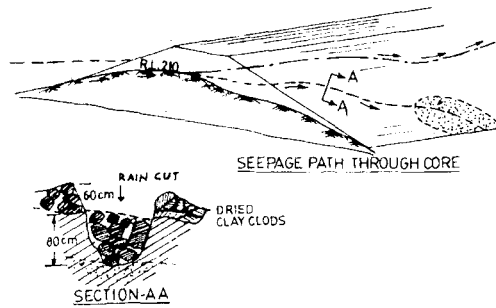
FIGURE 51 : Analysis of Exploration showing Probable Seepage Channels in Core of the Dam

This data and Fig. 51 highlighted a construction joint around RL 210' at centre of dam. The earth work was at different elevations upstream and down stream. The monsoon rain water traversed zigzag on both upstream and down stream to a depth of one meter or so. Post monsoon shrinkage cracks formed dry clods, filled up by deep rain cuts during stripping. Such channels could be from upstream to downstream and are prone to internal piping on filling of reservoir. Relief wells on downstream with controlled filling of reservoir above RL 205 FT was suggested. The seepage patches were observed on downstream in 1969. Low head saturation, over time, allowed clods to swell by 40% thus obstructing free flow of water (self healing). The downstream wet patches dried out with time, confirming self healing works.

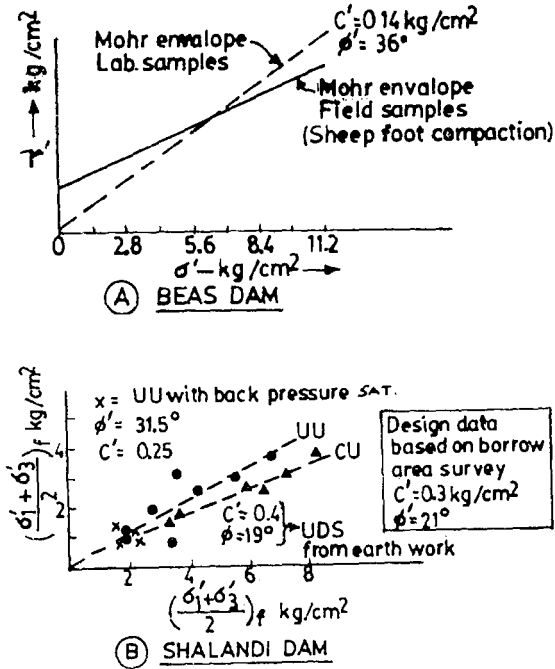
FIGURE 52 : Shear Parameters of Field Compacted Soils Compared with Design Data based on Laboratory Compacted Samples
