21st IGS Annual Lecture

Braced Excavation in Soft Clay – Experiences of Calcutta Metro Constructuion

N.N. Som[†]

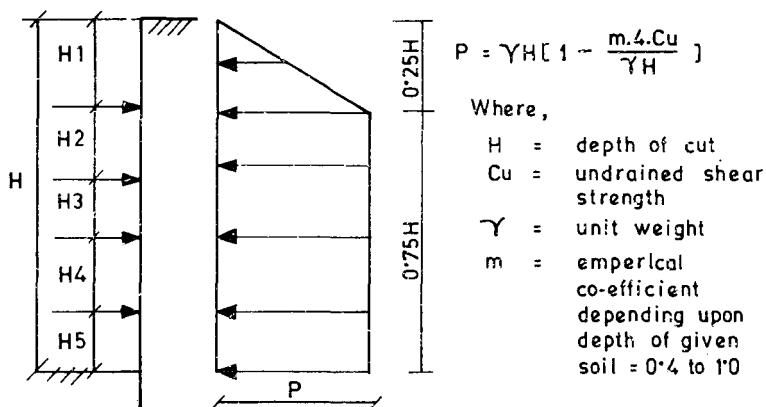
FIGURE 23 : Apparent Earth Pressure Diagram in Braced Cut (Peck, 1969)

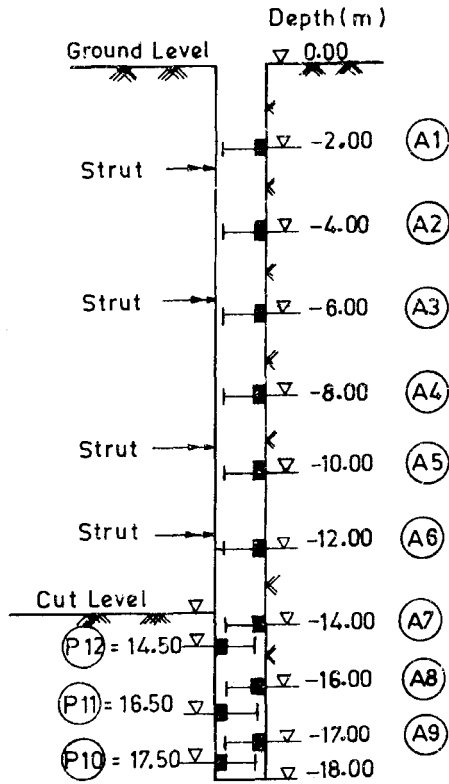
FIGURE 29 : Location of Earth Pressure Cells in Diaphragm Wall

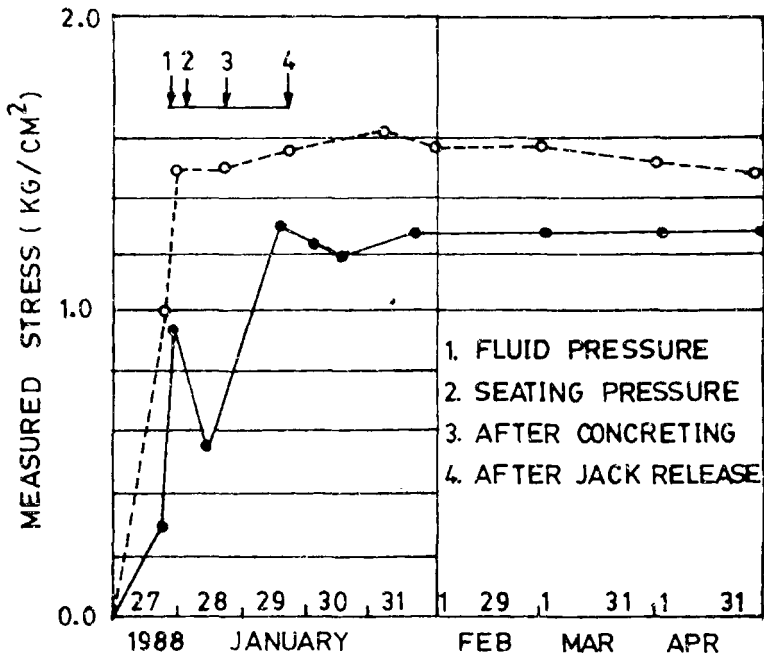
FIGURE 33 : Pressure Cell Readings during Installation

broken lines. The stable pressure cell readings upto four months after concreting of the diaphragm wall are also shown in, Fig. 32. Fig. 33, shows the measured stresses of two typical cells at different stages of installation at Test Section 1. There was some erratic reading during concreting but the pressure tended to stabilize within 7 days.

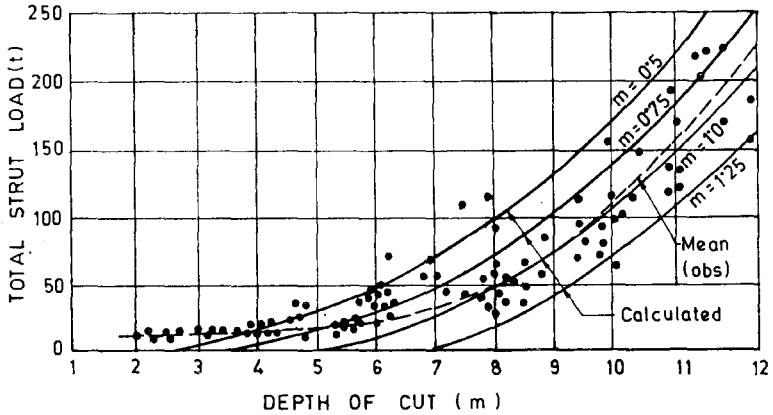
FIGURE 43 : Total Strut Load Vs. Depth of Excavation

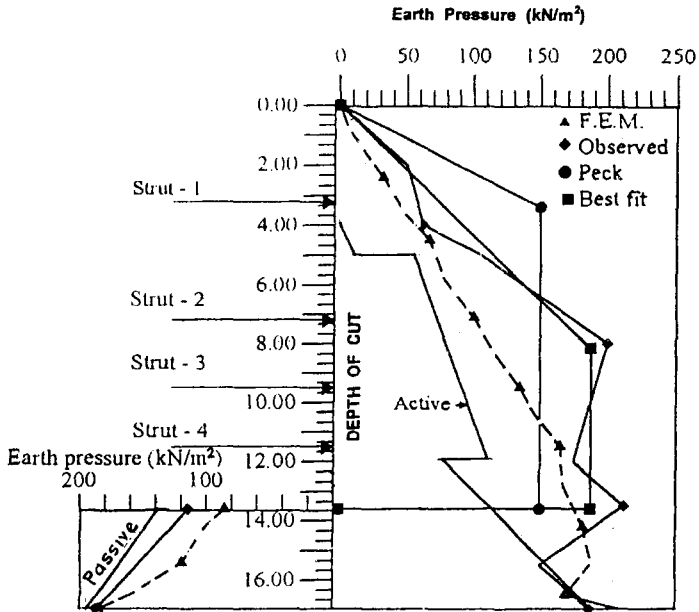
FIGURE 52 : Earth Pressure Distribution from F.E. Analysis

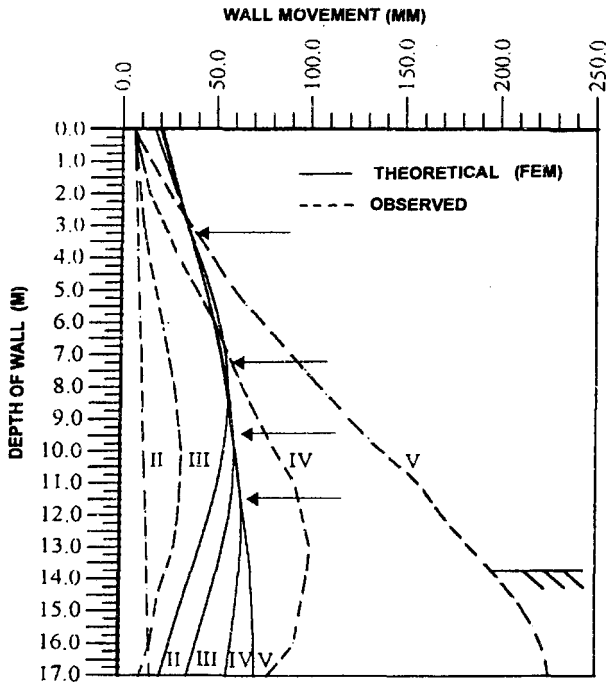
FIGURE 55 : Comparison of Theoretical and Observed Wall Deflection

The theoretical values of the wall deflection are compared with the field measurements for different excavation stages, Fig. 55. The general trend of the wall movement is similar to the observed data but the measured values are higher particularly for greater depths of cut where discrepancy is large.

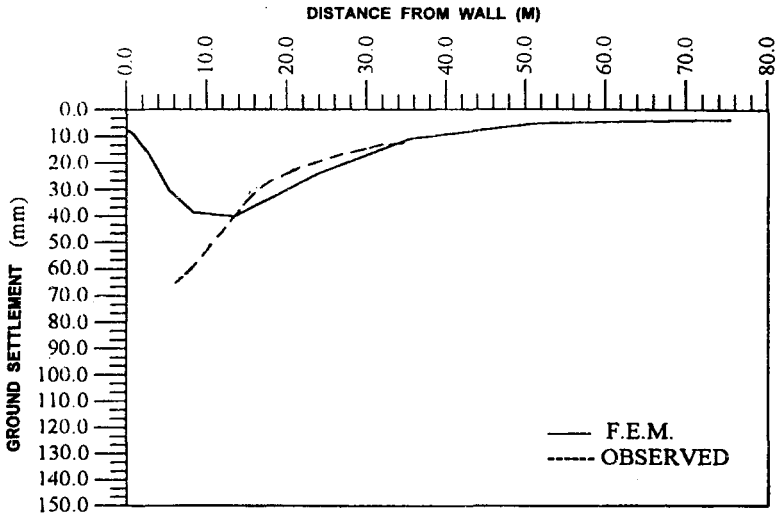
FIGURE 56 : Ground Settlement – Comparison of Theoretical and Observed Data

Figure 56 represents a plot of vertical ground settlement adjacent to the wall for the final stage of excavation while the best fit plots of maximum ground settlement against depth of cut, as obtained numerically and the field are shown in Fig. 57. In general, the ground settlement is underestimated in the FE analysis. This may be due to the fact that the theoretical analysis was carried out under short term conditions and assumed ideal conditions of construction which seldom prevail in the field. Lack of construction control, improper fixation of struts, delay in strut installation, slow rate of excavation etc. come to play. Moreover, long term effects of creep leads to large wall movements. All these factors would lead to discrepancy between the theoretical and observed data.

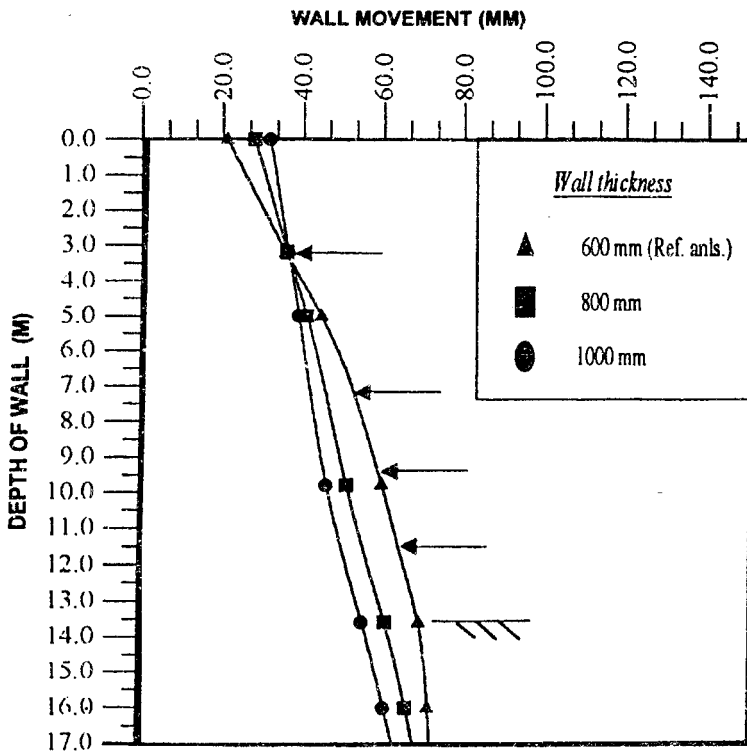
FIGURE 65 : Effect of Diaphragm Wall Thickness on Wall Deflection

Wall Thickness : A parametric study of effect of increasing wall thickness was carried out to investigate its effect on the performance of braced excavation. Increase in wall thickness inevitably means increase in the relative rigidity of the wall. The movement of the diaphragm wall at the final excavation level for different wall thickness is shown in Fig. 65. It is observed that wall thickness does not significantly affect the magnitude of wall deflection. In fact, increasing the wall thickness from 600 mm to 1000 mm reduces the maximum deflection of the wall by only 15 mm. Also, increase in wall thickness does not appear to have any major effect on the ground settlement. It can, therefore, be said that increase in wall thickness does not improve the performance of the braced excavation to a major extent. Similar parametric study of other factors, like strut pre-stressing, soil stiffness and soil anisotropy shows varying degrees of influence on the ground settlement and wall deflection. Of all the factors, however, strut spacing and penetration of wall appear to have the most significant influence on the performance of braced cuts.
